**ASBESTOS CONTAINING MATERIALS
SURVEY REPORT**

**Vacant
Rockhampton North**

Report Number 622.10968.00000/0040-R01-ASR-BLD200

BLD 200 - Vacant
Rockhampton North

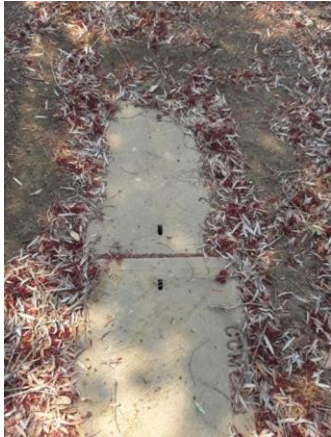
Sample No./ Visual Observation	Photo	Location			Analysis
		Int / Ext Floor Specific Location	Material Application	Extent	Result
1-279

External rear of building	Service pit cap, Fibrous Cement	1m ²	NAD

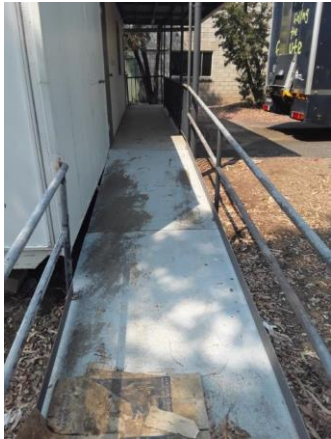
Sample No./ Visual Observation	Photo	Location			Analysis
		Int / Ext Floor Specific Location	Material Application	Extent	Result
1-280

External Ramp to building	Floor, Fibrous Cement	13m ²	NAD
1-281
