**ASBESTOS CONTAINING MATERIALS
SURVEY REPORT**

**Block B
Rockhampton City TAFE**

Report Number 622.10968.00000/0090-R01-ASR-Block B

01 November 2017

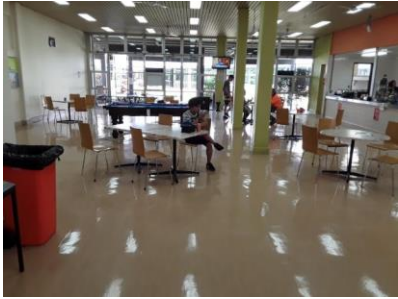
1st Floor B1.01 CANTEEN	VINYL SHEET FLOORING , Vinyl Products	151m ²	NAD
Similar to 3-946

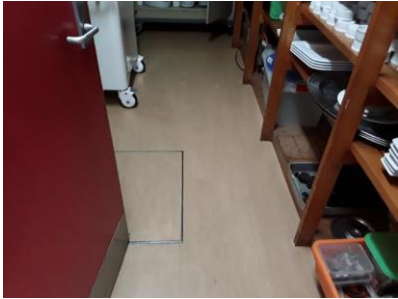
1st Floor B1.131 STORE ROOM	VINYL SHEET FLOORING , Vinyl Products	10m ²	NAD

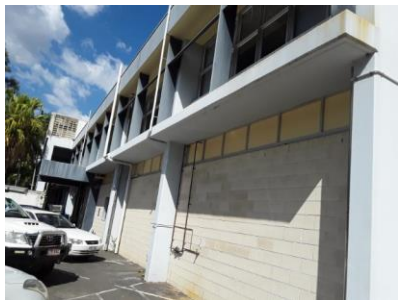
1st Floor INFILL PANELS - ALL ELEVATIONS	INFILL PANELS , Fibrous Cement	36m ²	NAD
3-948	 	1st Floor B1.04 MALE STUDENT TOILET	TOILET PARTITIONS, Fibrous Cement	16m ²	NAD

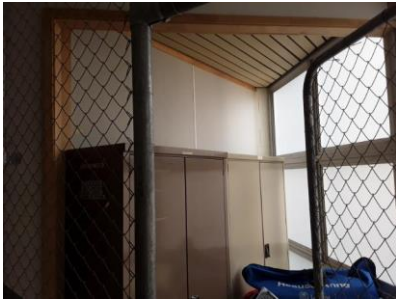
1st Floor B1.08	WALL SHEETING - EASTERN ELEVATION, Fibrous Cement	5m ²	NAD

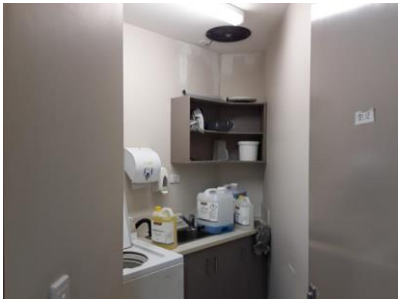
1st Floor B1.12 LAUNDRY - WALL SHEETING - ALL ELEVATIONS	WALL SHEETING - ALL ELEVATIONS, Fibrous Cement	18m ²	NAD
Similar to 3-950

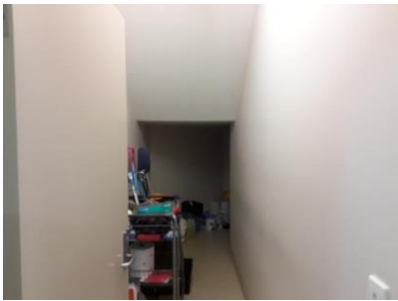
1st Floor B1.09 WALL SHEETING - ALL ELEVATIONS	WALL SHEETING - ALL ELEVATIONS, Fibrous Cement	20m ²	NAD
Similar to 3-950

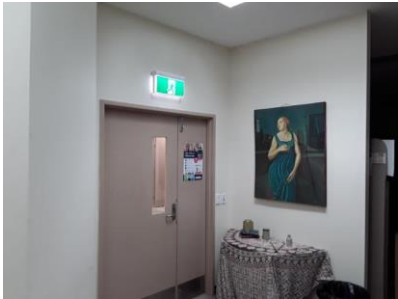
1st Floor B1.37	WALL SHEETING - WEST AND SOUTH ELEVATIONS, Fibrous Cement	30m ²	NAD

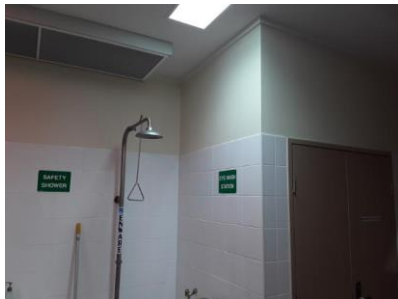
1st Floor B1.35	WALL SHEETING - ALL ELEVATIONS, Fibrous Cement	422m ²	NAD
Similar to 3-950	 	1st Floor B1.36	WALL SHEETING - WEST ELEVATION , Fibrous Cement	35m ²	NAD
Similar to 3-950

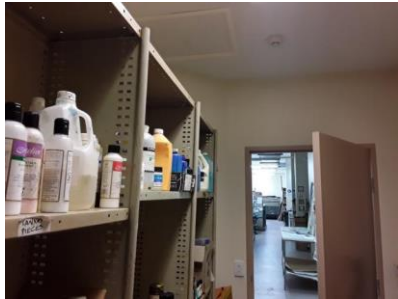
1st Floor B1.33	WALL SHEETING - SOUTH AND WEST ELEVATIONS , Fibrous Cement	10m ²	NAD

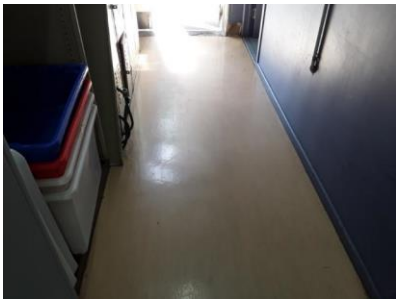
1st Floor B1.168 CORRIDOR - VINYL SHEET FLOOR	VINYL SHEET FLOORING , Vinyl Products	5m ²	NAD
Similar to 3-950	 	1st Floor B1.39 STORE	WALL SHEETING - SOUTH AND WEST ELEVATIONS , Fibrous Cement	17m ²	NAD

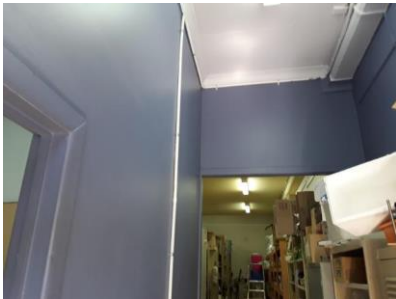
1st Floor B1.68 CORRIDOR	WALL SHEETING - WEST WALL, Fibrous Cement	10m ²	NAD
Similar to 3-950

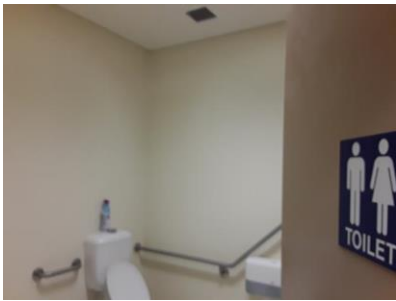
1st Floor B1.78	WALL SHEETING - ALL ELEVATIONS , Fibrous Cement	28m ²	NAD
Similar to 3-950

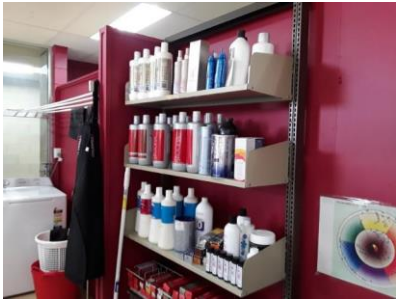
1st Floor B2.60 STORE - WALL SHEETING - SOUTHERN ELEVATION	WALL SHEETING - ALL ELEVATIONS , Fibrous Cement	16m ²	NAD

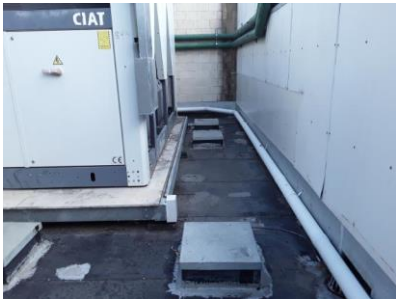
1st Floor NORTHERN ELEVATION - COOLING TOWER - FLOOR	WEATHERPROOF MEMBRANE TO FLOOR, Bituminous Product	54m ²	NAD
Similar to 3-946	 	2nd Floor B 2.28 GENERAL STUDIES AREA - VINYL SHEET TO KITCHENTTE	VINYL SHEET FLOORING , Vinyl Products	5m ²	NAD
Similar to 3-946	 	2nd Floor B 2.21 STORE	VINYL SHEET FLOORING , Vinyl Products	22m ²	NAD

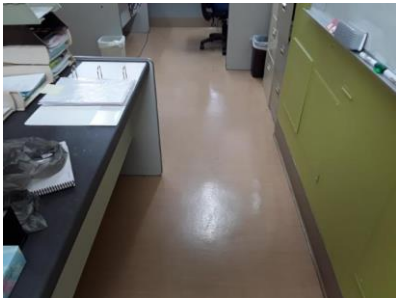
2nd Floor B 2. 61 OFFICE	VINYL SHEET FLOORING , Vinyl Products	20m ²	NAD
Similar to 3-946

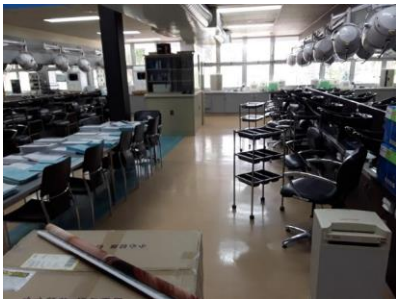
2nd Floor B 2.20 HAIRDRESSING	VINYL SHEET FLOORING , Vinyl Products	85m ²	NAD
Similar to 3-946

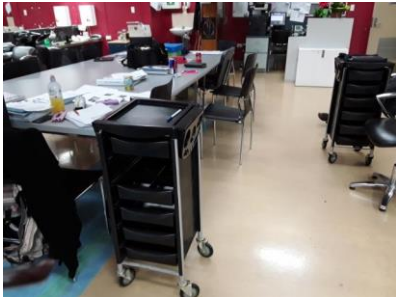
2nd Floor B 2.22 HAIRDRESSING	VINYL SHEET FLOORING , Vinyl Products	85m ²	NAD

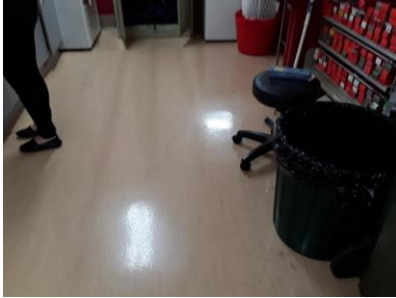
2nd Floor B 2.60HAIRDRESSING	VINYL SHEET FLOORING , Vinyl Products	12m ²	NAD
Similar to 3-946

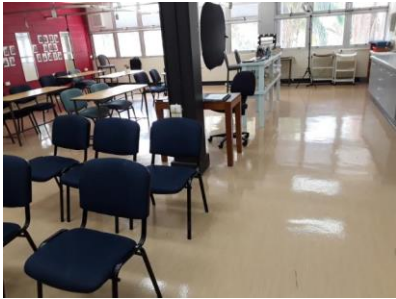
2nd Floor B 2.19	VINYL SHEET FLOORING , Vinyl Products	95m ²	NAD
Similar to 3-951

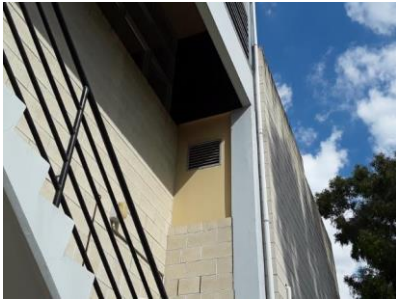
2nd Floor EXTERNAL WALL SHEET - WESTERN ELEVATION	WALL SHEETING - WEST ELEVATION,	2m ²	NAD

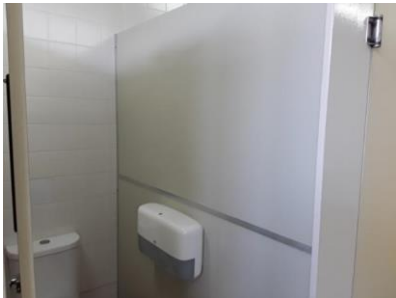
2nd Floor B1.207 MALE STUDENT TOILET	TOILET PARTITIONS, Fibrous Cement	16m ²	NAD
Similar to 3-946

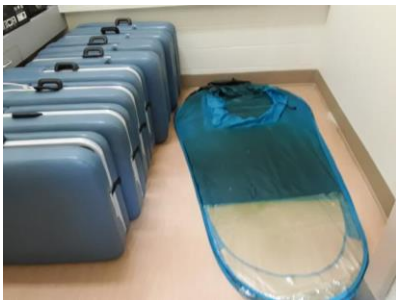
2nd Floor B 2.44	VINYL SHEET FLOORING , Vinyl Products	9m ²	NAD
Similar to 3-946

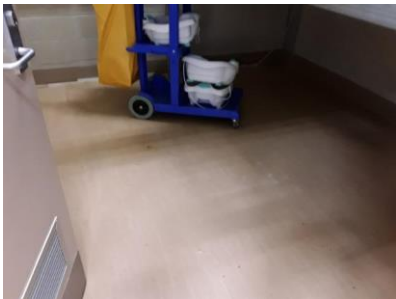
2nd Floor B 2.43	VINYL SHEET FLOORING , Vinyl Products	9m ²	NAD
