**ASBESTOS CONTAINING MATERIALS
SURVEY REPORT**

**Block C
Rockhampton City TAFE**

Report Number 622.10968.00000/0090-R01-ASR-Block C

01 November 2017

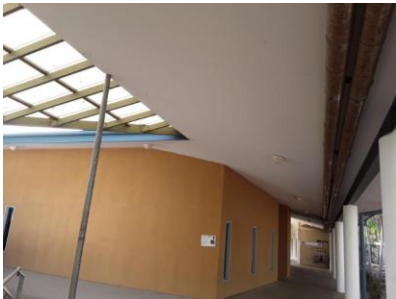
1st Floor EXTERNAL WALKWAY CEILING SHEETING - ALL ELEVATIONS	CEILING SHEETING, Fibrous Cement	220m ²	NAD
3-919	 	1st Floor EXTERNAL COLOUMS	EXTERNAL COLOUMS - WEST ELEVATION, Fibrous Cement	5no	NAD
