**ASBESTOS CONTAINING MATERIALS
SURVEY REPORT**

**Block D
Rockhampton City TAFE**

Report Number 622.10968.00000/0090-R01-ASR-BlockD

01 November 2017

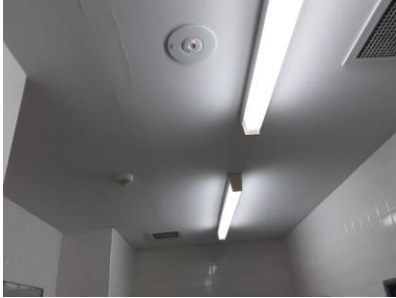
1st Floor D1.17 FEMALE TOILET INCLUDING AIRLOCK - CEILING LINING	CEILING SHEETING, Fibrous Cement	9m ²	NAD
Similar to 3-961

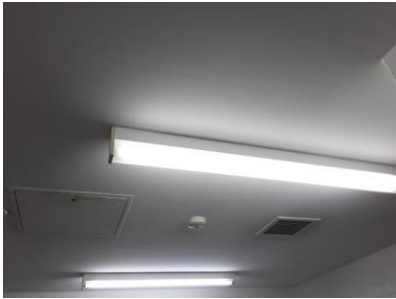
1st Floor D1.17 MALE TOILET INCLUDING AIRLOCK - CEILING LINING	CEILING SHEETING, Fibrous Cement	16.5m ²	NAD
Similar to 3-961

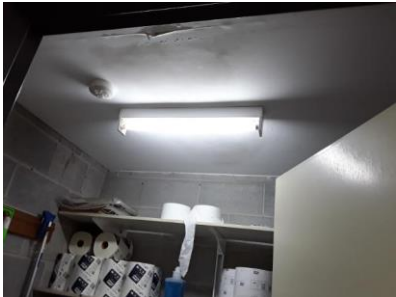
1st Floor D1.20 - CLEANERS CUPBOARD - CEILING LINING	CEILING SHEETING, Fibrous Cement	2.5m ²	NAD

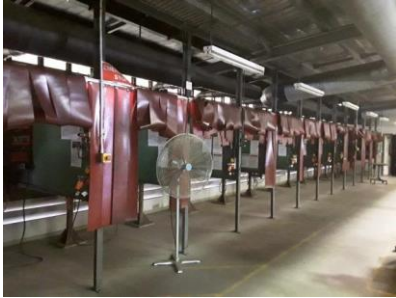
1st Floor D.124 ARC WELDING BAYS	WELDING BAYS , Fibrous Cement	60m ²	NAD
3-962

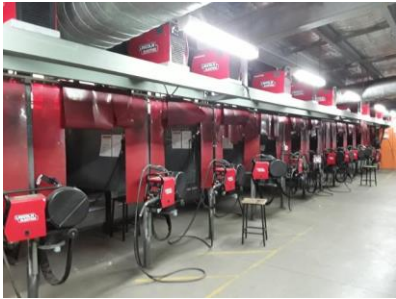
1st Floor D.123 ARC WELDING BAYS	WELDING BAYS , Fibrous Cement	60m ²	NAD
3-963

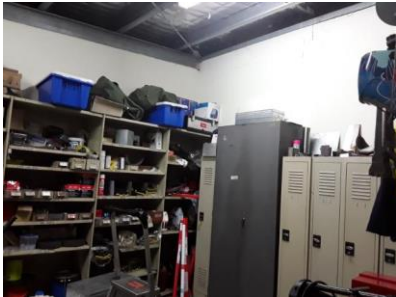
1st Floor D.130	WALL SHEETING - ALL ELEVATIONS , Fibrous Cement	65m ²	NAD
