**ASBESTOS CONTAINING MATERIALS
SURVEY REPORT**

**Block F
Rockhampton City TAFE**

Report Number 622.10968.00000/0090-R01-ASR-BlockF

01 November 2017

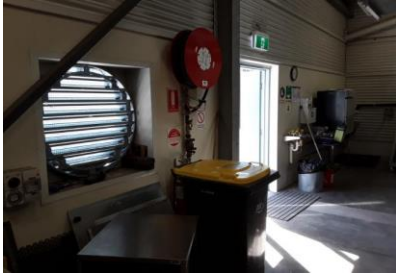
1st Floor F1.10 REFRIDGERATION	WALL SHEETING - NORTH ELEVATION , Fibrous Cement	27m ²	NAD
3-941

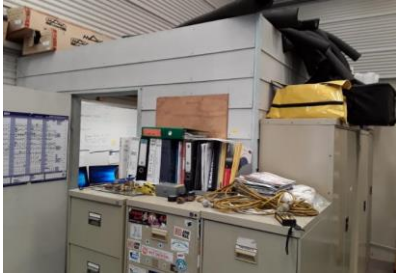
1st Floor F1.10 REFRIDGERATION	WALL SHEETING TO THE OFFICE - HARDIPLANK, Fibrous Cement	13m ²	NAD
3-942

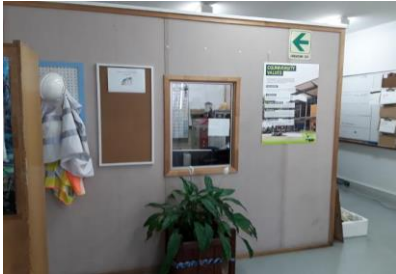
1st Floor F1.04 TEAM LEADER OFFICE	WALL SHEETING - NORTH AND WEST ELEVATION , Fibrous Cement	13m ²	NAD

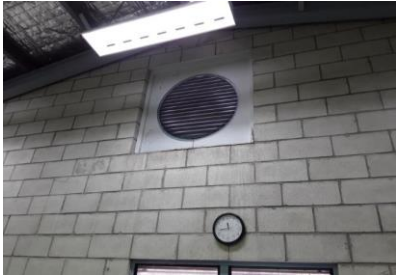
1st Floor F1.08	INFILL PANEL AROUND FAN - SOUTH ELEVATION, Fibrous Cement	1m ²	NAD
Similar to 3-940

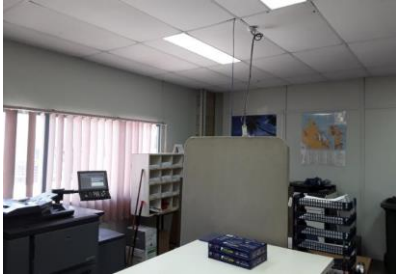
1st Floor F1.07	WALL SHEETING - EAST AND SOUTH ELEVATION, Fibrous Cement	32m ²	NAD
3-943

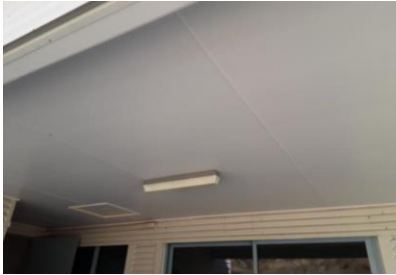
1st Floor EXTERNAL COVERED AREA - WEST ELEVATION	CEILING SHEETING, Fibrous Cement	14m ²	NAD

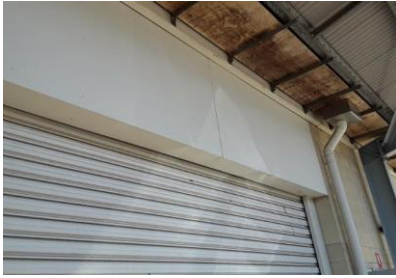
1st Floor EXTERNAL INFILL PANELS ABOVE WINDOWS AND DOORS	INFILL PANELS - EAST ELEVATION, Fibrous Cement	13m ²	NAD
3-944

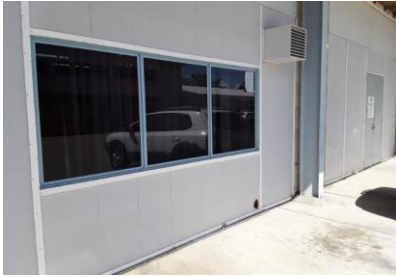
1st Floor EXTERNAL WALL SHEETING	WALL SHEETING - EAST ELEVATION, Fibrous Cement	22m ²	NAD
