# Hazardous Building Materials Assessment Office Block 160 Ann Street Brisbane, QLD 4000

Jones Lang LaSalle

May 2017

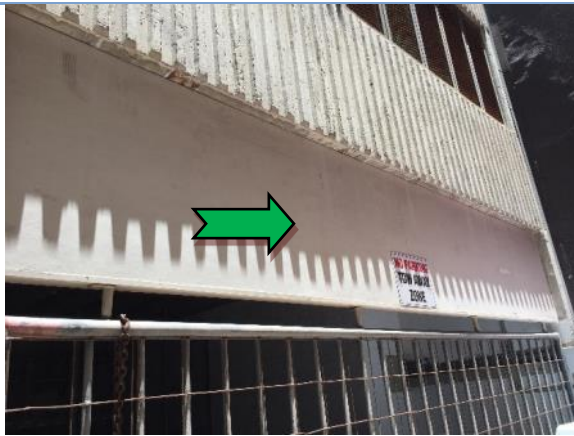
**Photo 1.** Exterior, Level 2 - Car Park, South-Eastern Corner, Above 'No Parking' bay - Infill panels - Fibre Cement Sheet - Non-asbestos containing material

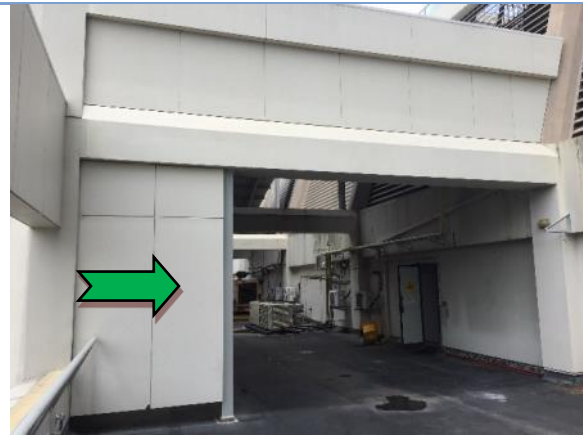
**Photo 2.** Exterior, Level 22 - Southern Elevation, Perimeter. Extends up to Level 23 - Partition Walls - Fibre Cement Sheet - Non-asbestos containing material

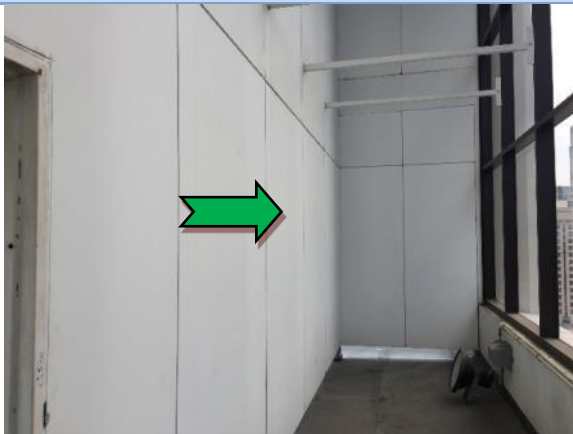
**Photo 3.** Exterior, Level 22 - Southern Elevation, Perimeter. Extends up to Level 23 - Partition Walls - Fibre Cement Sheet - Non-asbestos containing material

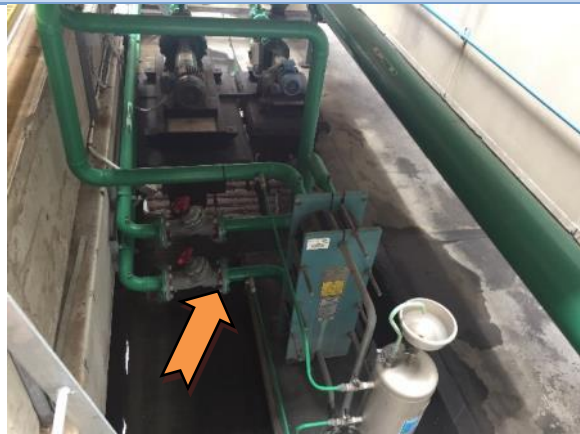
**Photo 4.** Exterior, Level 23 - Cooling tower condenser pump - Gasket - Gasket material - Asbestos containing material

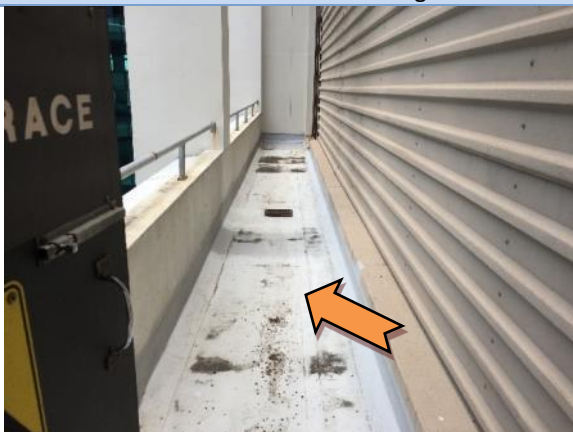
**Photo 5.** Exterior, Level 23 - Eastern Terrace accessed via Toilet Extraction Fan Room - Floor - Bituminous Membrane - Assumed Asbestos containing material

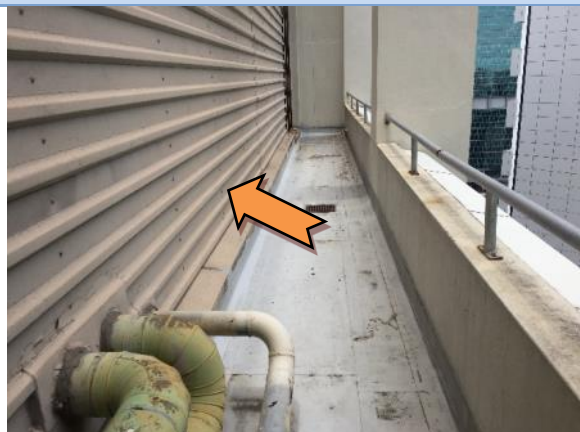
Exterior, Level 23	Northern Elevation, Western Terrace (Extends up to Level 24)	Wall	Galbestos	Asbestos	Coffey Report Ref: ENAUBRIS08680 DA - AM088	Assumed Positive	Non-friable	Low	Fair	Low	60m <sup>2</sup>	Maintain in current condition if to remain in-situ. Remove under controlled bonded asbestos removal conditions prior to refurbishment or demolition works by a Class B (bonded) licensed asbestos removal contractor.	P4	Nov-21	6	
Exterior, Level 23	Southern Elevation, Exterior Façade of Plant Room	Louvres	Galbestos	Asbestos	Coffey Report Ref: ENAUBRIS08680 DA - AM088	Assumed Positive	Non-friable	Low	Fair	Low	100m <sup>2</sup>	Maintain in current condition if to remain in-situ. Remove under controlled bonded asbestos removal conditions prior to refurbishment or demolition works by a Class B (bonded) licensed asbestos removal contractor.	P4	Nov-21	7	
Exterior, Level 23	Western Terrace accessed via Toilet Extraction Fan Room	Floor	Bituminous Membrane	Asbestos	73445-002-002	Positive	Non-friable	Low	Fair	Low	20m <sup>2</sup>	Maintain in current condition if to remain in-situ. Remove under controlled bonded asbestos removal conditions prior to refurbishment or demolition works by a Class B (bonded) licensed asbestos removal contractor.	P4	Nov-21	-

**Photo 6.** Exterior, Level 23 - Northern Elevation, Western Terrace (Extends up to Level 24) - Wall - Galbestos - Assumed Asbestos containing material

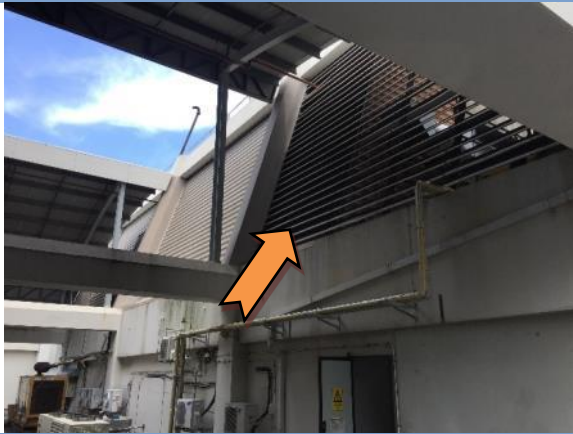
**Photo 7.** Exterior, Level 23 - Southern Elevation, Exterior Façade of Plant Room - Louvres - Galbestos - Assumed Asbestos containing material

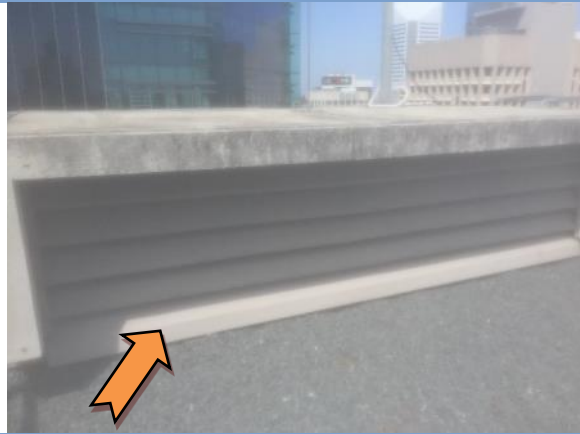
**Photo 8.** Exterior, Rooftop - Eastern Elevation, Fire Stairwell - Louvres - Galbestos - Assumed Asbestos containing material

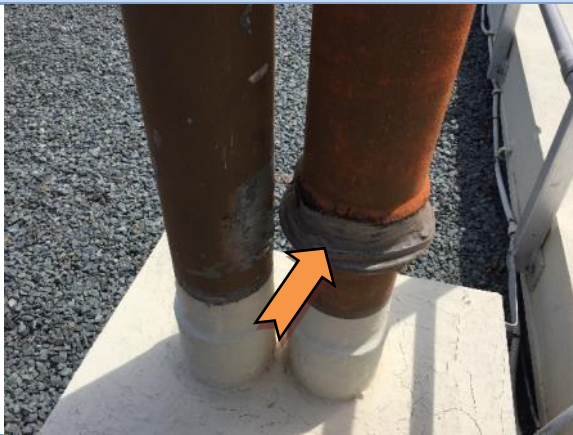
**Photo 9.** Exterior, Rooftop - Northern and Western Elevations - Flue - Mastic sealant - Assumed Asbestos containing material

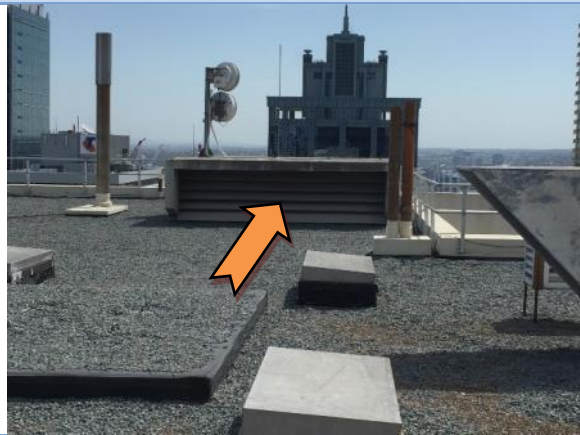
**Photo 10.** Exterior, Rooftop - Western Elevation, Fire Stairwell - Louvres - Galbestos - Assumed Asbestos containing material

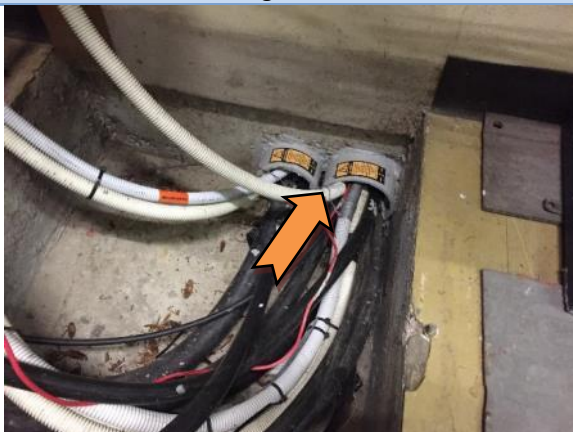
**Photo 11.** Interior, Ground Level - MDF Room, Recess to floor - Conduits - Moulded fibre cement - Asbestos containing material

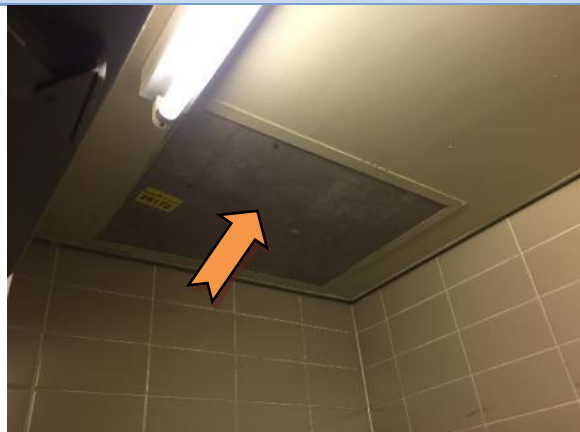
**Photo 12.** Interior, Ground Level - Plant Room 1, Washroom - Access hatch - Fibre cement sheet - Assumed Asbestos containing material - Removed May 2017

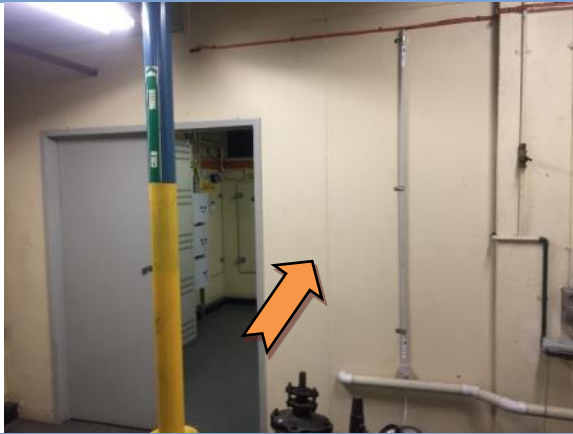
**Photo 13.** Interior, Ground Level - Plant room 2, adjacent to Data Room - Partition Wall - Fibre cement sheeting - Asbestos containing material

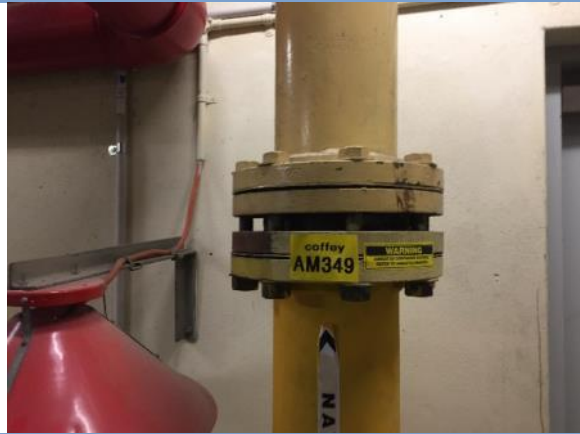
**Photo 14.** Interior, Ground Level - Plant room 2, adjacent to Data Room - Pipework - Gasket material - Assumed Asbestos containing material

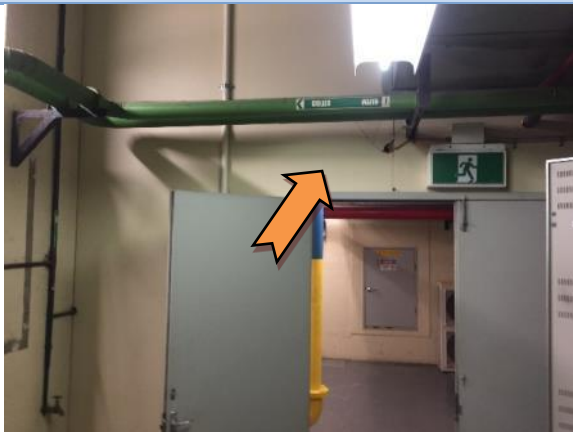
**Photo 15.** Interior, Ground Level - Plant room 2, Data Room - Partition Wall - Fibre cement sheeting - Assumed Asbestos containing material

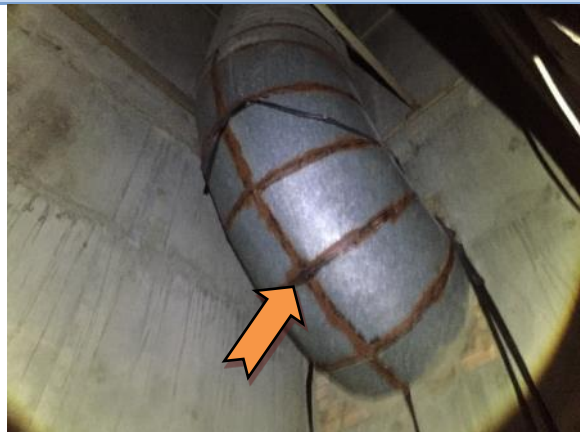
**Photo 16.** Interior, Ground Level - Plant Room 2, Duct Services Room - Duct - Mastic sealant - Assumed Asbestos containing material

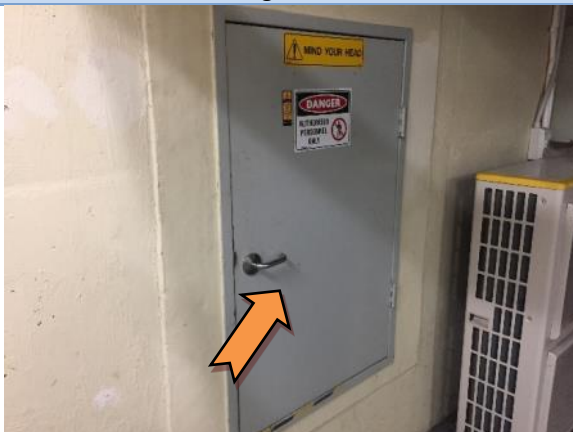
**Photo 17.** Interior, Ground Level - Plant Room 2, Duct Services Room - Door - Fire door core - Asbestos containing material - Removed May 2017

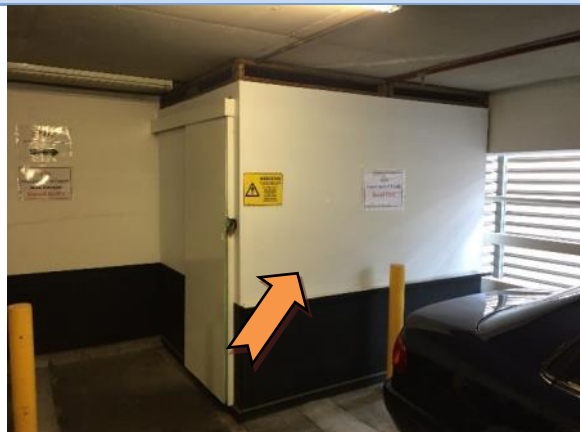
**Photo 18.** Interior, Level 2 - Department of Health & Ageing Store Room, Exterior - Walls - Fibre cement sheeting - Asbestos containing material

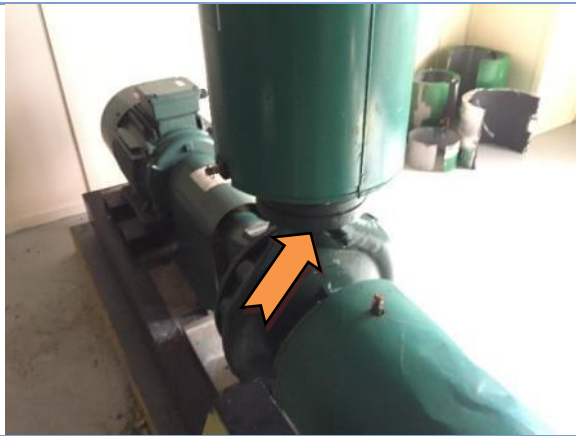
**Photo 19.** Interior, Level 22 - Chiller plant room - Pipe work - Gasket material - Asbestos containing material

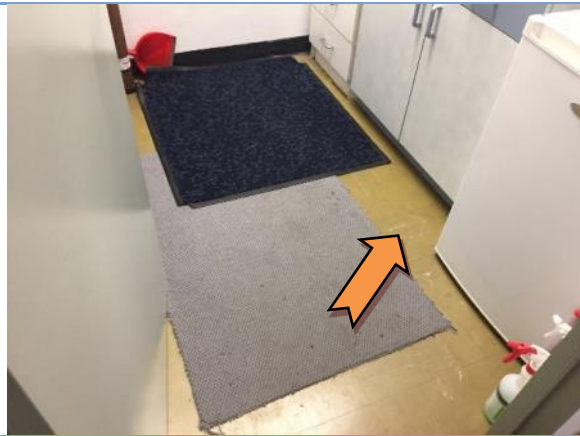
**Photo 20.** Interior, Level 22 - FM Office Kitchen - Floor coverings - brown (light) - Vinyl floor tiles - Assumed Asbestos containing material

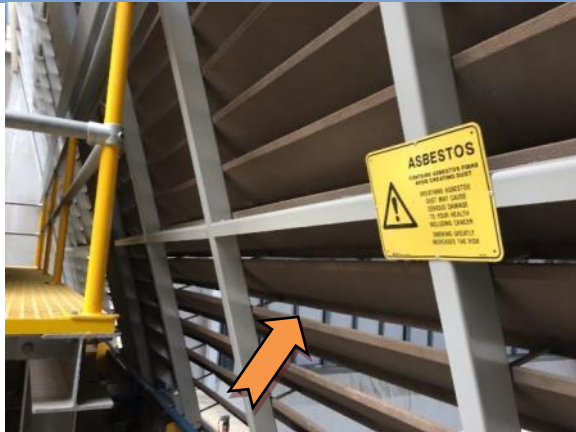
**Photo 21.** Interior, Level 23 - Cooling Tower Enclosure, Perimeter, All Elevations (Extends up to Level 24) - Walls - Galbestos - Assumed Asbestos containing material

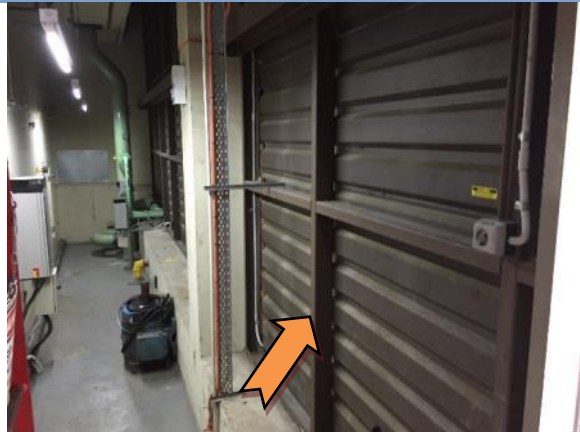
**Photo 22.** Interior, Level 23 - Fan Room, Southern Elevation - Wall - Galbestos - Assumed Asbestos containing material

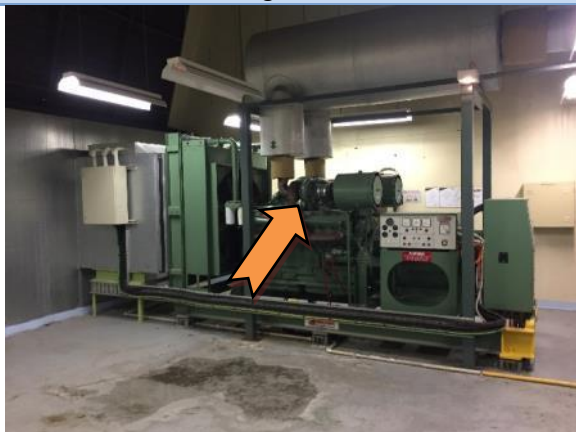
**Photo 23.** Interior, Level 23 - Generator Room - Gasket - Gasket material - Suspected Asbestos containing material

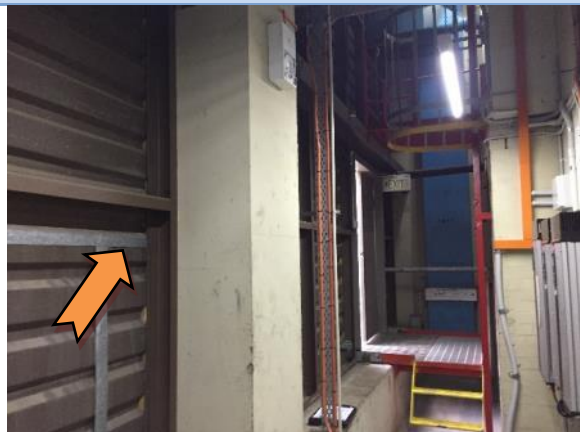
**Photo 24.** Interior, Level 23 - Plant Room, Northern Elevation - Wall - Galbestos - Assumed Asbestos containing material

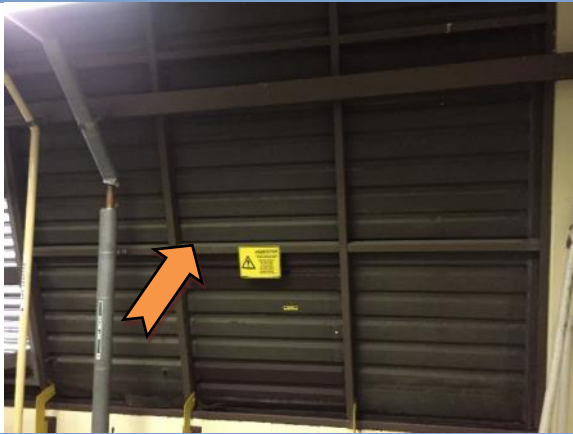
**Photo 25.** Interior, Level 23 - Plant Room, Southern Elevation - Louvres - Galbestos - Assumed Asbestos containing material

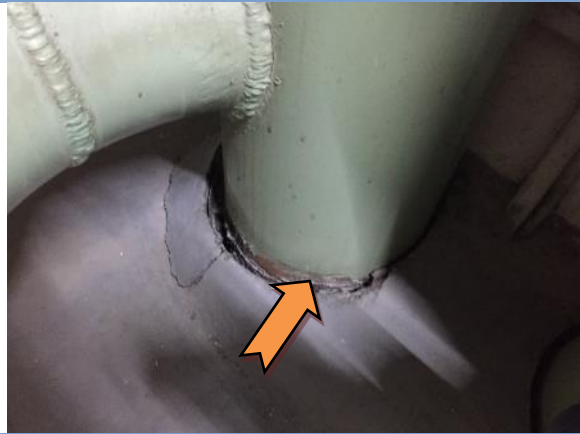
**Photo 26.** Interior, Level 23 - Fan room - Packer - Bituminous membrane - Asbestos containing material

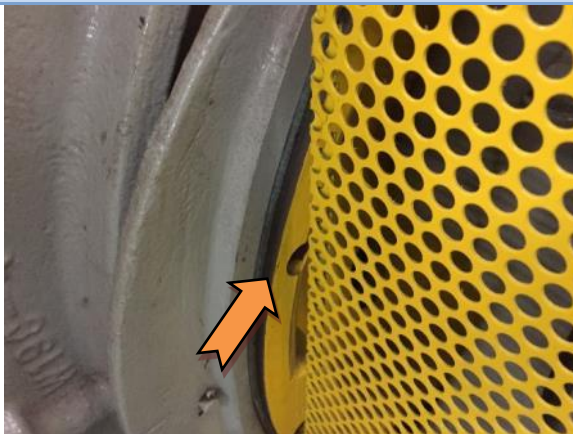
**Photo 27.** Interior, Level 24 - Lift Motor Room - Lift motor - Friction pads - Asbestos containing material

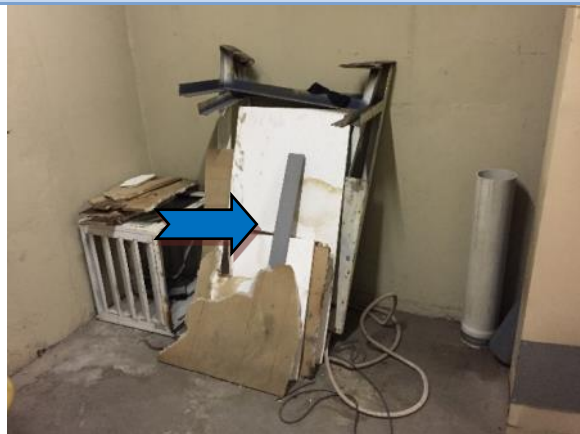
**Photo 28.** Interior, Level 23 - Toilet Extraction Fan Room (Accessed via ladder from Level 22 Plant Room behind FM Office) - Debris - Suspected SMF material - Not sighted in May 2017
