COMPLIANCE ASBESTOS RE-INSPECTION AND RISK ASSESSMENT

J033427

C126956 CQ University Australia

BUNDABERG CAMPUS_Campus Grounds
Isis Highway
Bundaberg QLD
4670

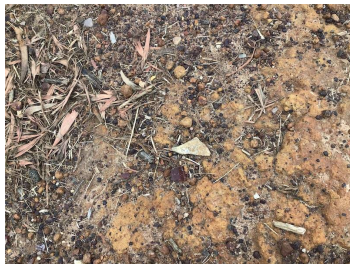
Location		Campus Grounds - Ground Floor - Forensic Crash Lab Grounds - -24.899345, 152.311433 - Debris - Fibre cement sheet									
Hazard Type		Asbestos		Material Assessment		Disturbance Assessment					
Friability		Non-friable		Product Type		3		Occupancy		0	
Sample No.		AO000090		Extent of damage		3		Disturbance		0	
Result		Positive Amosite + Chrysotile + Crocidolite		Surface Treatment		1		Exposure		0	
				Asbestos Type		3		Maintenance		0	
Item Number		2		Material Score		10		Disturbance Score		0	
				Priority Score		10		Low

Item 2	Asbestos	Campus Grounds, Ground Floor, Forensic Crash Lab Grounds, -24.899345, 152.311433, Debris - Fibre cement sheet	Remove Under Suitably Controlled Conditions

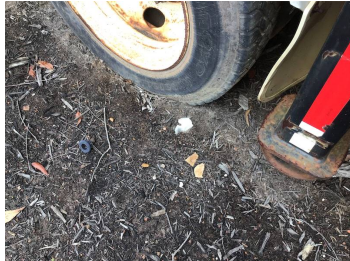
Location		Campus Grounds - Ground Floor - Forensic Crash Lab Grounds - -24.899081, 152.311287 - Debris - Fibre cement sheet									
Hazard Type		Asbestos		Material Assessment		Disturbance Assessment					
Friability		Non-friable		Product Type		3		Occupancy		0	
Sample No.		AO000091		Extent of damage		3		Disturbance		0	
Result		Positive Chrysotile + Amosite		Surface Treatment		1		Exposure		0	
				Asbestos Type		2		Maintenance		0	
Item Number		3		Material Score		9		Disturbance Score		0	
				Priority Score		9		Low

Item 3	Asbestos	Campus Grounds, Ground Floor, Forensic Crash Lab Grounds, -24.899081, 152.311287, Debris - Fibre cement sheet	Remove Under Suitably Controlled Conditions

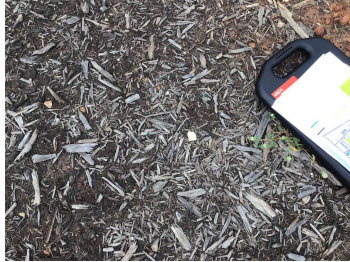
Location		Campus Grounds - Ground Floor - Forensic Crash Lab Grounds - -24.899258, 152.310832 - Debris - Fibre cement sheet									
Hazard Type		Asbestos		Material Assessment		Disturbance Assessment					
Friability		Non-friable		Product Type		3		Occupancy		0	
Sample No.		AO000092		Extent of damage		3		Disturbance		0	
Result		Positive Chrysotile		Surface Treatment		1		Exposure		0	
				Asbestos Type		1		Maintenance		0	
Item Number		4		Material Score		8		Disturbance Score		0	
				Priority Score		8		Very Low

Item 4	Asbestos	Campus Grounds, Ground Floor, Forensic Crash Lab Grounds, -24.899258, 152.310832, Debris - Fibre cement sheet	Remove Under Suitably Controlled Conditions

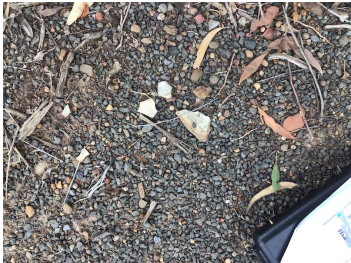
Location	Campus Grounds - Ground Floor - Admin Car Park --24.898323, 152.312297 - Debris - Fibre cement sheet

Hazard Type	Asbestos	Material Assessment		Disturbance Assessment	
Friability	Non-friable	Product Type	3	Occupancy	0
Sample No.	AO000095	Extent of damage	3	Disturbance	0
Result	Positive Chrysotile + Amosite	Surface Treatment	1	Exposure	0
		Asbestos Type	2	Maintenance	0
Item Number	7	Material Score	9	Disturbance Score	0
		Priority Score	9	Low

Item No.	Hazard Type	Item Location and Description	Recommendations
Item 7	Asbestos	Campus Grounds, Ground Floor, Admin Car Park, -24.898323, 152.312297, Debris - Fibre cement sheet	Remove Under Suitably Controlled Conditions

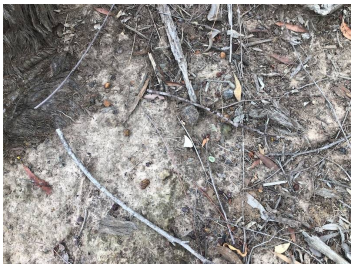
Location	Campus Grounds - Ground Floor - Admin Car Park --24.897947, 152.312165 - Debris - Fibre cement sheet

Hazard Type	Asbestos	Material Assessment		Disturbance Assessment	
Friability	Non-friable	Product Type	3	Occupancy	0
Sample No.	AO000096	Extent of damage	3	Disturbance	0
Result	Positive Chrysotile + Amosite	Surface Treatment	1	Exposure	0
		Asbestos Type	2	Maintenance	0
Item Number	8	Material Score	9	Disturbance Score	0
		Priority Score	9	Low

Item 8	Asbestos	Campus Grounds, Ground Floor, Admin Car Park, -24.897947, 152.312165, Debris - Fibre cement sheet	Remove Under Suitably Controlled Conditions

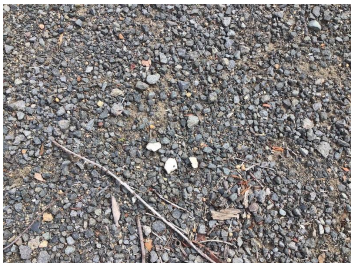
Location	Campus Grounds - Ground Floor - Admin Car Park --24.898838, 152.312127 - Debris - Fibre cement sheet

Hazard Type	Asbestos	Material Assessment		Disturbance Assessment	
Friability	Non-friable	Product Type	3	Occupancy	0
Sample No.	AO000097	Extent of damage	3	Disturbance	0
Result	Positive Chrysotile + Amosite	Surface Treatment	1	Exposure	0
		Asbestos Type	2	Maintenance	0
Item Number	9	Material Score	9	Disturbance Score	0
		Priority Score	9	Low

Item 9	Asbestos	Campus Grounds, Ground Floor, Admin Car Park, -24.898838, 152.312127, Debris - Fibre cement sheet	Remove Under Suitably Controlled Conditions

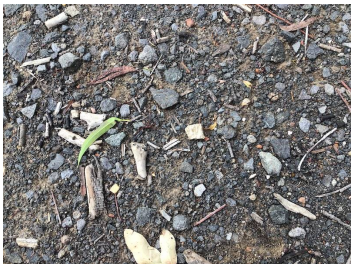
Location	Campus Grounds - Ground Floor - Admin Car Park --24.899304, 152.311872 - Debris - Fibre cement sheet

Hazard Type	Asbestos	Material Assessment		Disturbance Assessment	
Friability	Non-friable	Product Type	3	Occupancy	0
Sample No.	AO000098	Extent of damage	3	Disturbance	0
Result	Positive Chrysotile + Amosite	Surface Treatment	1	Exposure	0
		Asbestos Type	2	Maintenance	0
Item Number	10	Material Score	9	Disturbance Score	0
		Priority Score	9	Low

Item 10	Asbestos	Campus Grounds, Ground Floor, Admin Car Park, -24.899304, 152.311872, Debris - Fibre cement sheet	Remove Under Suitably Controlled Conditions

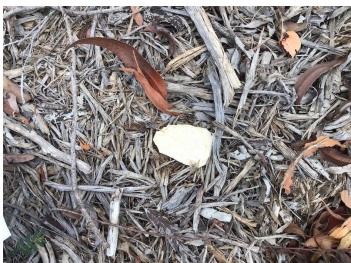
Location	Campus Grounds - Ground Floor - Admin Car Park --24.898867, 152.312029 - Debris - Fibre cement sheet

Hazard Type	Asbestos	Material Assessment		Disturbance Assessment	
Friability	Non-friable	Product Type	3	Occupancy	0
Sample No.	AO000099	Extent of damage	3	Disturbance	0
Result	Positive Chrysotile	Surface Treatment	1	Exposure	0
		Asbestos Type	1	Maintenance	0
Item Number	11	Material Score	8	Disturbance Score	0
		Priority Score	8	Very Low

Item 11	Asbestos	Campus Grounds, Ground Floor, Admin Car Park, -24.898867, 152.312029, Debris - Fibre cement sheet	Remove Under Suitably Controlled Conditions
