ASBESTOS CONTAINING MATERIALS SURVEY REPORT

Building 401
Administration
Bundaberg Campus

Report Number 622.10968.00010-R01-Bld 401-ASR

03 October 2017

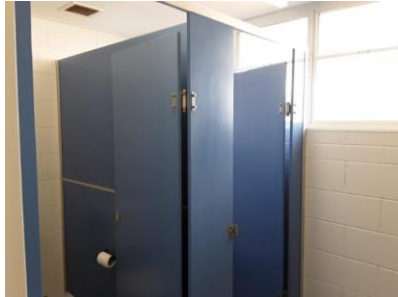
Ground Floor G.T38 MALE STAFF TOILET	TOILET PARTITION, Fibrous Cement	8m ²	NAD
Similar to 3-891

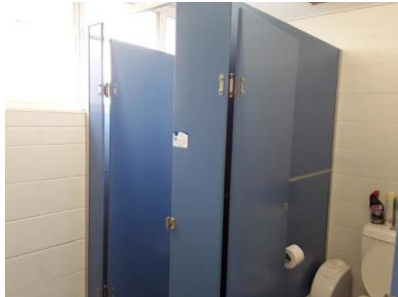
Ground Floor G.T36 FEMALE STAFF TOILET	TOILET PARTITION, Fibrous Cement	8m ²	NAD

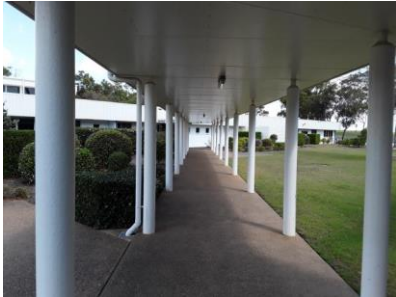
Ground Floor COVERED WALKWAY - SOUTH ELEVATION	COLUMNS, Fibrous Cement	20no	NAD
3-897

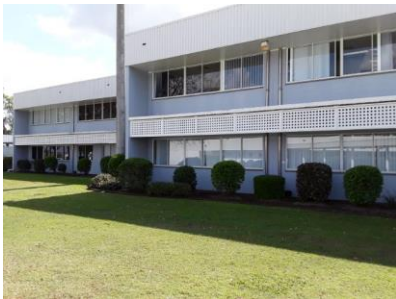
Ground Floor SUN HOOD	LATTACE SUNHOOD SHEETING - SOUTH ELEVATION , Fibrous Cement	20m²	NAD
3-892

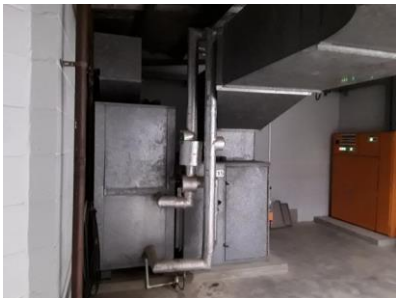
1st Floor 1.P03 PLANT ROOM	PIPE INSULATION, Insulation	45lin m	NAD

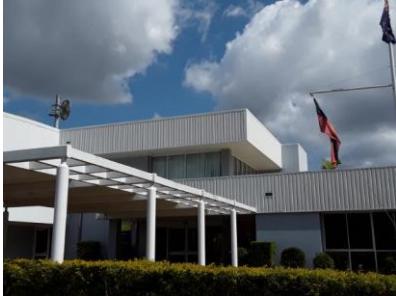
1st Floor SOFFIT SHEETING	SOFFIT SHEETING - NORTH, EAST AND WEST ELEVATIONS, Fibrous Cement	85m ²	NAD
