**ASBESTOS CONTAINING MATERIALS
SURVEY REPORT**

**BUILDING 403
Library
Bundaberg Campus**

Report Number 622.10968.00010-R01- BLD 403-ASR

03 October 2017

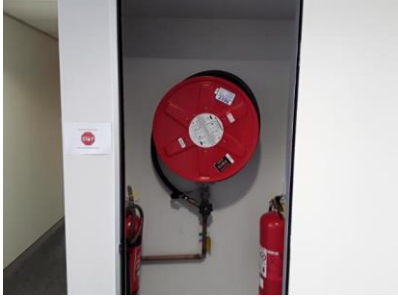
Sample No./ Visual Observation	Photo	Location			Analysis
		Int / Ext Floor Specific Location	Material Application	Extent	Result
3-898

Ground Floor G.F47 FIRE HOSE CUPBOARD	WALL SHEETING - ALL ELEVATIONS, Fibrous Cement	4m ²	NAD
3-899

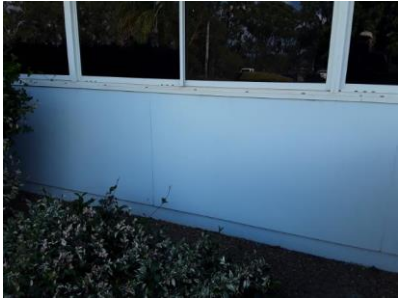
Ground Floor EXTERNAL WINDOW INFILL PANELS	WINDOW INFILL PANELS - NORTH AND EAST ELEVATIONS, Fibrous Cement	27m ²	NAD

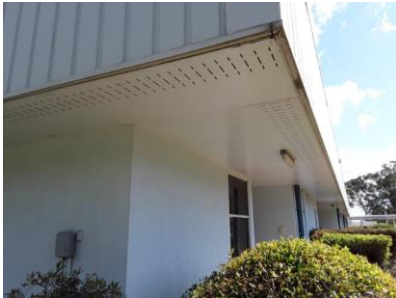
Sample No./ Visual Observation	Photo	Location			Analysis
		Int / Ext Floor Specific Location	Material Application	Extent	Result
3-900

Ground Floor SOFFITS	SOFFIT SHEETING - ALL ELEVATIONS, Fibrous Cement	m ²	NAD
3-901

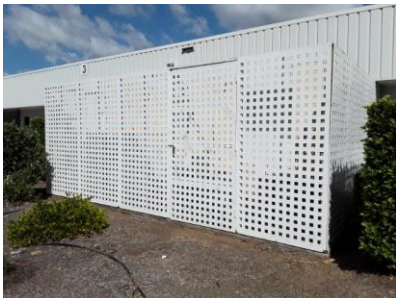
Ground Floor EXTERNAL WALL SHEETING	LATTICE WALL SHEETING - NORTH AND SOUTH ELEVATION, Fibrous Cement	65m ²	NAD
