**ASBESTOS CONTAINING MATERIALS
SURVEY REPORT**

**BUILDING 404
DFM Shed
Bundaberg Campus**

Report Number 622.10968.00010-R01-BLD404-ASR

03 October 2017

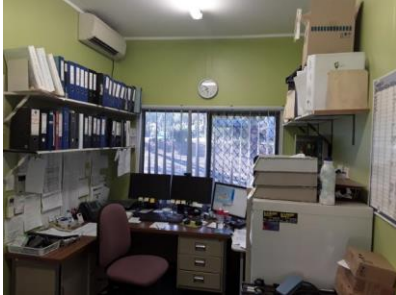
Ground Floor G.01 OFFICE	WALL SHEETING - ALL ELEVATIONS, Fibrous Cement	32m ²	NAD
3-903

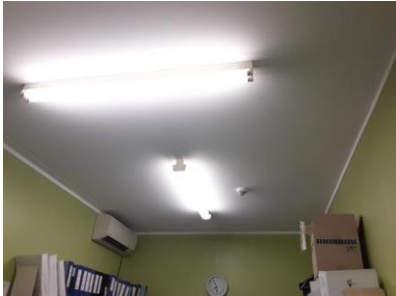
Ground Floor G.01 OFFICE	CEILING SHEETING, Fibrous Cement	10m ²	NAD

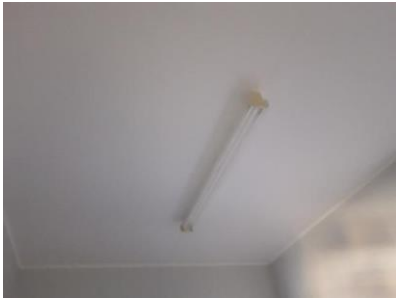
Ground Floor G.02 OFFICE	CEILING SHEETING, Fibrous Cement	10m ²	NAD
Similar to 3-902

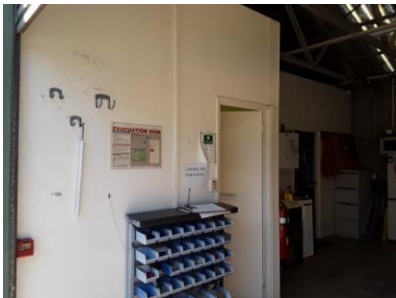
Ground Floor G.04 WORKSHOP	WALL SHEETING - EAST ELEVATION , Fibrous Cement	24m ²	NAD
