**ASBESTOS CONTAINING MATERIALS  
SURVEY REPORT**

**BUILDING 405  
Academic and Teaching  
Bundaberg Campus**

Report Number 622.10968.00010-R01-Bld 405-ASR

03 October 2017

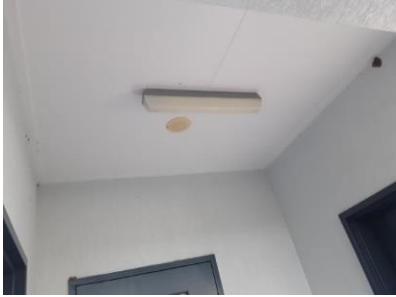
Ground Floor EXTERNAL ENTRANCE CEILING - NORTH AND EAST ELEVATIONS	CEILING SHEETING, Fibrous Cement	13m <sup>2</sup>	NAD
3-905

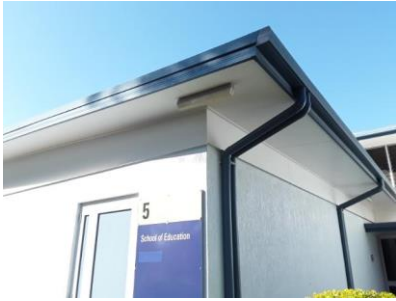
Ground Floor SOFFIT	SOFFIT SHEETING - ALL ELEVATIONS, Fibrous Cement	100m <sup>2</sup>	NAD

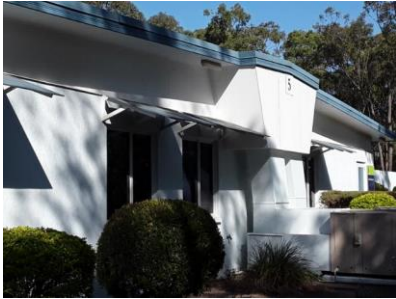
Ground Floor EXTERNAL WALL SHEETING	WALL SHEETING - ALL ELEVATIONS, Fibrous Cement	145m <sup>2</sup>	NAD
3-907

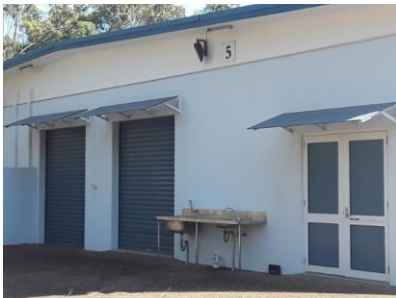
Ground Floor EXTERNAL SUN HOODS	SUN HOOD SHEETING - ALL ELEVATIONS, Fibrous Cement	14no	NAD
