**ASBESTOS CONTAINING MATERIALS  
SURVEY REPORT**

**BUILDING 406  
Refectory  
Bundaberg Campus**

Report Number 622.10968.00010-R01-Bld406-ASR

03 October 2017

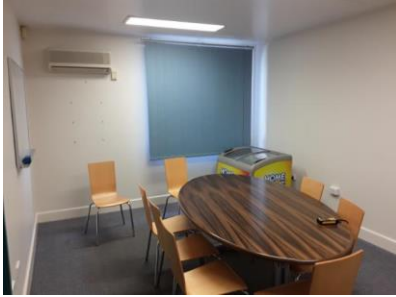
Ground Floor G.08	WALL SHEETING - ALL ELEVATIONS, Fibrous Cement	35m <sup>2</sup>	NAD
Similar to 3-908

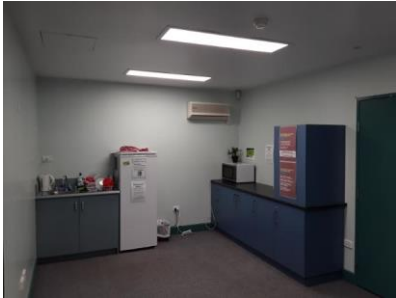
Ground Floor G.07 STUDENT KITCHEN	WALL SHEETING - ALL ELEVATIONS, Fibrous Cement	30m <sup>2</sup>	NAD

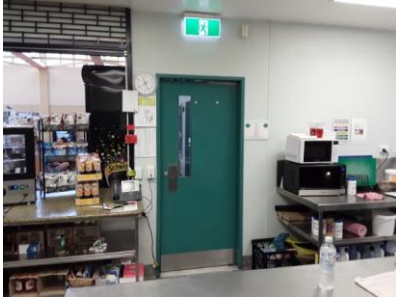
Ground Floor G.09	WALL SHEETING - SOUTH ELEVATION - AROUND DOOR, Fibrous Cement	2m <sup>2</sup>	NAD
Similar to 3-908

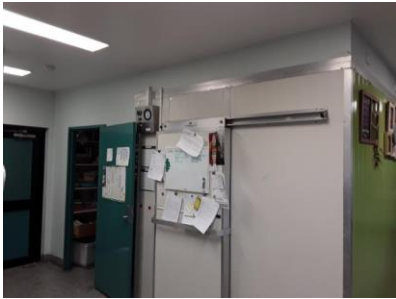
Ground Floor G.09	WALL SHEETING - NORTH ELEVATION - AROUND COLDROOM, Fibrous Cement	8m <sup>2</sup>	NAD
Similar to 3-908

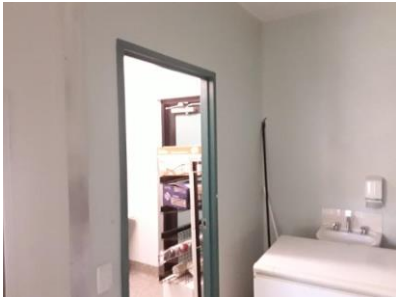
Ground Floor G.12	WALL SHEETING - SOUTH ELEVATION - AROUND ROLLER DOOR AND STORE ROOM DOOR, Fibrous Cement	8m <sup>2</sup>	NAD

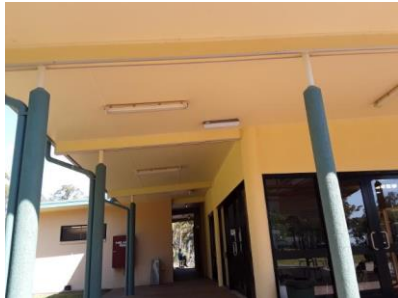
Ground Floor SOFFIT	SOFFIT SHEETING - ALL ELEVATIONS, Fibrous Cement	155m <sup>2</sup>	NAD
3-910

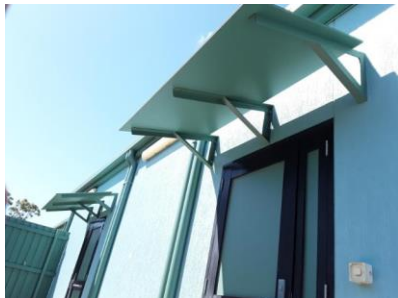
Ground Floor SUN HOOD	SUN HOOD SHEETING - NORTH ELEVATIONS, Fibrous Cement	2 sunhoods	NAD
