ASBESTOS CONTAINING MATERIALS SURVEY REPORT

BUILDING 406
Refectory
Bundaberg Campus

Reference	Date	Prepared	Checked	Authorised
622.10968.00010-R01-BLD406-ASR	03 October 2017	Jason Hutchins	Narelle Carnes	Narelle Carnes

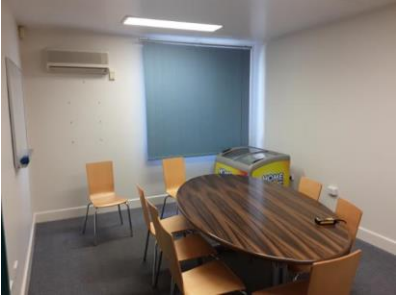
Ground Floor G.08	WALL SHEETING - ALL ELEVATIONS, Fibrous Cement	35m ²	NAD
Similar to 3-908

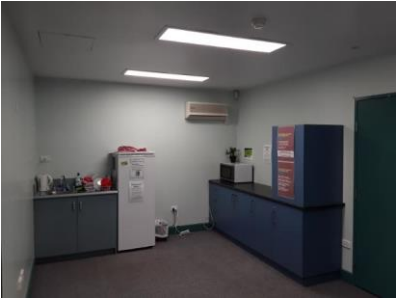
Ground Floor G.07 STUDENT KITCHEN	WALL SHEETING - ALL ELEVATIONS, Fibrous Cement	30m ²	NAD

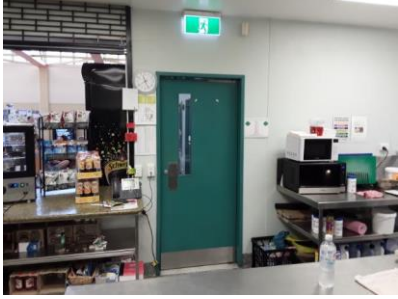
Ground Floor G.09	WALL SHEETING - SOUTH ELEVATION - AROUND DOOR, Fibrous Cement	2m ²	NAD
Similar to 3-908

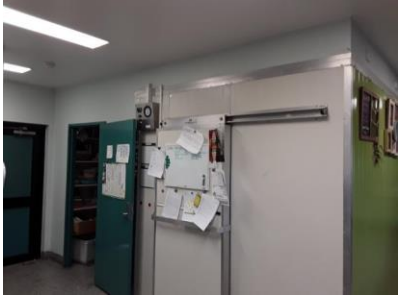
Ground Floor G.09	WALL SHEETING - NORTH ELEVATION - AROUND COLDROOM, Fibrous Cement	8m ²	NAD
Similar to 3-908

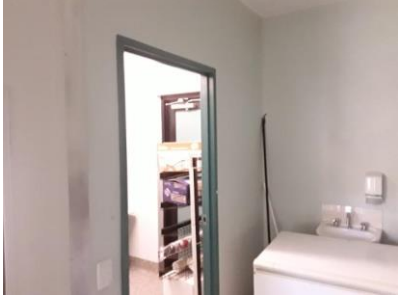
Ground Floor G.12	WALL SHEETING - SOUTH ELEVATION - AROUND ROLLER DOOR AND STORE ROOM DOOR, Fibrous Cement	8m ²	NAD

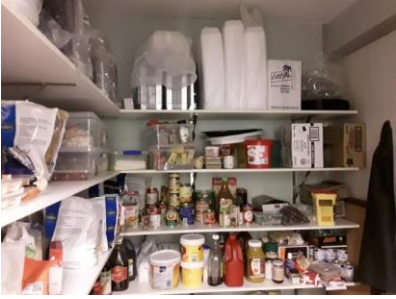
Ground Floor G.10 PANTRY	WALL SHEETING - EAST, SOUTH AND WEST ELEVATION , Fibrous Cement	10m ²	NAD
Similar to 3-908	 	Ground Floor G.02	WALL SHEETING - ALL ELEVATIONS, Fibrous Cement	90m ²	NAD

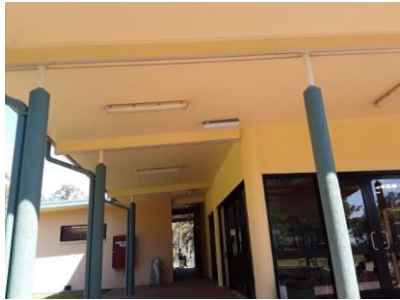
Ground Floor SOFFIT	SOFFIT SHEETING - ALL ELEVATIONS, Fibrous Cement	155m ²	NAD
3-910

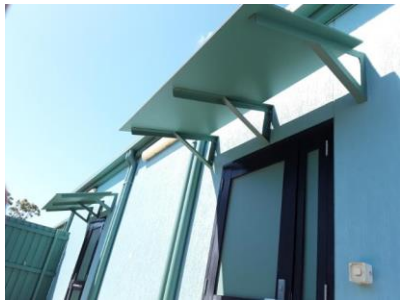
Ground Floor SUN HOOD	SUN HOOD SHEETING - NORTH ELEVATIONS, Fibrous Cement	2 sunhoods	NAD
