**ASBESTOS CONTAINING MATERIALS  
SURVEY REPORT**

**BUILDING 407  
Demountable (Nulloo Yumbah/Academic)  
Bundaberg Campus**

Report Number 622.10968.00010-R01-BLD 407-ASR

03 October 2017

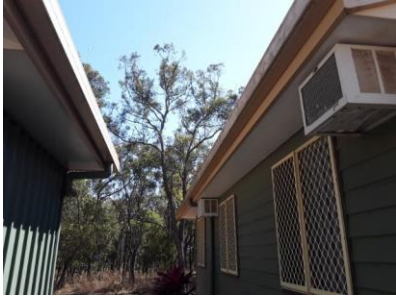
Ground Floor SOFFIT	SOFFIT SHEETING - NORTH, EAST AND WEST ELEVATIONS, Fibrous Cement	20m <sup>2</sup>	NAD
3-911

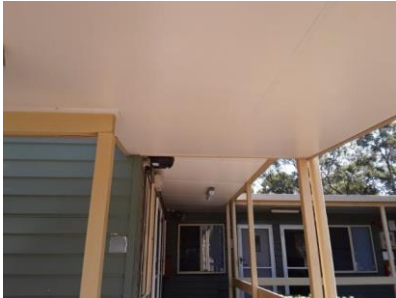
Ground Floor WALKWAY CEILING	CEILING SHEETING TO WALKWAY, Fibrous Cement	40m <sup>2</sup>	NAD

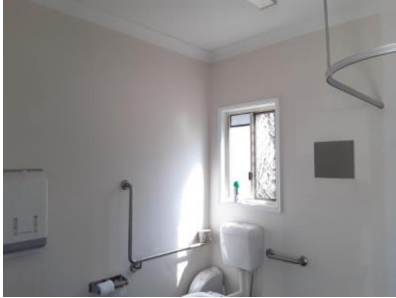
Ground Floor G.12 TOILET	WALL SHEETING - ALL ELEVATIONS, Fibrous Cement	22m <sup>2</sup>	NAD
