COMPLIANCE ASBESTOS RE-INSPECTION AND RISK ASSESSMENT

NOVEMBER 2021

J033428

BUNDABERG CAMPUS_Rolling Stock
Isis Highway
Bundaberg QLD
4670

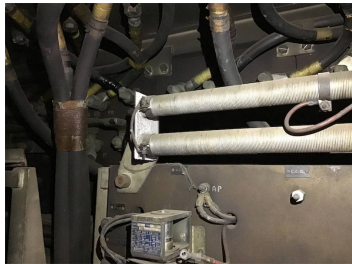
Location		Rolling Stock - 1603 - Toolbox Room - Millboard Insulation Board - Electrical Board - Inside Electrical Box			
Hazard Type		Asbestos		Material Assessment	
Friability		Friable		Product Type 2	
Sample No.		2-268 {AO000076}		Occupancy 0	
Result		Positive Chrysotile		Extent of damage 1	
				Disturbance 1	
Item Number		1		Surface Treatment 3	
				Exposure 0	
				Asbestos Type 1	
				Maintenance 0	
				Material Score 7	
				Disturbance Score 1	
				Priority Score 8	
				Very Low

Item No.	Hazard Type	Item Location and Description	Recommendations
Item 1	Asbestos	Rolling Stock, 1603, Toolbox Room, Inside Electrical Box, Millboard Insulation Board - Electrical Board	Remove Under Suitably Controlled Conditions or Manage In Situ if not disturbed by works
Item 2	Asbestos	Rolling Stock, 1603, Toolbox Room, Central section, Above head, Woven Material - Electrical Component	Remove Under Suitably Controlled Conditions or Manage In Situ if not disturbed by works

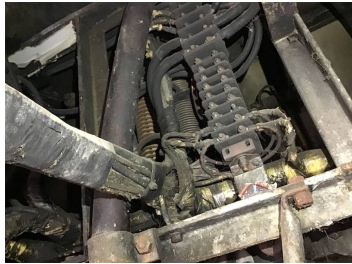
Location		Rolling Stock - 1603 - Toolbox Room - Woven Material - Electrical Component - Central section, Above head			
Hazard Type		Asbestos		Material Assessment	
Friability		Friable		Product Type 2	
Sample No.		2-270 (AO000077)		Occupancy 0	
Result		Positive Chrysotile		Extent of damage 1	
				Disturbance 1	
				Surface Treatment 3	
Item Number		2		Exposure 0	
				Asbestos Type 1	
				Maintenance 0	
				Material Score 7	
				Disturbance Score 1	
				Priority Score 8	
				Very Low
