# COMPLIANCE ASBESTOS RE-INSPECTION AND RISK ASSESSMENT

NOVEMBER 2021

J033457

ROCKHAMPTON NORTH CAMPUS\_CQIRP Building 361 - Health & Social Science Research  
Bruce Highway  
ROCKHAMPTON NORTH QLD  
4700

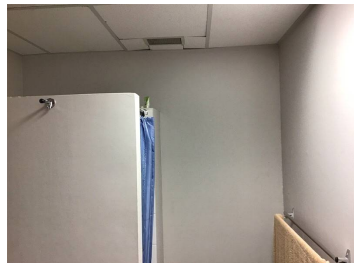
Location		361 Social Science Research - Ground Floor - Male Shower - Wall - Fibre cement sheet - North elevation

Hazard Type		Asbestos		Material Assessment			Disturbance Assessment		
Friability		Non-friable		Product Type			1	Occupancy	0
Sample No.		1-728 {AO000165}		Extent of damage			0	Disturbance	2
Result		Positive Chrysotile		Surface Treatment			1	Exposure	0
				Asbestos Type			1	Maintenance	0
Item Number		6		Material Score			3	Disturbance Score	2
				Priority Score			5	Very Low

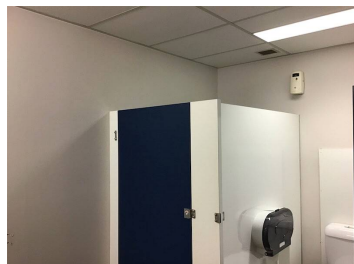
Location		361 Social Science Research - Ground Floor - Male Bathroom - Walls - Fibre cement sheet - All elevations									
Hazard Type		Asbestos		Material Assessment		Disturbance Assessment					
Friability		Non-friable		Product Type		1		Occupancy		0	
Sample No.		As 2-807 {AO000164}		Extent of damage		0		Disturbance		1	
Result		Strongly Assumed Positive Chrysotile		Surface Treatment		1		Exposure		0	
				Asbestos Type		1		Maintenance		0	
Item Number		7		Material Score		3		Disturbance Score		1	
				Priority Score		4		Very Low

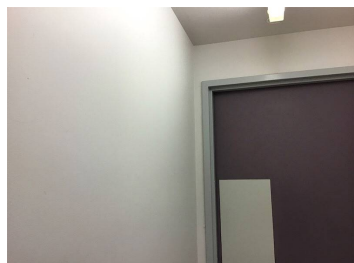
Location		361 Social Science Research - Ground Floor - Male Bathroom - Walls - Fibre cement sheet - Airlock - All elevations

Hazard Type		Asbestos		Material Assessment			Disturbance Assessment		
Friability		Non-friable		Product Type			1	Occupancy	0
Sample No.		As 2-807 {AO000164}		Extent of damage			0	Disturbance	1
Result		Strongly Assumed Positive Chrysotile		Surface Treatment			1	Exposure	0
				Asbestos Type			1	Maintenance	0
Item Number		8		Material Score			3	Disturbance Score	1
				Priority Score			4	Very Low

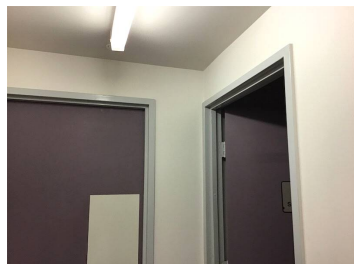
Location		361 Social Science Research - Ground Floor - Female Shower & Toilet - Walls - Fibre cement sheet - Airlock - All elevations									
Hazard Type		Asbestos		Material Assessment		Disturbance Assessment					
Friability		Non-friable		Product Type		1		Occupancy		0	
Sample No.		As 2-807 {AO000164}		Extent of damage		0		Disturbance		1	
Result		Strongly Assumed Positive Chrysotile		Surface Treatment		1		Exposure		0	
				Asbestos Type		1		Maintenance		0	
Item Number		9		Material Score		3		Disturbance Score		1	
				Priority Score		4		Very Low

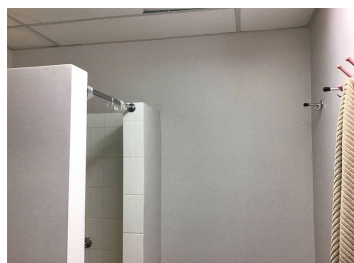
Location		361 Social Science Research - Ground Floor - Female Shower & Toilet - Wall - Fibre cement sheet - Shower Room - North elevation

Hazard Type		Asbestos		Material Assessment			Disturbance Assessment					
Friability		Non-friable		Product Type			1		Occupancy		0	
Sample No.		As 1-728 {AO000165}		Extent of damage			0		Disturbance		1	
Result		Strongly Assumed Positive Chrysotile		Surface Treatment			1		Exposure		0	
				Asbestos Type			1		Maintenance		0	
Item Number		10		Material Score			3		Disturbance Score		1	
				Priority Score			4		Very Low

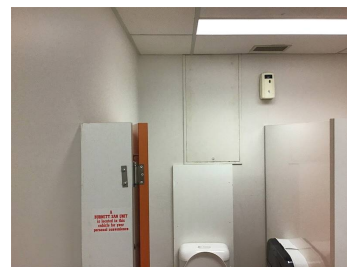
Location		361 Social Science Research - Ground Floor - Female Shower & Toilet - Walls - Fibre cement sheet - All elevations							
Hazard Type		Asbestos		Material Assessment		Disturbance Assessment			
Friability		Non-friable		Product Type		1 Occupancy		0	
Sample No.		As 2-807 {AO000164}		Extent of damage		0 Disturbance		1	
Result		Strongly Assumed Positive Chrysotile		Surface Treatment		1 Exposure		0	
				Asbestos Type		1 Maintenance		0	
Item Number		11		Material Score		3 Disturbance Score		1	
				Priority Score		4 Very Low
