# COMPLIANCE ASBESTOS RE-INSPECTION AND RISK ASSESSMENT

NOVEMBER 2021

J033458

ROCKHAMPTON NORTH CAMPUS\_CQIRP Building 362 - plant Room  
Bruce Highway  
ROCKHAMPTON NORTH QLD  
4700

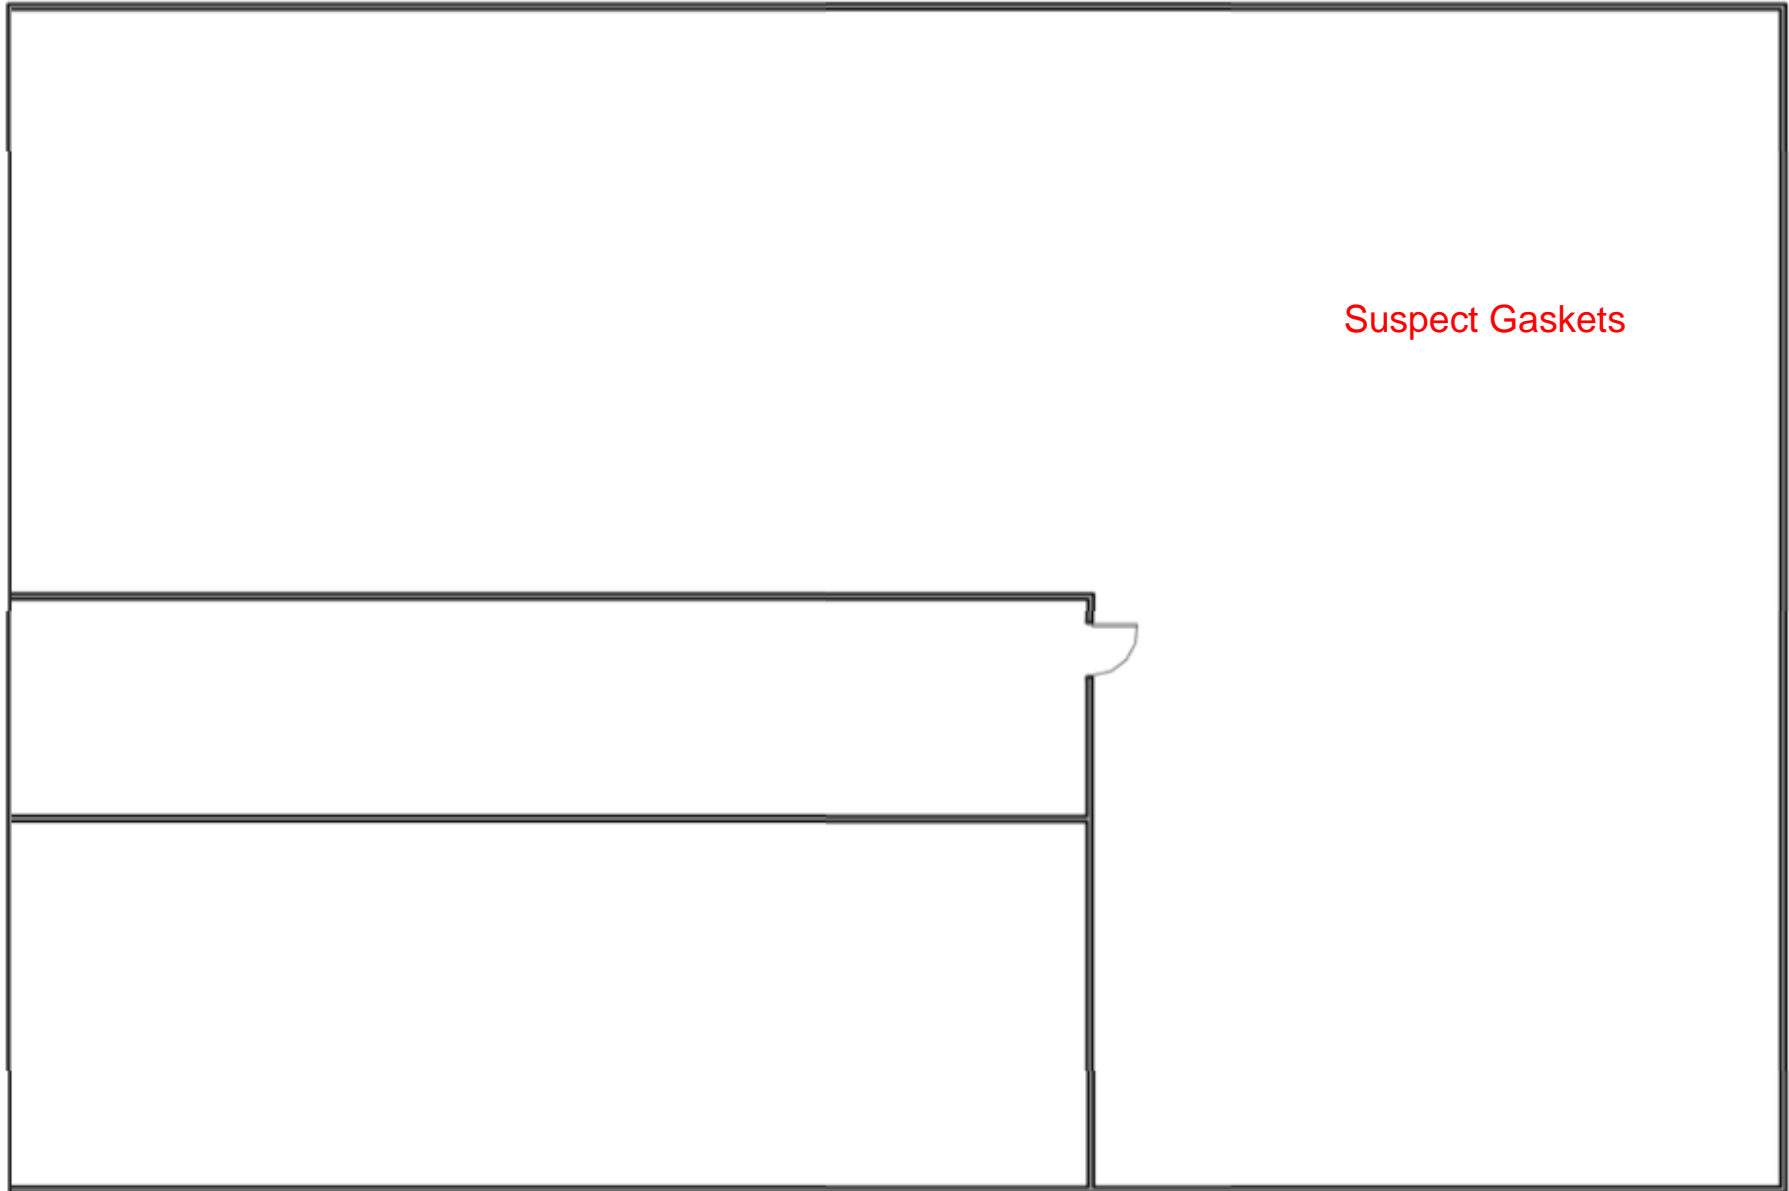
**AREA: Building 362 - Ground Level**

Area Not Accessed	Comments
362 Plant Room, Ground Floor, Plant Room, Compressed generator pumps, Gaskets - Various pumps

Suspect Gaskets

Item No	Location / Description	Hazard Type	Sample No.	Item Status	Est. Extent	Current Label	Condition	Friability	Disturbance Risk	Material Risk	Control Priority	Recommended Action	Record of Works
1	362 Plant Room - Ground Floor - Plant Room, Inaccessible												
	Gaskets - Various pumps	Asbestos	Visual	Assumed, Positive	Inaccessible	No	Unknown	Unknown	-	-	P*	Unable to Access Conduct Further Investigations/Sampling Prior to Disturbance
