COMPLIANCE ASBESTOS RE-INSPECTION AND RISK ASSESSMENT

NOVEMBER 2021

J033458

ROCKHAMPTON NORTH CAMPUS_CQIRP Building 362 - plant Room
Bruce Highway
ROCKHAMPTON NORTH QLD
4700

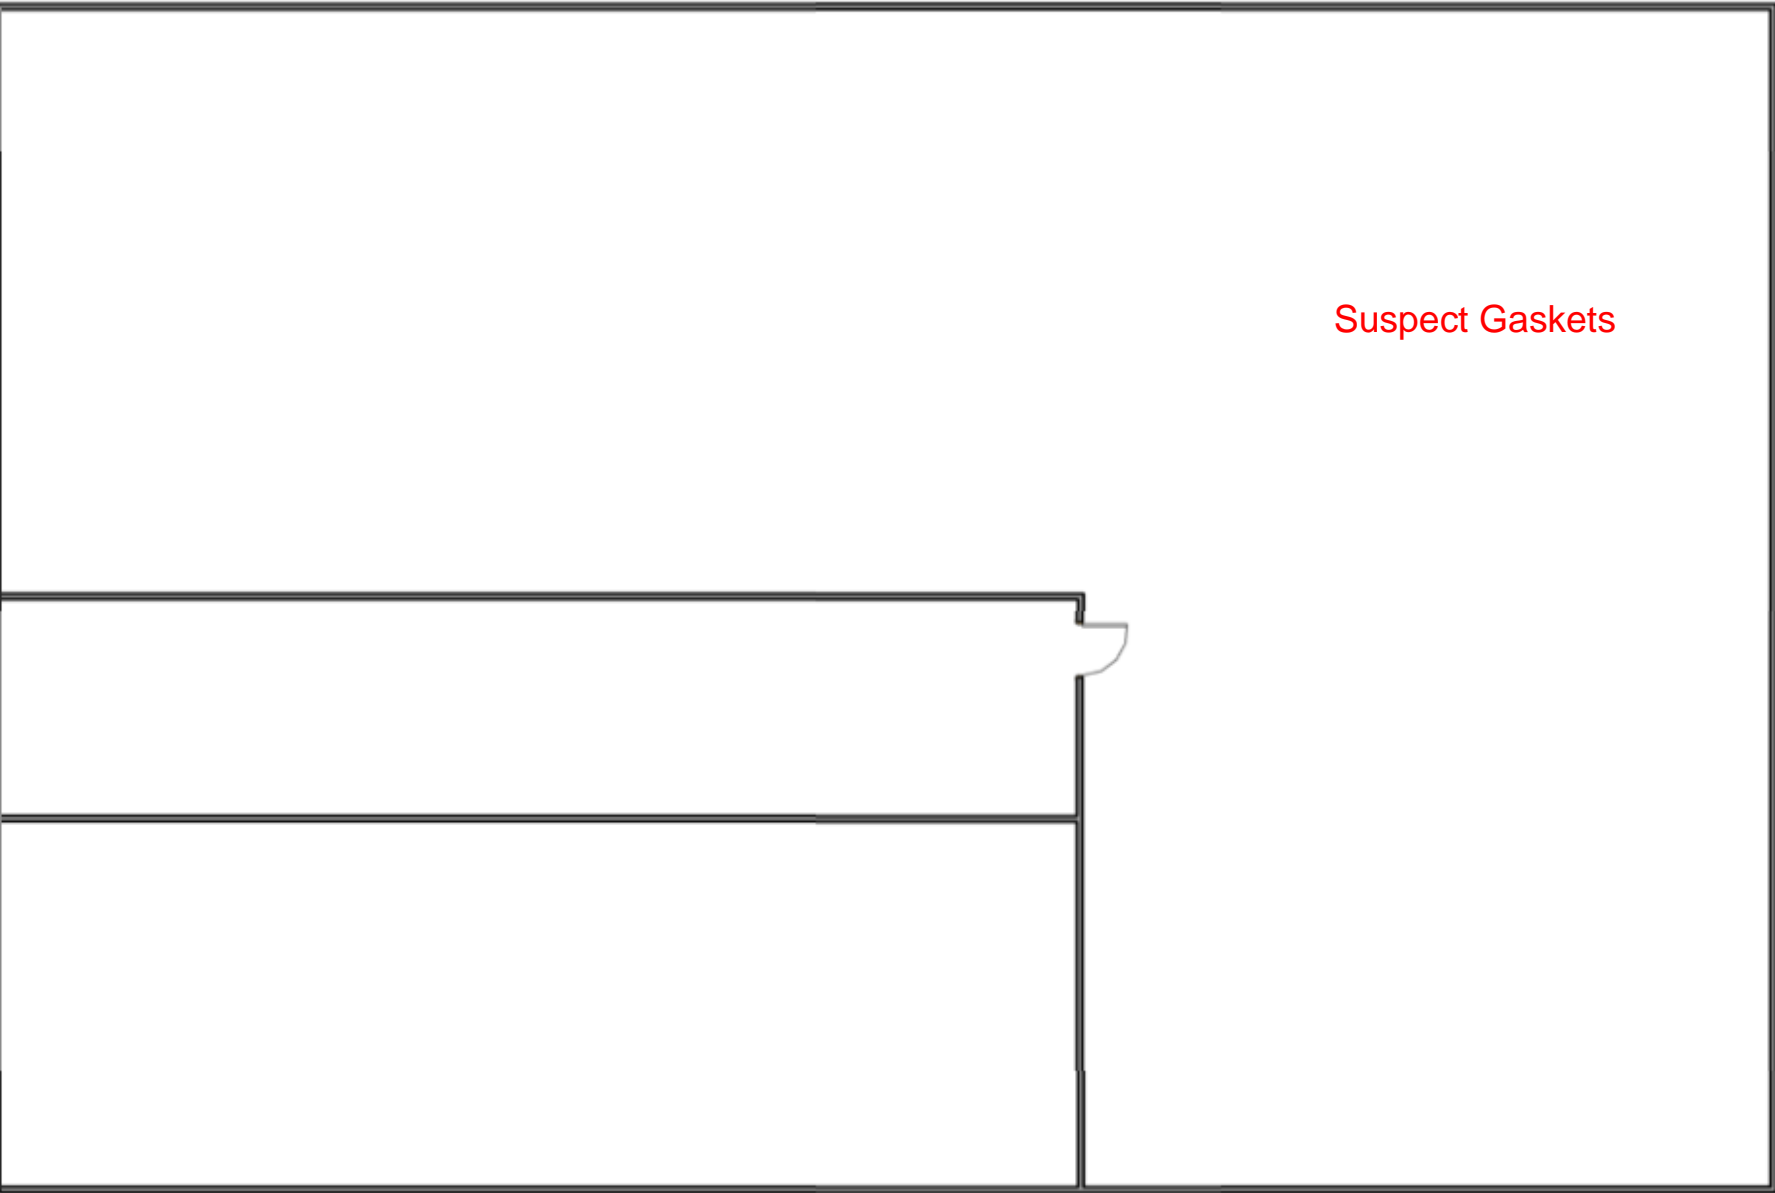
LEGEND:
No samples taken
