COMPLIANCE ASBESTOS RE-INSPECTION AND RISK ASSESSMENT

NOVEMBER 2021

J033459

ROCKHAMPTON NORTH CAMPUS_CQIRP Building 363 - Animal Shed
Bruce Highway
ROCKHAMPTON NORTH QLD
4700

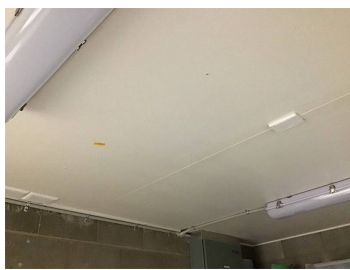
Location		363 Animal Shed - Ground Floor - Central Office - Throughout - Ceiling - Fibre cement sheet									
Hazard Type		Asbestos		Material Assessment		Disturbance Assessment					
Friability		Non-friable		Product Type		1		Occupancy		0	
Sample No.		1-445 (AO000169)		Extent of damage		0		Disturbance		1	
Result		Positive Chrysotile		Surface Treatment		1		Exposure		0	
				Asbestos Type		1		Maintenance		0	
Item Number		6		Material Score		3		Disturbance Score		1	
				Priority Score		4		Very Low

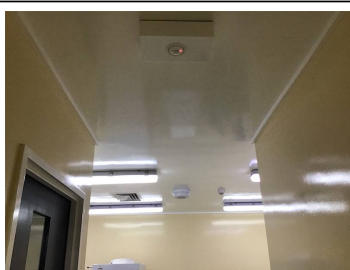
Location		363 Animal Shed - Ground Floor - Crop Lab - Throughout - Ceiling - Fibre cement sheet				
Hazard Type		Asbestos	Material Assessment		Disturbance Assessment	
Friability		Non-friable	Product Type	1	Occupancy	0
Sample No.		As 1-443 {AO000168}	Extent of damage	0	Disturbance	1
Result		Strongly Assumed Positive Chrysotile	Surface Treatment	1	Exposure	0
			Asbestos Type	1	Maintenance	0
Item Number		8	Material Score	3	Disturbance Score	1
			Priority Score	4	Very Low
