COMPLIANCE ASBESTOS RE-INSPECTION AND RISK ASSESSMENT

NOVEMBER 2021

J033460

ROCKHAMPTON NORTH CAMPUS_CQIRP Building 364 - Facilities Management Store
Bruce Highway
ROCKHAMPTON NORTH QLD
4700

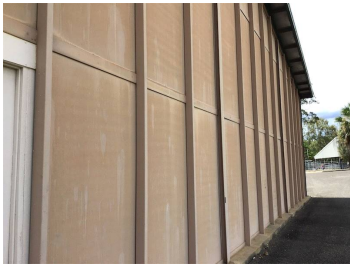
Location		364 Facilities Store - Ground Floor - External - All elevationsWall claddings - Fibre cement sheet					
Hazard Type		Asbestos		Material Assessment		Disturbance Assessment	
Friability		Non-friable		Product Type		1Occupancy0	
Sample No.		1-368 {AO000171}		Extent of damage		0Disturbance1	
Result		Positive Chrysotile		Surface Treatment		1Exposure0	
				Asbestos Type		1Maintenance0	
Item Number		2		Material Score		3Disturbance Score1	
				Priority Score		4Very Low

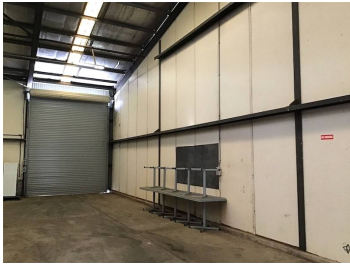
Location		364 Facilities Store - Ground Floor - Internal - All elevationsWall claddings - Fibre cement sheet			
Hazard Type		Asbestos		Material Assessment	
Friability		Non-friable		Product Type 1	
Sample No.		1-369 {AO000170}		Occupancy 0	
Result		Positive Chrysotile		Extent of damage 0	
				Disturbance 2	
Item Number		1		Surface Treatment 1	
				Exposure 0	
				Asbestos Type 1	
				Maintenance 0	
				Material Score 3	
				Disturbance Score 2	
				Priority Score 5	
				Very Low
