COMPLIANCE ASBESTOS RE-INSPECTION AND RISK ASSESSMENT

NOVEMBER 2021

J033461

ROCKHAMPTON NORTH CAMPUS_CQIRP Building 365 - Furnace
Bruce Highway
ROCKHAMPTON NORTH QLD
4700

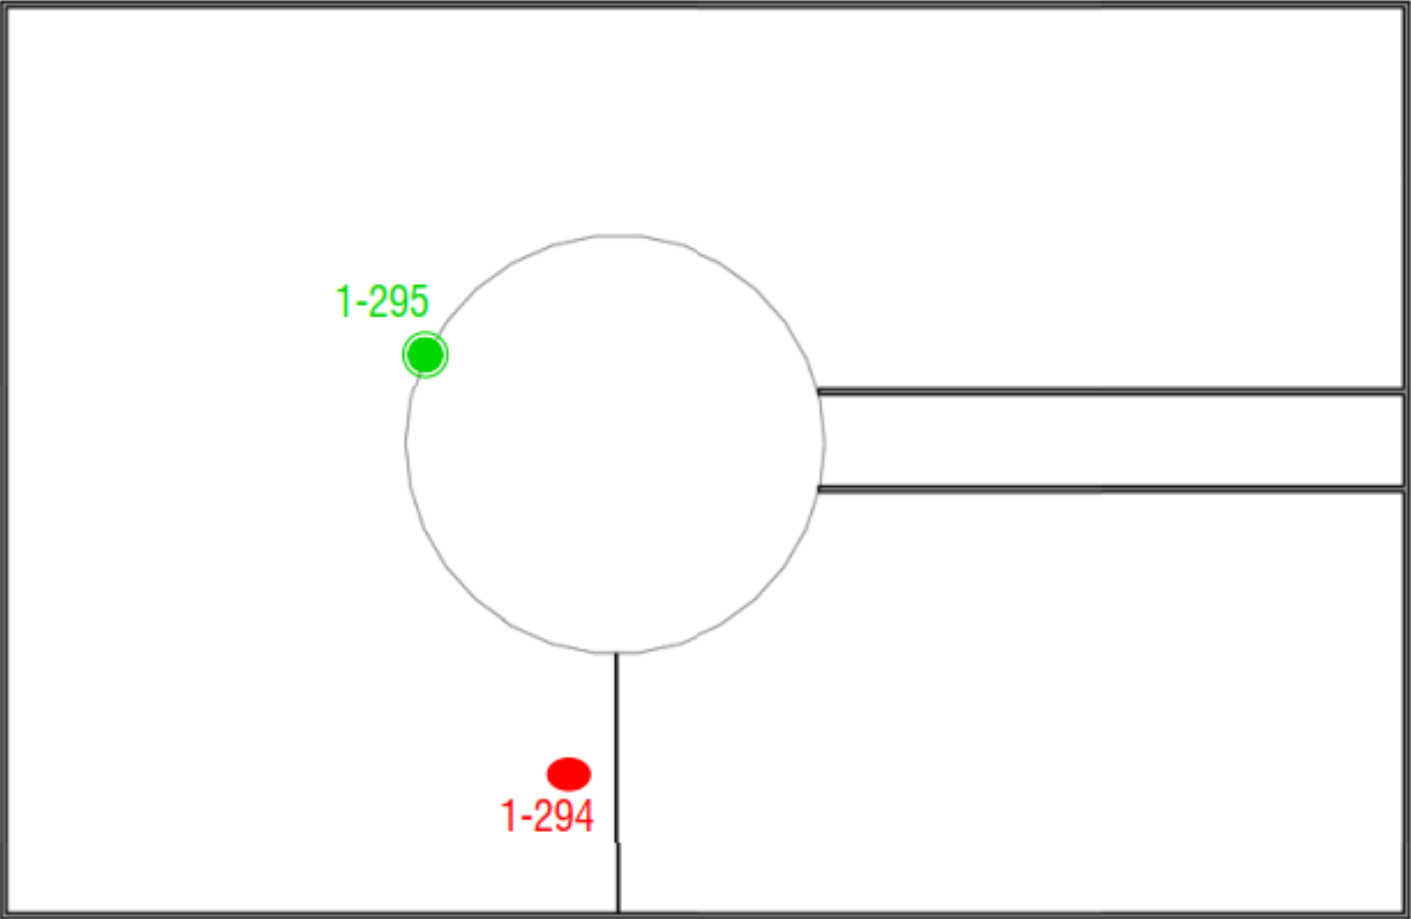
No positive items were identified within the scope of this inspection.

Sample location.
No Asbestos Detected
