COMPLIANCE ASBESTOS RE-INSPECTION AND RISK ASSESSMENT

J033462

C126956 CQ University Australia

ROCKHAMPTON NORTH CAMPUS_CQIRP Building 367 - Caretaker residence
Bruce Highway
ROCKHAMPTON NORTH QLD
4700

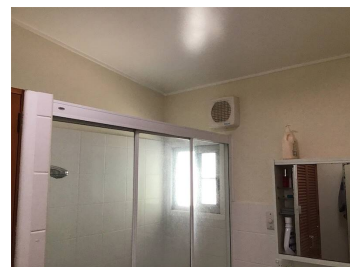
Location		367 Caretakers Residence - Ground Floor - Shower Room - All elevationsWall - Fibre cement sheet			
Hazard Type	Asbestos	Material Assessment		Disturbance Assessment	
Friability	Non-friable	Product Type	1	Occupancy	0
Sample No.	1-722 {AO000175}	Extent of damage	0	Disturbance	1
Result	Positive Chrysotile	Surface Treatment	1	Exposure	0
		Asbestos Type	1	Maintenance	0
Item Number	5	Material Score	3	Disturbance Score	1
		Priority Score	4	Very Low

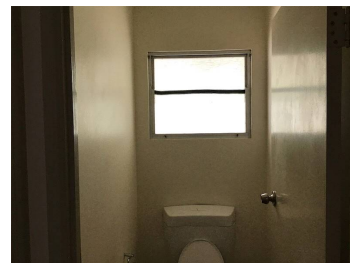
Location		367 Caretakers Residence - Ground Floor - Toilet - All elevationsWalls - Fibre cement sheet			
Hazard Type	Asbestos	Material Assessment		Disturbance Assessment	
Friability	Non-friable	Product Type	1	Occupancy	0
Sample No.	1-723 {AO000176}	Extent of damage	0	Disturbance	1
Result	Positive Chrysotile	Surface Treatment	1	Exposure	0
		Asbestos Type	1	Maintenance	0
Item Number	6	Material Score	3	Disturbance Score	1
		Priority Score	4	Very Low
