# COMPLIANCE ASBESTOS RE-INSPECTION AND RISK ASSESSMENT

NOVEMBER 2021

J033463

ROCKHAMPTON NORTH CAMPUS\_CQIRP Building 368 - Irrigation Pump Shed  
Bruce Highway  
ROCKHAMPTON NORTH QLD  
4700

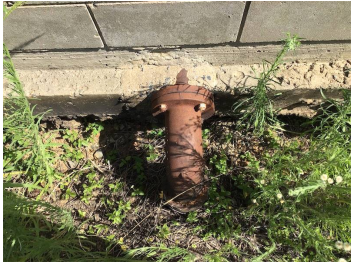
Location	368 Irrigation Pump Shed - Ground Floor - External - Pump Shed - South elevationPipe collar - Fibre cement

Hazard Type	Asbestos	Material Assessment		Disturbance Assessment	
Friability	Non-friable	Product Type	1	Occupancy	0
Sample No.	1-297 {AO000183}	Extent of damage	0	Disturbance	1
Result	Positive Chrysotile + Amosite	Surface Treatment	1	Exposure	0
		Asbestos Type	2	Maintenance	0
Item Number	1	Material Score	4	Disturbance Score	1
		Priority Score	5	Very Low

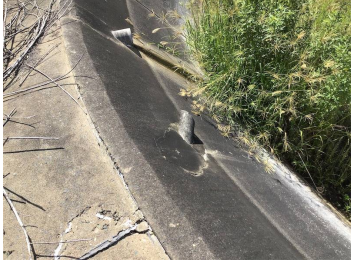
Location	368 Irrigation Pump Shed - Ground Floor - External - Irrigation sump - North elevationInlet pipe - Moulded cement

Hazard Type	Asbestos	Material Assessment		Disturbance Assessment	
Friability	Non-friable	Product Type	1	Occupancy	0
Sample No.	1-298 {AO000184}	Extent of damage	0	Disturbance	1
Result	Positive Chrysotile + Amosite	Surface Treatment	1	Exposure	0
		Asbestos Type	2	Maintenance	0
Item Number	2	Material Score	4	Disturbance Score	1
		Priority Score	5	Very Low

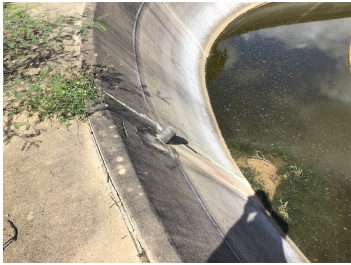
Location	368 Irrigation Pump Shed - Ground Floor - External - Irrigation sump - South elevationInlet pump - Moulded cement

Hazard Type	Asbestos	Material Assessment		Disturbance Assessment	
Friability	Non-friable	Product Type	1	Occupancy	0
Sample No.	As 1-298 {AO000184}	Extent of damage	0	Disturbance	1
Result	Strongly Assumed Positive Chrysotile + Amosite	Surface Treatment	1	Exposure	0
		Asbestos Type	2	Maintenance	0
Item Number	3	Material Score	4	Disturbance Score	1
		Priority Score	5	Very Low
