**ASBESTOS MATERIALS AUDIT  
REPORT AND REGISTER**

96 Buchan Street  
Portsmith  
Cairns QLD 4870

Assessment Conducted: 22<sup>nd</sup> September 2017  
Report No. CE129605

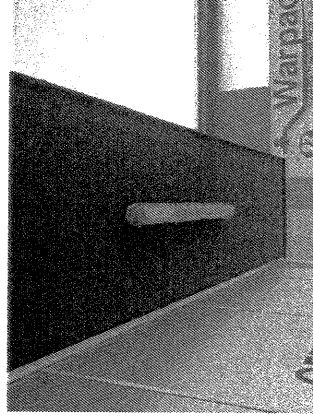
**Sample CE129605 - 1 (NAD)**

Table 1. Asbestos and SMF Materials Register								
Survey Date: 22/09/2017		Address: 96 Buchan Street, Portsmith				Lab Report Number: CE129605		
Location	Material	Sample	Result	Condition	Friability	Disturb. Potential	Risk Rating	Comment
BUILDING FRONTAGE								
Eave	Fibro cement sheeting	CE129605- 1	NAD					
Fascia	Fibro cement sheeting	CE129605- 2	NAD
