ASBESTOS CONTAINING MATERIALS SURVEY REPORT

Building 5 - Fire Pump Shed
Emerald Campus

Report Number 622.10968.00000/0050-R01-V01-ASR-BLD 5 Fire Pump Shed

11 October 2017

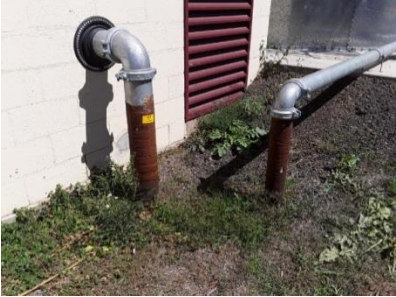
External North side	Textile material around lower section of pipes, Woven Product	3lin m	NAD
