# COMPLIANCE ASBESTOS RE-INSPECTION AND RISK ASSESSMENT

NOVEMBER 2021

J033430

EMERALD CAMPUS\_10 Diamond Avenue  
10 Diamond Avenue  
Emerald QLD  
4720

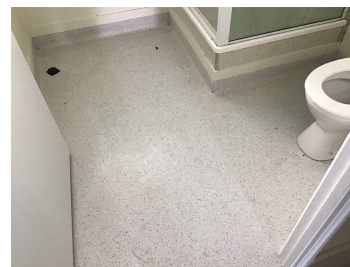
Location		10 A Diamond Avenue - 1st Floor - Bathroom - Under vinyl sheet - Under floor - Fibre cement sheet					
Hazard Type		Asbestos		Material Assessment		Disturbance Assessment	
Friability		Non-friable		Product Type		1	
Sample No.		As 5-933 {AO000244}		Extent of damage		0	
Result		Strongly Assumed Positive Chrysotile		Surface Treatment		1	
				Asbestos Type		1	
Item Number		12		Material Score		3	
				Priority Score		5	
				Occupancy		1	
				Disturbance		1	
				Exposure		0	
				Maintenance		0	
				Disturbance Score		2	
						Very Low

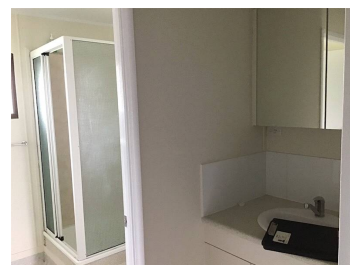
Location		10 A Diamond Avenue - 1st Floor - Washroom - All elevations - Wall - Fibre cement sheet							
Hazard Type		Asbestos		Material Assessment		Disturbance Assessment			
Friability		Non-friable		Product Type		1			
Sample No.		5-928 {AO000240}		Extent of damage		0			
Result		Positive Chrysotile		Surface Treatment		1			
				Asbestos Type		1			
Item Number		5		Material Score		3			
				Priority Score		5			
						Occupancy		1	
						Disturbance		1	
						Exposure		0	
						Maintenance		0	
						Disturbance Score		2	
						Very Low

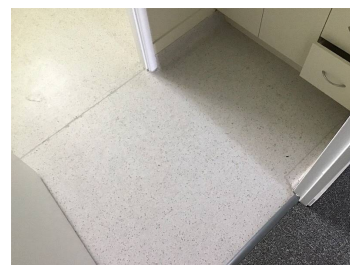
Location	10 A Diamond Avenue - 1st Floor - Washroom - Under vinyl sheet - Under floor - Fibre cement sheet				
Hazard Type	Asbestos	Material Assessment		Disturbance Assessment	
Friability	Non-friable	Product Type	1	Occupancy	0
Sample No.	5-933 {AO000244}	Extent of damage	0	Disturbance	1
Result	Positive Chrysotile	Surface Treatment	1	Exposure	0
		Asbestos Type	1	Maintenance	0
Item Number	11	Material Score	3	Disturbance Score	1
		Priority Score	4	Very Low

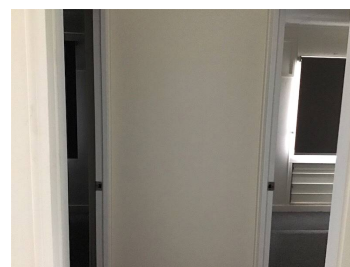
Location	10 A Diamond Avenue - 1st Floor - Corridor - Between bedrooms - Wall - Fibre cement sheet				
Hazard Type	Asbestos	Material Assessment		Disturbance Assessment	
Friability	Non-friable	Product Type	1	Occupancy	0
Sample No.	5-930 {AO000241}	Extent of damage	0	Disturbance	1
Result	Positive Chrysotile	Surface Treatment	1	Exposure	0
		Asbestos Type	1	Maintenance	0
Item Number	6	Material Score	3	Disturbance Score	1
		Priority Score	4	Very Low

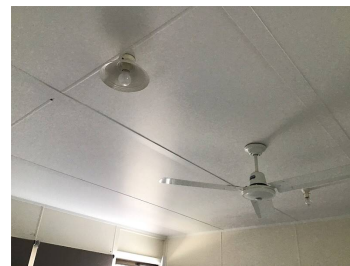
Location		10 A Diamond Avenue - 1st Floor - Throughout - Throughout - Ceiling - Fibre cement sheet									
Hazard Type		Asbestos		Material Assessment		Disturbance Assessment					
Friability		Non-friable		Product Type		1		Occupancy		1	
Sample No.		5-931 {AO000242}		Extent of damage		0		Disturbance		1	
Result		Positive Chrysotile		Surface Treatment		1		Exposure		0	
				Asbestos Type		1		Maintenance		0	
Item Number		7		Material Score		3		Disturbance Score		2	
				Priority Score		5		Very Low

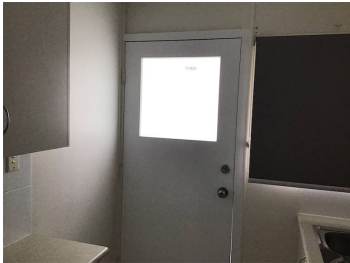
Location	10 A Diamond Avenue - 1st Floor - Kitchen - East & North elevations - Walls - Fibre cement sheet

Hazard Type	Asbestos	Material Assessment		Disturbance Assessment	
Friability	Non-friable	Product Type	1	Occupancy	0
Sample No.	5-925 {AO000243}	Extent of damage	0	Disturbance	1
Result	Positive Chrysotile	Surface Treatment	1	Exposure	0
		Asbestos Type	1	Maintenance	0
Item Number	8	Material Score	3	Disturbance Score	1
		Priority Score	4	Very Low

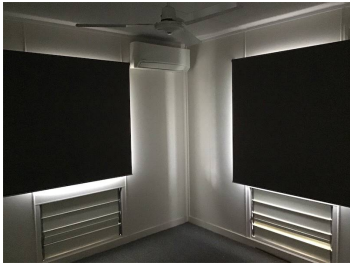
Location	10 A Diamond Avenue - 1st Floor - Bedroom 1 (Front) - All elevations - Walls - Fibre cement sheet

Hazard Type	Asbestos	Material Assessment		Disturbance Assessment	
Friability	Non-friable	Product Type	1	Occupancy	0
Sample No.	As 5-927 {AO000238}	Extent of damage	0	Disturbance	1
Result	Strongly Assumed Positive Chrysotile	Surface Treatment	1	Exposure	0
		Asbestos Type	1	Maintenance	0
Item Number	9	Material Score	3	Disturbance Score	1
		Priority Score	4	Very Low

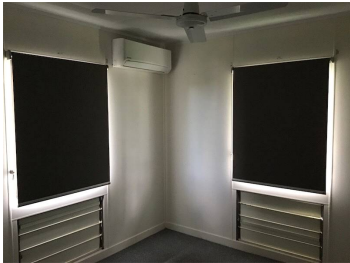
Location	10 A Diamond Avenue - 1st Floor - Bedroom 2 (Back) - All elevations - Walls - Fibre cement sheet

Hazard Type	Asbestos	Material Assessment		Disturbance Assessment	
Friability	Non-friable	Product Type	1	Occupancy	0
Sample No.	As 5-927 {AO000238}	Extent of damage	0	Disturbance	1
Result	Strongly Assumed Positive Chrysotile	Surface Treatment	1	Exposure	0
		Asbestos Type	1	Maintenance	0
Item Number	10	Material Score	3	Disturbance Score	1
		Priority Score	4	Very Low

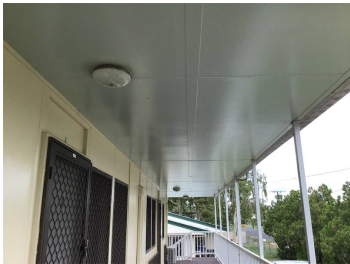
Location	10 A Diamond Avenue - 1st Floor - External - Throughout - Awning - Fibre cement sheet

Hazard Type	Asbestos	Material Assessment		Disturbance Assessment	
Friability	Non-friable	Product Type	1	Occupancy	0
Sample No.	As 5-931 {AO000242}	Extent of damage	0	Disturbance	1
Result	Strongly Assumed Positive Chrysotile	Surface Treatment	1	Exposure	0
		Asbestos Type	1	Maintenance	0
Item Number	23	Material Score	3	Disturbance Score	1
		Priority Score	4	Very Low

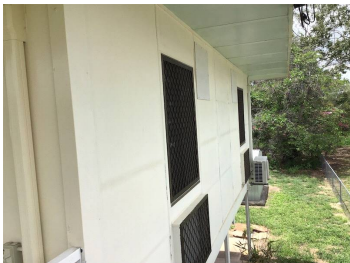
Location	10 A Diamond Avenue - 1st Floor - External - All elevations - Walls - Fibre cement sheet

Hazard Type	Asbestos	Material Assessment		Disturbance Assessment	
Friability	Non-friable	Product Type	1	Occupancy	0
Sample No.	As 5-932 {AO000245}	Extent of damage	0	Disturbance	1
Result	Strongly Assumed Positive Chrysotile	Surface Treatment	1	Exposure	0
		Asbestos Type	1	Maintenance	0
Item Number	25	Material Score	3	Disturbance Score	1
		Priority Score	4	Very Low

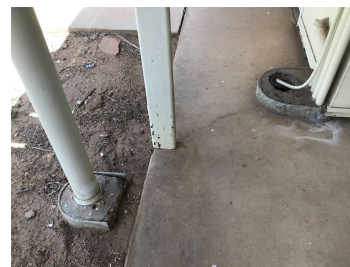
Location		10 B Diamond Avenue - Ground Floor - External - East elevation - Drain trap surround - Fibre cement sheet			
Hazard Type	Asbestos	Material Assessment		Disturbance Assessment	
Friability	Non-friable	Product Type	1	Occupancy	0
Sample No.	As 5-938 {AO000246}	Extent of damage	0	Disturbance	1
Result	Strongly Assumed Positive Chrysotile	Surface Treatment	1	Exposure	0
		Asbestos Type	1	Maintenance	0
Item Number	27	Material Score	3	Disturbance Score	1
		Priority Score	4	Very Low

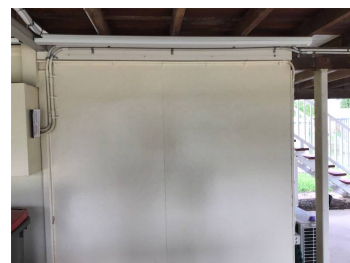
Location		10 B Diamond Avenue - Ground Floor - Laundry - All elevations - External wall - Fibre cement sheet			
Hazard Type	Asbestos	Material Assessment		Disturbance Assessment	
Friability	Non-friable	Product Type	1	Occupancy	0
Sample No.	5-939 {AO000247}	Extent of damage	0	Disturbance	1
Result	Positive Chrysotile	Surface Treatment	1	Exposure	0
		Asbestos Type	1	Maintenance	0
Item Number	28	Material Score	3	Disturbance Score	1
		Priority Score	4	Very Low

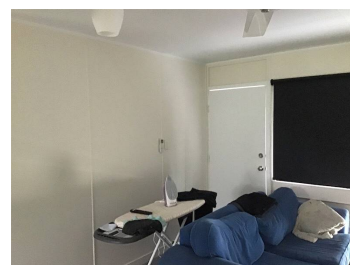
Location		10 B Diamond Avenue - 1st Floor - Lounge - North, West & South elevations - Walls - Fibre cement sheet			
Hazard Type	Asbestos	Material Assessment		Disturbance Assessment	
Friability	Non-friable	Product Type	1	Occupancy	0
Sample No.	As 5-927 {AO000238}	Extent of damage	0	Disturbance	1
Result	Strongly Assumed Positive Chrysotile	Surface Treatment	1	Exposure	0
		Asbestos Type	1	Maintenance	0
Item Number	1	Material Score	3	Disturbance Score	1
		Priority Score	4	Very Low

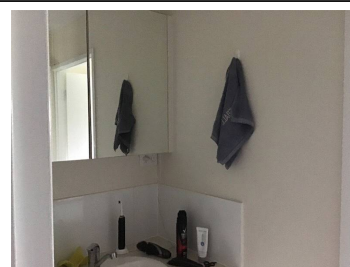
Location		10 B Diamond Avenue - 1st Floor - Washroom - All elevations - Walls - Fibre cement sheet			
Hazard Type	Asbestos	Material Assessment		Disturbance Assessment	
Friability	Non-friable	Product Type	1	Occupancy	0
Sample No.	As 5-928 {AO000240}	Extent of damage	0	Disturbance	1
Result	Strongly Assumed Positive Chrysotile	Surface Treatment	1	Exposure	0
		Asbestos Type	1	Maintenance	0
Item Number	13	Material Score	3	Disturbance Score	1
		Priority Score	4	Very Low

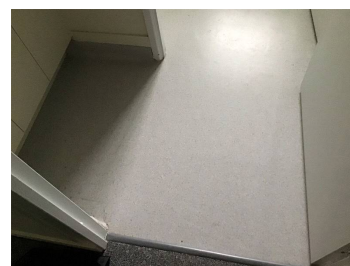
Location		10 B Diamond Avenue - 1st Floor - Washroom - Under vinyl sheet - Underfloor - Fibre cement sheet			
Hazard Type	Asbestos	Material Assessment		Disturbance Assessment	
Friability	Non-friable	Product Type	1	Occupancy	0
Sample No.	As 5-933 {AO000244}	Extent of damage	0	Disturbance	1
Result	Strongly Assumed Positive Chrysotile	Surface Treatment	1	Exposure	1
		Asbestos Type	1	Maintenance	0
Item Number	20	Material Score	3	Disturbance Score	2
		Priority Score	5	Very Low

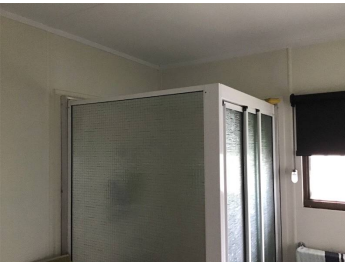
Location		10 B Diamond Avenue - 1st Floor - Bathroom - Behind laminate - South, East & West elevations - Walls - Fibre cement sheet					
Hazard Type		Asbestos		Material Assessment		Disturbance Assessment	
Friability		Non-friable		Product Type		1	
Sample No.		As 5-929 (AO000239)		Occupancy		0	
Result		Strongly Assumed Positive Chrysotile		Extent of damage		0	
				Disturbance		1	
				Surface Treatment		1	
Item Number		16		Exposure		1	
				Asbestos Type		1	
				Maintenance		0	
				Material Score		3	
				Disturbance Score		2	
				Priority Score		5	
				Very Low

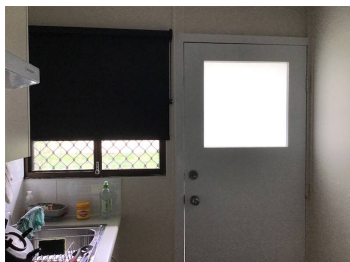
Location		10 B Diamond Avenue - 1st Floor - Kitchen - East elevation - Wall - Fibre cement sheet					
Hazard Type		Asbestos		Material Assessment		Disturbance Assessment	
Friability		Non-friable		Product Type		1	
Sample No.		As 5-925 {AO000243}		Occupancy		0	
Result		Strongly Assumed Positive Chrysotile		Extent of damage		0	
				Disturbance		1	
				Surface Treatment		1	
Item Number		15		Exposure		0	
				Maintenance		0	
				Material Score		3	
				Disturbance Score		1	
				Priority Score		4	
				Very Low

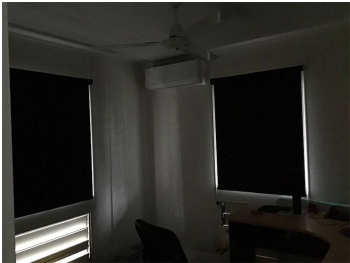
Location	10 B Diamond Avenue - 1st Floor - Bedroom 1 (Front) - All elevations - Walls - Fibre cement sheet

Hazard Type	Asbestos	Material Assessment		Disturbance Assessment	
Friability	Non-friable	Product Type	1	Occupancy	1
Sample No.	As 5-927 {AO000238}	Extent of damage	0	Disturbance	1
Result	Strongly Assumed Positive Chrysotile	Surface Treatment	1	Exposure	0
		Asbestos Type	1	Maintenance	0
Item Number	18	Material Score	3	Disturbance Score	2
		Priority Score	5	Very Low

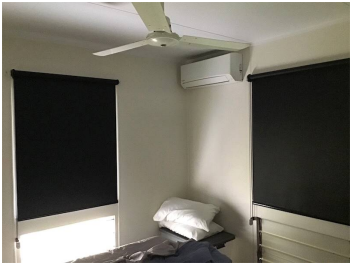
Location	10 B Diamond Avenue - 1st Floor - Bedroom 2 (Back) - All elevations - Walls - Fibre cement sheet

Hazard Type	Asbestos	Material Assessment		Disturbance Assessment	
Friability	Non-friable	Product Type	1	Occupancy	0
Sample No.	As 5-927 {AO000238}	Extent of damage	0	Disturbance	1
Result	Strongly Assumed Positive Chrysotile	Surface Treatment	1	Exposure	0
		Asbestos Type	1	Maintenance	0
Item Number	19	Material Score	3	Disturbance Score	1
		Priority Score	4	Very Low

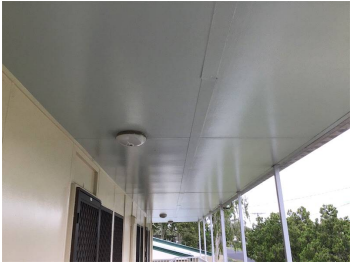
Location	10 B Diamond Avenue - 1st Floor - External - Throughout - Awning - Fibre cement sheet

Hazard Type	Asbestos	Material Assessment		Disturbance Assessment	
Friability	Non-friable	Product Type	1	Occupancy	0
Sample No.	As 5-931 {AO000242}	Extent of damage	0	Disturbance	1
Result	Strongly Assumed Positive Chrysotile	Surface Treatment	1	Exposure	0
		Asbestos Type	1	Maintenance	0
Item Number	22	Material Score	3	Disturbance Score	1
		Priority Score	4	Very Low

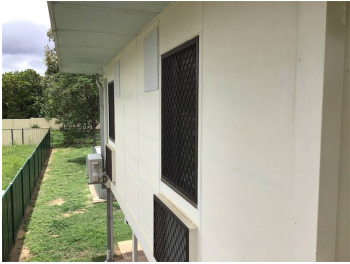
Location	10 B Diamond Avenue - 1st Floor - External - All elevations - Walls - Fibre cement sheet

Hazard Type	Asbestos	Material Assessment		Disturbance Assessment	
Friability	Non-friable	Product Type	1	Occupancy	0
Sample No.	5-932 {AO000245}	Extent of damage	0	Disturbance	1
Result	Positive Chrysotile	Surface Treatment	1	Exposure	0
		Asbestos Type	1	Maintenance	0
Item Number	24	Material Score	3	Disturbance Score	1
		Priority Score	4	Very Low
