# COMPLIANCE ASBESTOS RE-INSPECTION AND RISK ASSESSMENT

NOVEMBER 2021

J033431

EMERALD CAMPUS\_116 Harris Street  
116 Harris Street  
Emerald QLD  
4720

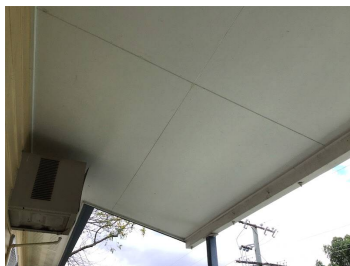
Location		116 Harris Street - 1st Floor - External - North elevation - Awning - Fibre cement sheet				
Hazard Type		Asbestos	Material Assessment		Disturbance Assessment	
Friability		Non-friable	Product Type	1	Occupancy	1
Sample No.		5-946 {AO000248}	Extent of damage	0	Disturbance	1
Result		Positive Chrysotile	Surface Treatment	1	Exposure	0
			Asbestos Type	1	Maintenance	0
Item Number	4	Material Score	3	Disturbance Score	2	
		Priority Score	5	Very Low

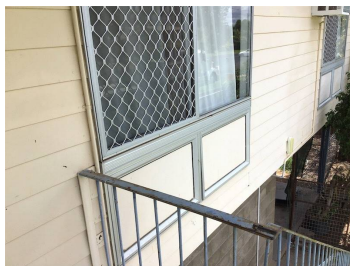
Location		116 Harris Street - 1st Floor - External - Below windows - All elevations - Infill panels - Fibre cement sheet									
Hazard Type		Asbestos		Material Assessment		Disturbance Assessment					
Friability		Non-friable		Product Type		1		Occupancy		0	
Sample No.		5-945 {AO000249}		Extent of damage		0		Disturbance		1	
Result		Positive Chrysotile		Surface Treatment		1		Exposure		0	
				Asbestos Type		1		Maintenance		0	
Item Number		5		Material Score		3		Disturbance Score		1	
				Priority Score		4		Very Low

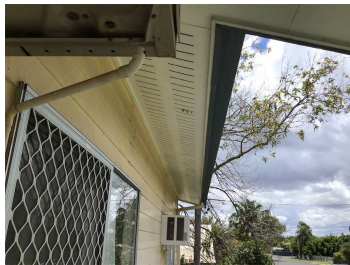
Location	116 Harris Street - 1st Floor - External - All elevations - Soffits - Fibre cement sheet

Hazard Type	Asbestos	Material Assessment		Disturbance Assessment		
Friability	Non-friable	Product Type	1	Occupancy		1
Sample No.	As 5-946 (AO000248)	Extent of damage	0	Disturbance		1
Result	Strongly Assumed Positive Chrysotile	Surface Treatment	1	Exposure		0
		Asbestos Type	1	Maintenance		0
Item Number	6	Material Score	3	Disturbance Score		2
		Priority Score	5	Very Low

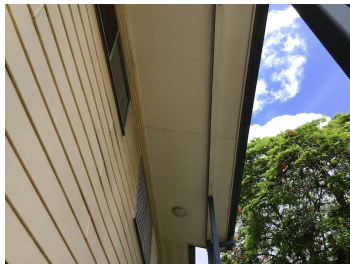
Location		116 Harris Street - 1st Floor - External - South elevation - Awning - Fibre cement sheet					
Hazard Type		Asbestos		Material Assessment		Disturbance Assessment	
Friability		Non-friable		Product Type		1	
Sample No.		As 5-946 (AO000248)		Extent of damage		0	
Result		Strongly Assumed Positive Chrysotile		Surface Treatment		1	
				Asbestos Type		1	
Item Number		8		Material Score		3	
				Priority Score		5	
				Disturbance Score		2	
						Very Low

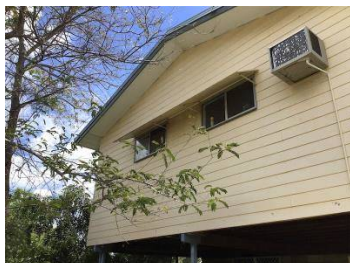
18	116 Harris Street -1st Floor -External, East & West Elevation												
	Sunhoods -Fibre cement sheet	Asbestos	Visual	Assumed, Positive	3lm	No	Good Condition	Non-friable	Very Low	Low	P4	Manage In Situ

Location		116 Harris Street - 1st Floor - External - East & West Elevation - Sunhoods - Fibre cement sheet									
Hazard Type		Asbestos		Material Assessment		Disturbance Assessment					
Friability		Non-friable		Product Type		1		Occupancy		0	
Sample No.		Visual		Extent of damage		0		Disturbance		1	
Result		Assumed Positive Unknown or Crocidolite		Surface Treatment		1		Exposure		0	
				Asbestos Type		3		Maintenance		1	
Item Number		18		Material Score		5		Disturbance Score		2	
				Priority Score		7		Very Low
