COMPLIANCE ASBESTOS RE-INSPECTION AND RISK ASSESSMENT

NOVEMBER 2021

J033432

EMERALD CAMPUS_2 Maguire PI
2 Maguire PI
Emerald QLD
4720

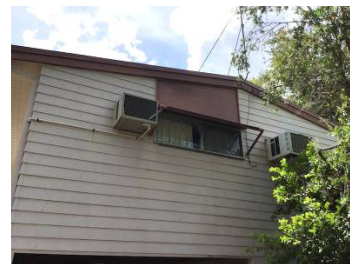
30	2 Maguire Place -1st Floor -External, East & West Elevation												
	Sunhoods -Fibre cement sheet	Asbestos	Visual	Assumed, Positive	6lm	No	Good Condition	Non-friable	Very Low	Low	P4	Manage In Situ

Location		2 Maguire Place - 1st Floor - External - East & West Elevation Sunhoods - Fibre cement sheet									
Hazard Type		Asbestos		Material Assessment		Disturbance Assessment					
Friability		Non-friable		Product Type		1		Occupancy		0	
Sample No.		Visual		Extent of damage		0		Disturbance		1	
Result		Assumed Positive Unknown or Crocidolite		Surface Treatment		1		Exposure		0	
				Asbestos Type		3		Maintenance		0	
Item Number		30		Material Score		5		Disturbance Score		1	
				Priority Score		6		Very Low

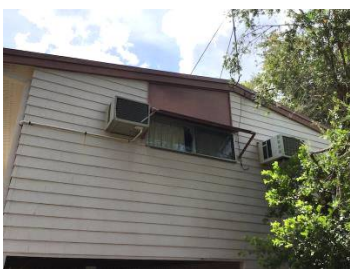
Location		2 Maguire Place - 1st Floor - External - East & West elevation Infill panels - Fibre cement sheet									
Hazard Type		Asbestos		Material Assessment		Disturbance Assessment					
Friability		Non-friable		Product Type		1		Occupancy		0	
Sample No.		Visual		Extent of damage		0		Disturbance		1	
Result		Assumed Positive Unknown or Crocidolite		Surface Treatment		1		Exposure		0	
				Asbestos Type		3		Maintenance		0	
Item Number		31		Material Score		5		Disturbance Score		1	
				Priority Score		6		Very Low

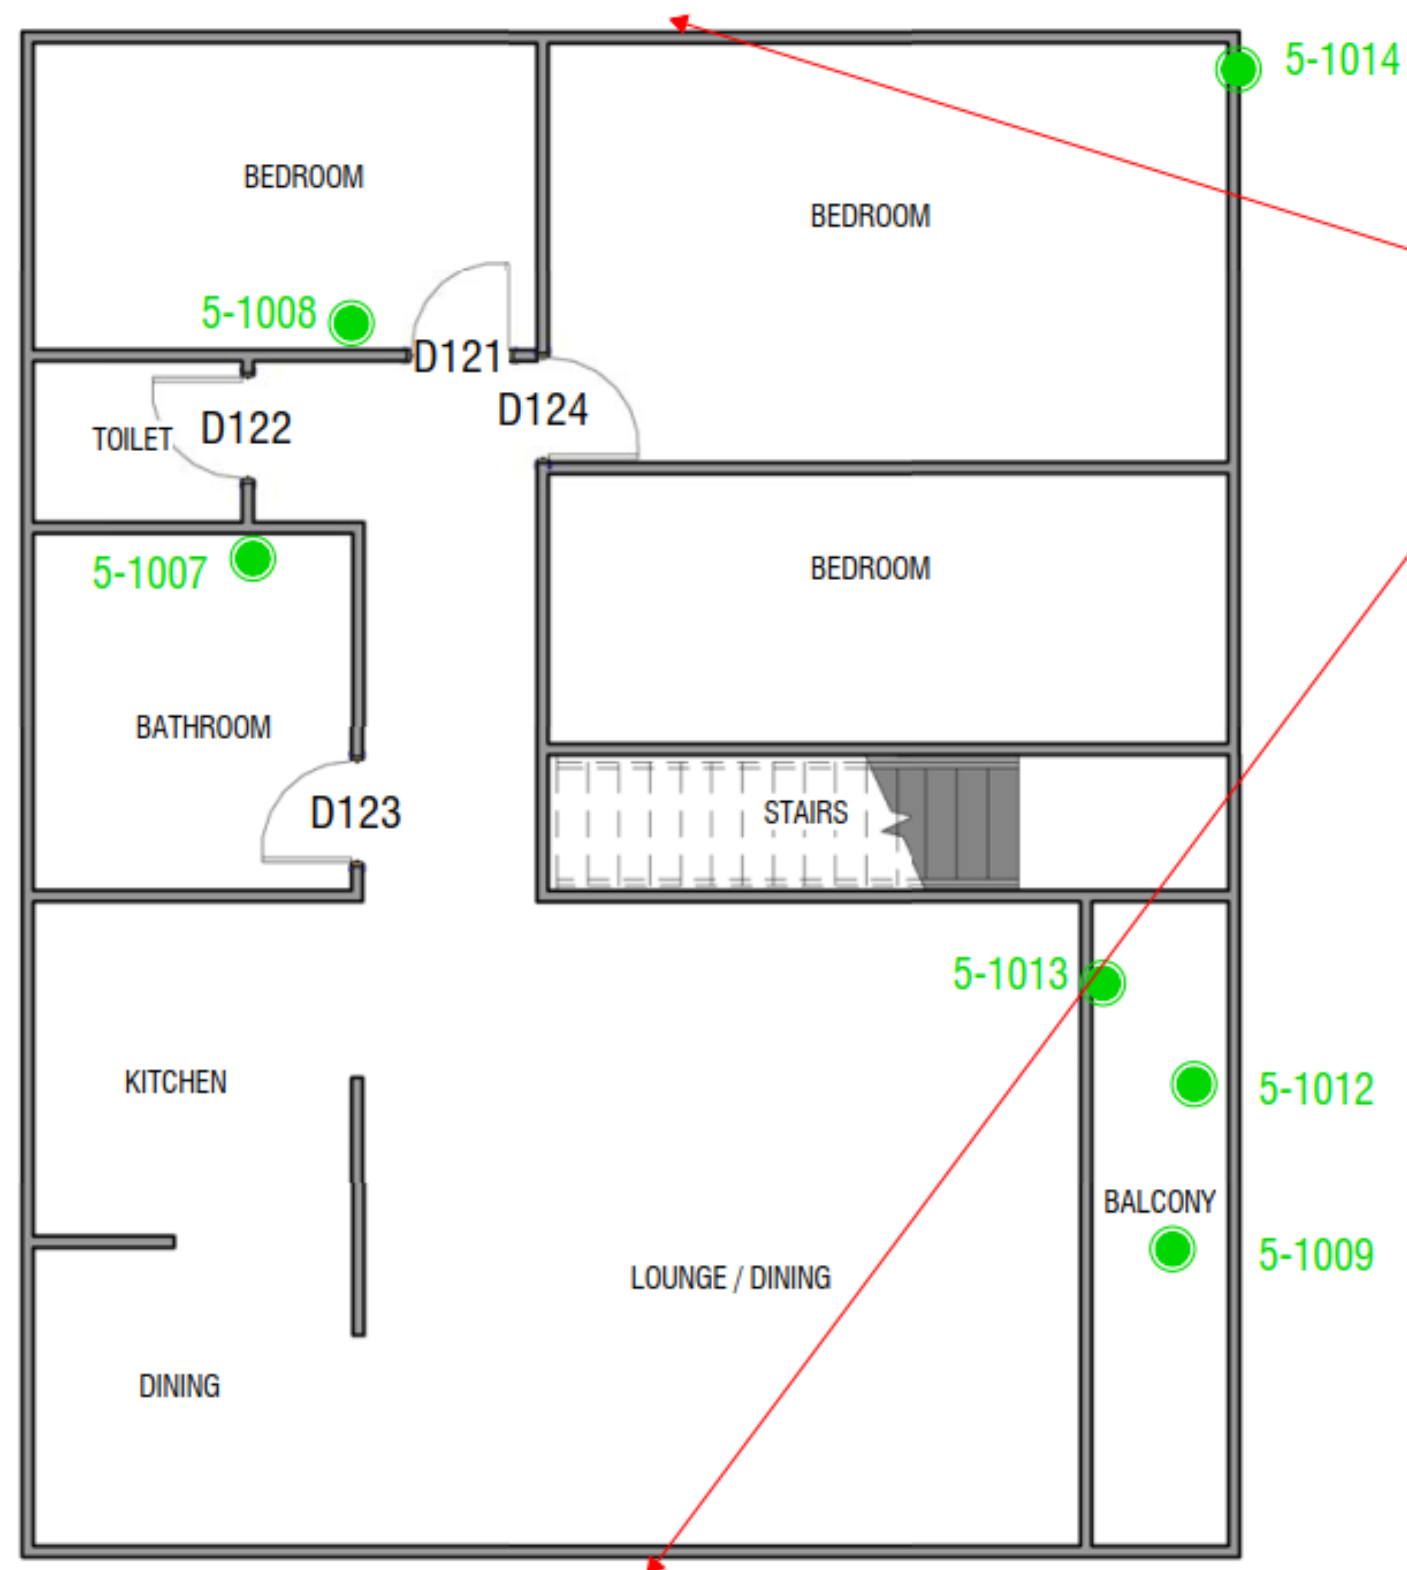
AREA: 2 Maguire Street – First Level

Assumed asbestos - Sun hoods and In-fill above the sun hoods
