COMPLIANCE ASBESTOS RE-INSPECTION AND RISK ASSESSMENT

NOVEMBER 2021

J033433

EMERALD CAMPUS_5 Andrew PI
5 Andrew PI
Emerald QLD
4720

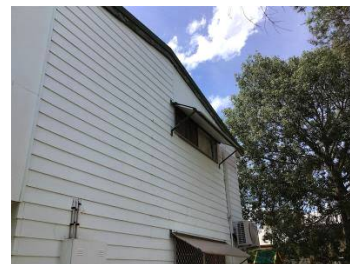
Location		5 Andrew Place - 1st Floor - External - East & West elevation - Sunhoods - Fibre cement sheet			
Hazard Type	Asbestos	Material Assessment		Disturbance Assessment	
Friability	Non-friable	Product Type	1	Occupancy	0
Sample No.	Visual	Extent of damage	0	Disturbance	1
Result	Assumed Positive Unknown or Crocidolite	Surface Treatment	1	Exposure	0
		Asbestos Type	3	Maintenance	0
Item Number	36	Material Score	5	Disturbance Score	1
		Priority Score	6	Very Low

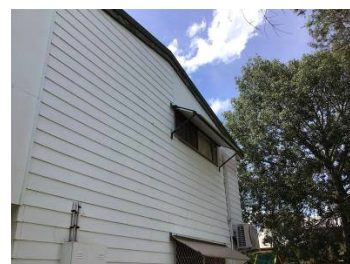
Location		5 Andrew Place - 1st Floor - External - East & West elevation - Infill panels - Fibre cement sheet			
Hazard Type	Asbestos	Material Assessment		Disturbance Assessment	
Friability	Non-friable	Product Type	1	Occupancy	0
Sample No.	Visual	Extent of damage	0	Disturbance	1
Result	Assumed Positive Unknown or Crocidolite	Surface Treatment	1	Exposure	0
		Asbestos Type	3	Maintenance	0
Item Number	37	Material Score	5	Disturbance Score	1
		Priority Score	6	Very Low
