COMPLIANCE ASBESTOS RE-INSPECTION AND RISK ASSESSMENT

NOVEMBER 2021

J033434

EMERALD CAMPUS_5 Willans Street
5 Willans Street
Emerald QLD
4720

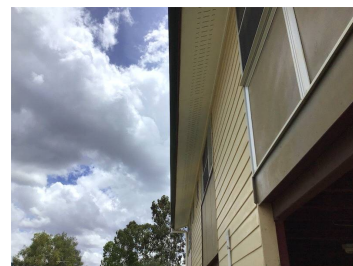
Location		5 Willans Street - 1st Floor - External - - Soffits - Fibre cement sheet			
Hazard Type		Asbestos	Material Assessment		Disturbance Assessment
Friability	Non-friable	Product Type	1	Occupancy	0
Sample No.	Visual	Extent of damage	0	Disturbance	1
Result	Assumed Positive Unknown or Crocidolite	Surface Treatment	1	Exposure	0
		Asbestos Type	3	Maintenance	0
Item Number	1	Material Score	5	Disturbance Score	1
		Priority Score	6	Very Low

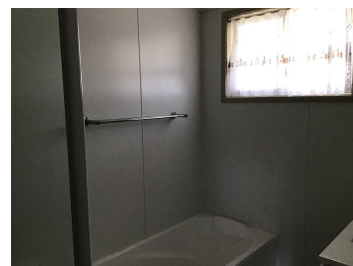
Location		5 Willans Street - 1st Floor - Bathroom - Behind Laminex 'Splashback' - Walls - Fibre cement sheet					
Hazard Type		Asbestos		Material Assessment		Disturbance Assessment	
Friability		Non-friable		Product Type		1 Occupancy 0	
Sample No.		Visual		Extent of damage		0 Disturbance 1	
Result		Assumed Positive Unknown or Crocidolite		Surface Treatment		1 Exposure 0	
				Asbestos Type		3 Maintenance 0	
Item Number		2		Material Score		5 Disturbance Score 1	
				Priority Score		6 Very Low
