# COMPLIANCE ASBESTOS RE-INSPECTION AND RISK ASSESSMENT

NOVEMBER 2021

J033435

EMERALD CAMPUS\_77 Roberts Street  
77 Roberts Street  
Emerald QLD  
4720

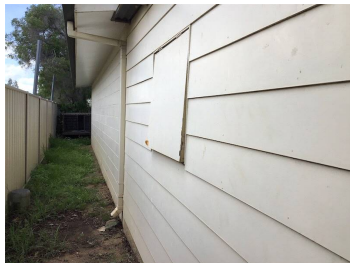
Location		77 Roberts Street - Ground Floor - Garage Store - West elevation - Infill panel - Fibre cement sheet									
Hazard Type		Asbestos		Material Assessment		Disturbance Assessment					
Friability		Non-friable		Product Type		1 Occupancy		0			
Sample No.		5-991 {AO000256}		Extent of damage		0		Disturbance		1	
Result		Positive Chrysotile		Surface Treatment		1		Exposure		0	
				Asbestos Type		1		Maintenance		0	
Item Number		24		Material Score		3		Disturbance Score		1	
				Priority Score		4		Very Low

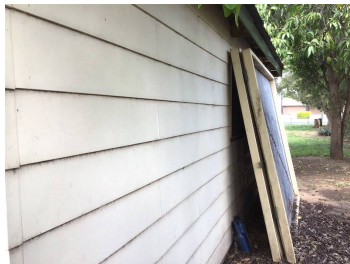
Location		77 Roberts Street - Ground Floor - Garage Store - All elevations - External wall cladding - Fibre cement sheet									
Hazard Type		Asbestos		Material Assessment		Disturbance Assessment					
Friability		Non-friable		Product Type		1		Occupancy		0	
Sample No.		As 5-979 (AO000254)		Extent of damage		0		Disturbance		1	
Result		Strongly Assumed Positive Chrysotile		Surface Treatment		1		Exposure		0	
				Asbestos Type		1		Maintenance		0	
Item Number		25		Material Score		3		Disturbance Score		1	
				Priority Score		4		Very Low

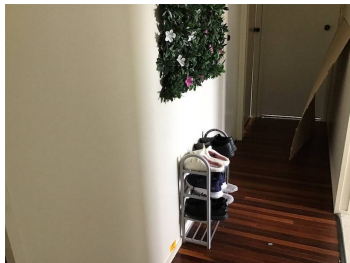
Location		77 Roberts Street - 1st Floor - Hallway - North & South elevation - Walls - Fibre cement sheet									
Hazard Type		Asbestos		Material Assessment		Disturbance Assessment					
Friability		Non-friable		Product Type		1		Occupancy		0	
Sample No.		5-986 {AO000251}		Extent of damage		0		Disturbance		1	
Result		Positive Chrysotile		Surface Treatment		1		Exposure		0	
				Asbestos Type		1		Maintenance		0	
Item Number		4		Material Score		3		Disturbance Score		1	
				Priority Score		4		Very Low

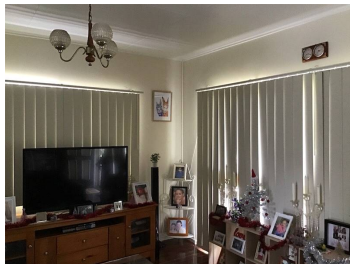
Location		77 Roberts Street - 1st Floor - Lounge - North, West & South elevation - Walls - Fibre cement sheet									
Hazard Type		Asbestos		Material Assessment		Disturbance Assessment					
Friability		Non-friable		Product Type		1		Occupancy		0	
Sample No.		As 5-986 {AO000251}		Extent of damage		0		Disturbance		1	
Result		Strongly Assumed Positive Chrysotile		Surface Treatment		1		Exposure		0	
				Asbestos Type		1		Maintenance		0	
Item Number		5		Material Score		3		Disturbance Score		1	
				Priority Score		4		Very Low

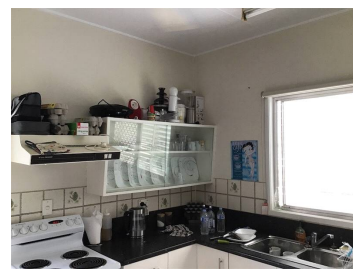
Location		77 Roberts Street - 1st Floor - Kitchen - All elevations - Walls - Fibre cement sheet									
Hazard Type		Asbestos		Material Assessment		Disturbance Assessment					
Friability		Non-friable		Product Type		1		Occupancy		0	
Sample No.		As 5-986 (AO000251}		Extent of damage		0		Disturbance		1	
Result		Strongly Assumed Positive Chrysotile		Surface Treatment		1		Exposure		1	
				Asbestos Type		1		Maintenance		0	
Item Number		6		Material Score		3		Disturbance Score		2	
				Priority Score		5		Very Low

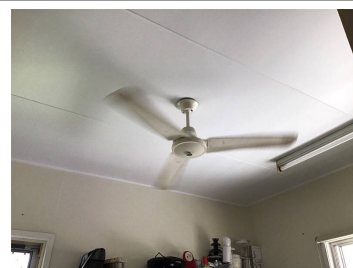
Location		77 Roberts Street - 1st Floor - Kitchen - Throughout - Ceiling - Fibre cement sheet									
Hazard Type		Asbestos		Material Assessment		Disturbance Assessment					
Friability		Non-friable		Product Type		1		Occupancy		0	
Sample No.		As 5-988 (AO000252)		Extent of damage		0		Disturbance		1	
Result		Strongly Assumed Positive Chrysotile		Surface Treatment		1		Exposure		0	
				Asbestos Type		1		Maintenance		0	
Item Number		19		Material Score		3		Disturbance Score		1	
				Priority Score		4		Very Low

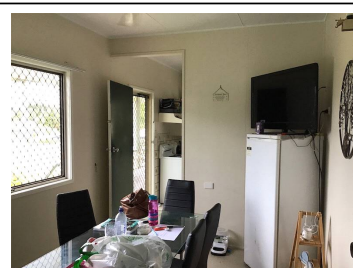
Location		77 Roberts Street - 1st Floor - Dining Room - All elevations - Walls - Fibre cement sheet									
Hazard Type		Asbestos		Material Assessment		Disturbance Assessment					
Friability		Non-friable		Product Type		1		Occupancy		0	
Sample No.		As 5-986 {AO000251}		Extent of damage		0		Disturbance		1	
Result		Strongly Assumed Positive Chrysotile		Surface Treatment		1		Exposure		0	
				Asbestos Type		1		Maintenance		0	
Item Number		7		Material Score		3		Disturbance Score		1	
				Priority Score		4		Very Low

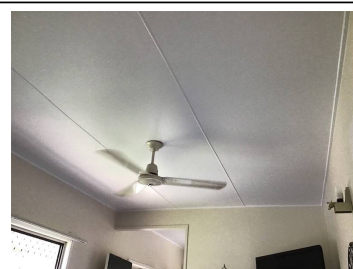
Location		77 Roberts Street - 1st Floor - Dining Room - Throughout - Ceiling - Fibre cement sheet				
Hazard Type		Asbestos	Material Assessment		Disturbance Assessment	
Friability		Non-friable	Product Type	1	Occupancy	0
Sample No.		As 5-988 (AO000252)	Extent of damage	0	Disturbance	1
Result		Strongly Assumed Positive Chrysotile	Surface Treatment	1	Exposure	0
			Asbestos Type	1	Maintenance	0
Item Number	18	Material Score	3	Disturbance Score		1
		Priority Score	4	Very Low

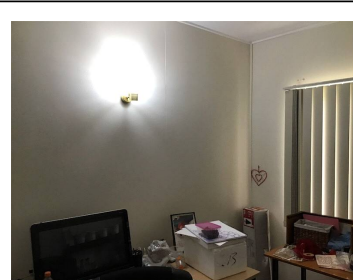
Location		77 Roberts Street - 1st Floor - Bedroom 1 (Office) - All elevations - Walls - Fibre cement sheet							
Hazard Type		Asbestos		Material Assessment		Disturbance Assessment			
Friability		Non-friable		Product Type		1 Occupancy		0	
Sample No.		As 5-986 {AO000251}		Extent of damage		0 Disturbance		1	
Result		Strongly Assumed Positive Chrysotile		Surface Treatment		1 Exposure		0	
				Asbestos Type		1 Maintenance		0	
Item Number		8		Material Score		3 Disturbance Score		1	
				Priority Score		4 Very Low

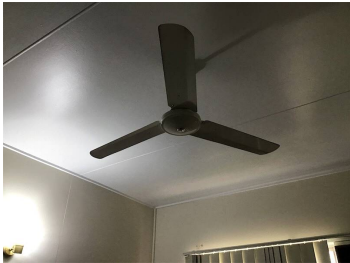
Location	77 Roberts Street - 1st Floor - Bedroom 1 (Office) - Throughout - Ceiling -Fibre cement sheet

Hazard Type	Asbestos	Material Assessment		Disturbance Assessment	
Friability	Non-friable	Product Type	1	Occupancy	0
Sample No.	As 5-988 {AO000252}	Extent of damage	0	Disturbance	1
Result	Strongly Assumed Positive Chrysotile	Surface Treatment	1	Exposure	0
		Asbestos Type	1	Maintenance	0
Item Number	15	Material Score	3	Disturbance Score	1
		Priority Score	4	Very Low

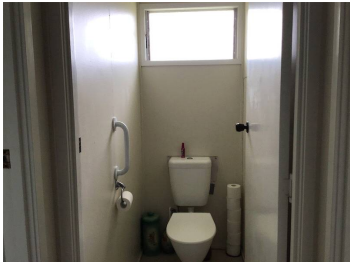
Location	77 Roberts Street - 1st Floor - Toilet - All elevations - Walls - Fibre cement sheet

Hazard Type	Asbestos	Material Assessment		Disturbance Assessment	
Friability	Non-friable	Product Type	1	Occupancy	0
Sample No.	As 5-988 {AO000251}	Extent of damage	0	Disturbance	1
Result	Strongly Assumed Positive Chrysotile	Surface Treatment	1	Exposure	0
		Asbestos Type	1	Maintenance	0
Item Number	9	Material Score	3	Disturbance Score	1
		Priority Score	4	Very Low

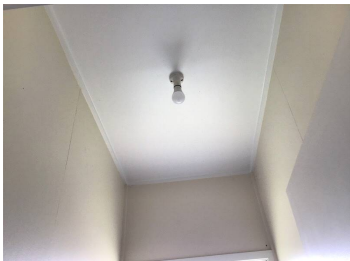
Location	77 Roberts Street - 1st Floor - Toilet - Throughout - Ceiling - Fibre cement sheet

Hazard Type	Asbestos	Material Assessment		Disturbance Assessment	
Friability	Non-friable	Product Type	1	Occupancy	0
Sample No.	As 5-988 {AO000252}	Extent of damage	0	Disturbance	1
Result	Strongly Assumed Positive Chrysotile	Surface Treatment	1	Exposure	0
		Asbestos Type	1	Maintenance	0
Item Number	17	Material Score	3	Disturbance Score	1
		Priority Score	4	Very Low

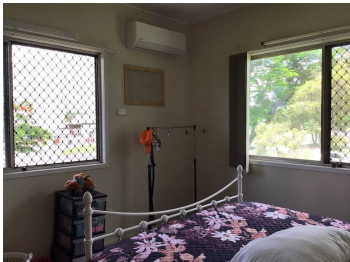
Location	77 Roberts Street - 1st Floor - Bedroom 2 (NE) - All elevations - Walls - Fibre cement sheet

Hazard Type	Asbestos	Material Assessment		Disturbance Assessment	
Friability	Non-friable	Product Type	1	Occupancy	1
Sample No.	As 5-986 {AO000251}	Extent of damage	0	Disturbance	1
Result	Strongly Assumed Positive Chrysotile	Surface Treatment	1	Exposure	0
		Asbestos Type	1	Maintenance	0
Item Number	10	Material Score	3	Disturbance Score	2
		Priority Score	5	Very Low

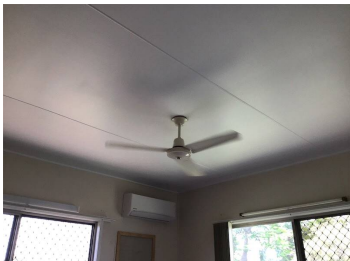
Location	77 Roberts Street - 1st Floor - Bedroom 2 (NE) - Throughout - Ceiling - Fibre cement sheet

Hazard Type	Asbestos	Material Assessment		Disturbance Assessment	
Friability	Non-friable	Product Type	1	Occupancy	1
Sample No.	As 5-988 {AO000252}	Extent of damage	0	Disturbance	1
Result	Strongly Assumed Positive Chrysotile	Surface Treatment	1	Exposure	1
		Asbestos Type	1	Maintenance	0
Item Number	14	Material Score	3	Disturbance Score	3
		Priority Score	6	Very Low

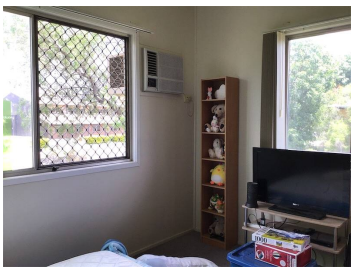
Location	77 Roberts Street - 1st Floor - Bedroom 3 (SE) - All elevations - Walls - Fibre cement sheet

Hazard Type	Asbestos	Material Assessment	Disturbance Assessment	
Friability	Non-friable	Product Type	1	
Sample No.	As 5-986 {AO000251}	Extent of damage	0	
Result	Strongly Assumed Positive Chrysotile	Surface Treatment	1	
		Asbestos Type	1	
Item Number	11	Material Score	3	
		Priority Score	5	Very Low

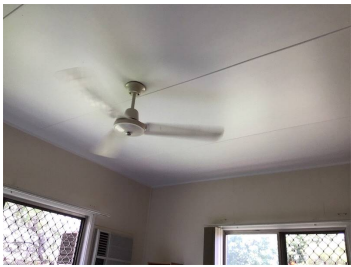
Location	77 Roberts Street - 1st Floor - Bedroom 3 (SE) - Throughout - Ceiling - Fibre cement sheet

Hazard Type	Asbestos	Material Assessment	Disturbance Assessment	
Friability	Non-friable	Product Type	1	
Sample No.	As 5-988 {AO000252}	Extent of damage	0	
Result	Strongly Assumed Positive Chrysotile	Surface Treatment	1	
		Asbestos Type	1	
Item Number	13	Material Score	3	
		Priority Score	5	Very Low

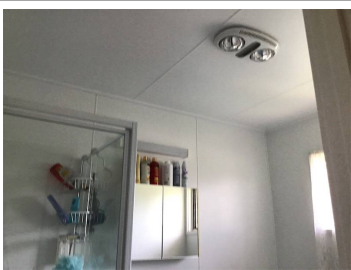
Location	77 Roberts Street - 1st Floor - Bathroom - Throughout - Ceiling - Fibre cement sheet

Hazard Type	Asbestos	Material Assessment	Disturbance Assessment	
Friability	Non-friable	Product Type	1	
Sample No.	As 5-988 {AO000252}	Extent of damage	0	
Result	Strongly Assumed Positive Chrysotile	Surface Treatment	1	
		Asbestos Type	1	
Item Number	16	Material Score	3	
		Priority Score	4	Very Low

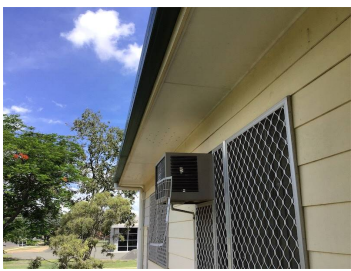
Location	77 Roberts Street - 1st Floor - External - All elevations - Soffits - Fibre cement sheet

Hazard Type	Asbestos	Material Assessment	Disturbance Assessment	
Friability	Non-friable	Product Type	1	
Sample No.	5-990 {AO000253}	Extent of damage	0	
Result	Positive Chrysotile	Surface Treatment	1	
		Asbestos Type	1	
Item Number	20	Material Score	3	
		Priority Score	4	Very Low

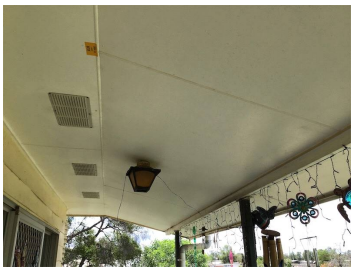
Location	77 Roberts Street - 1st Floor - External - North elevation - Awning - Fibre cement sheet

Hazard Type	Asbestos	Material Assessment	Disturbance Assessment	
Friability	Non-friable	Product Type	1	
Sample No.	As 5-990 {AO000253}	Extent of damage	0	
Result	Strongly Assumed Positive Chrysotile	Surface Treatment	1	
		Asbestos Type	1	
Item Number	21	Material Score	3	
		Priority Score	4	Very Low

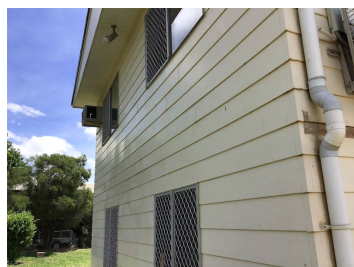
Location		77 Roberts Street - 1st Floor - External - All elevations - Wall cladding - Fibre cement sheet									
Hazard Type		Asbestos		Material Assessment		Disturbance Assessment					
Friability		Non-friable		Product Type		1		Occupancy		0	
Sample No.		5-979 (AO000254)		Extent of damage		0		Disturbance		1	
Result		Positive Chrysotile		Surface Treatment		1		Exposure		0	
				Asbestos Type		1		Maintenance		0	
Item Number		22		Material Score		3		Disturbance Score		1	
				Priority Score		4		Very Low

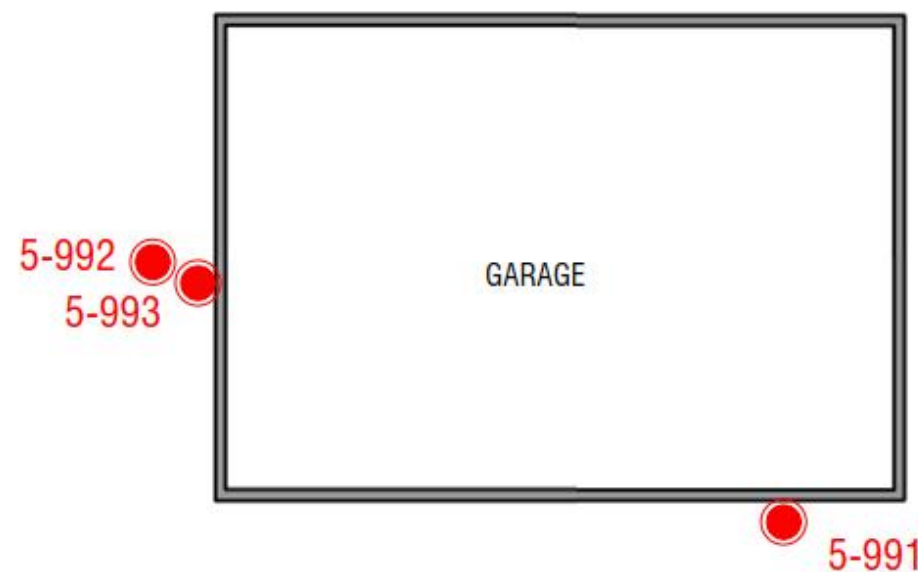
Location		77 Roberts Street - 1st Floor - External - West elevation - Fascia - Fibre cement sheet									
Hazard Type		Asbestos		Material Assessment		Disturbance Assessment					
Friability		Non-friable		Product Type		1		Occupancy		0	
Sample No.		As 5-993 {AO000257}		Extent of damage		0		Disturbance		1	
Result		Strongly Assumed Positive Chrysotile		Surface Treatment		1		Exposure		0	
				Asbestos Type		1		Maintenance		0	
Item Number		27		Material Score		3		Disturbance Score		1	
				Priority Score		4		Very Low
