# COMPLIANCE ASBESTOS RE-INSPECTION AND RISK ASSESSMENT

NOVEMBER 2021

J033436

EMERALD CAMPUS\_8 Kathleen Court  
8 Kathleen Court  
Emerald QLD  
4720

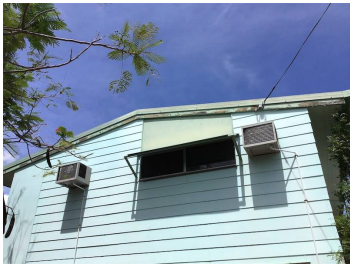
Location	8 Kathleen Court - 1st Floor - External - - Sunhood - Fibre cement sheet

Hazard Type	Asbestos	Material Assessment		Disturbance Assessment	
Friability	Non-friable	Product Type	1	Occupancy	0
Sample No.	Visual	Extent of damage	0	Disturbance	1
Result	Assumed Positive Unknown or Crocidolite	Surface Treatment	1	Exposure	0
		Asbestos Type	3	Maintenance	0
Item Number	1	Material Score	5	Disturbance Score	1
		Priority Score	6	Very Low

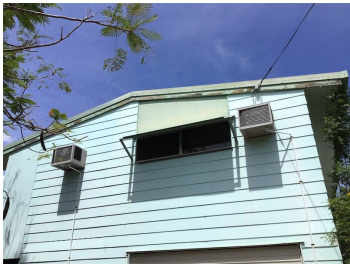
Location	8 Kathleen Court - 1st Floor - External - - Infill panels - Fibre cement sheet

Hazard Type	Asbestos	Material Assessment		Disturbance Assessment	
Friability	Non-friable	Product Type	1	Occupancy	0
Sample No.	Visual	Extent of damage	0	Disturbance	1
Result	Assumed Positive Unknown or Crocidolite	Surface Treatment	1	Exposure	0
		Asbestos Type	3	Maintenance	0
Item Number	2	Material Score	5	Disturbance Score	1
		Priority Score	6	Very Low
