COMPLIANCE ASBESTOS RE-INSPECTION AND RISK ASSESSMENT

NOVEMBER 2021

J033437

EMERALD CAMPUS_8 Loch Street
8 Loch Street
Emerald QLD
4720

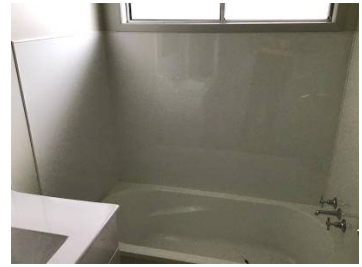
Location		8 Loch Street - 1st Floor - Bathroom - - Wall lining - Tilux					
Hazard Type		Asbestos		Material Assessment		Disturbance Assessment	
Friability		Non-friable		Product Type		1	
Sample No.		Visual		Extent of damage		0	
Result		Assumed Positive Unknown or Crocidolite		Surface Treatment		1	
				Asbestos Type		3	
Item Number		1		Material Score		5	
				Priority Score		6	
						Very Low

1	8 Loch Street -1st Floor -Bathroom,												
	Wall lining -Tilux	Asbestos	Visual	Assumed, Positive	10m ²	No	Good Condition	Non-friable	Very Low	Low	P4	Conduct Further Investigations/Sampling Prior to Disturbance

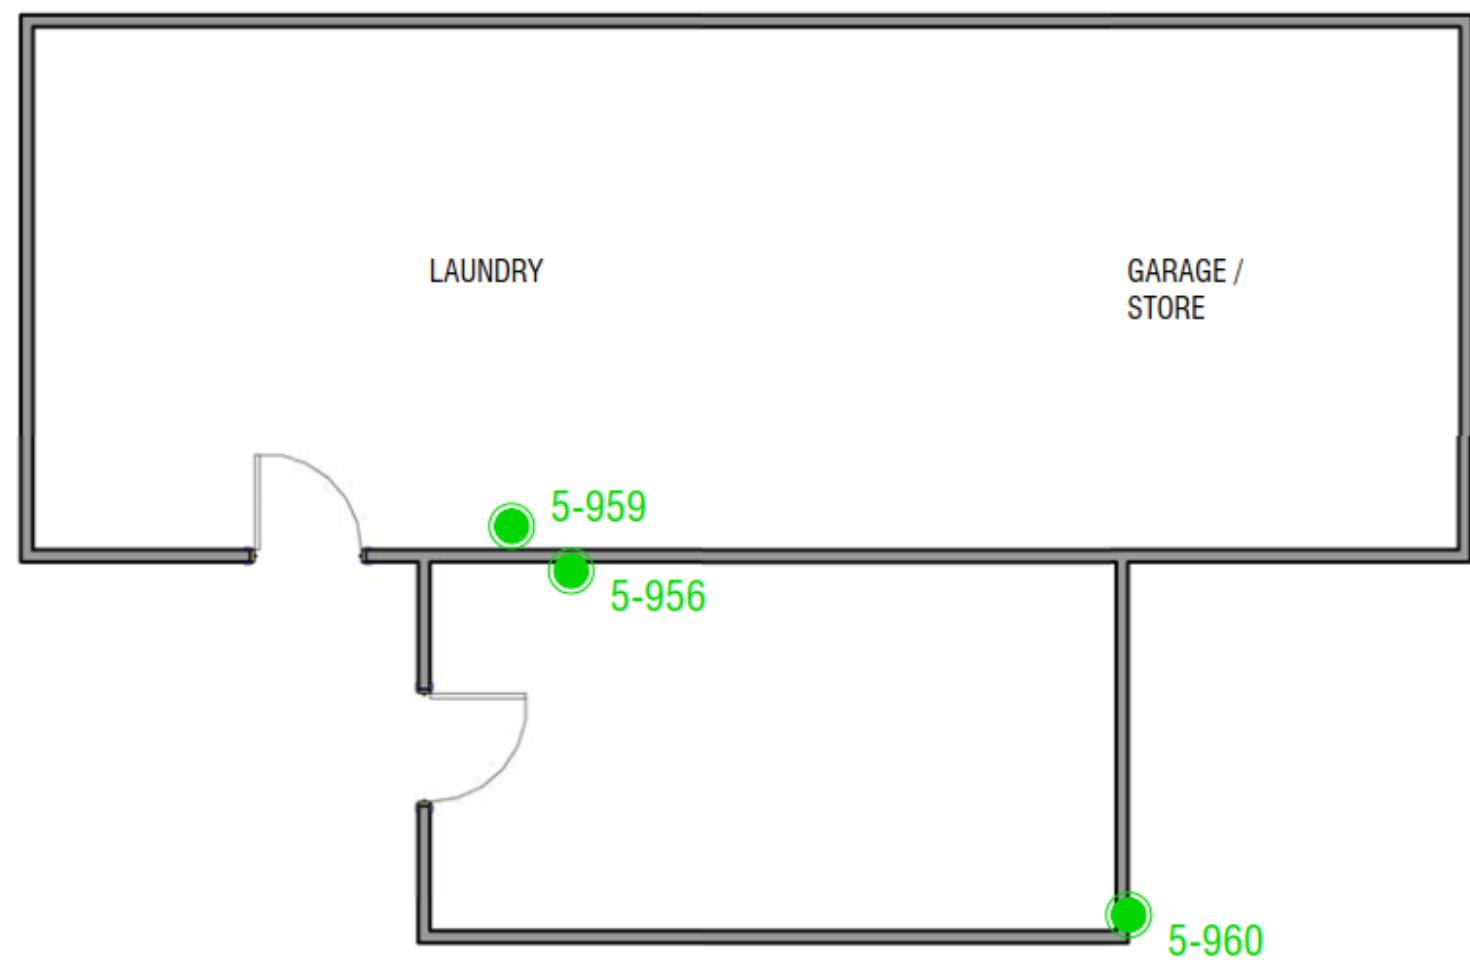
AREA: 8 Loch Street – Ground Level

Item No	Location / Description	Hazard Type	Sample No.	Item Status	Est. Extent	Current Label	Condition	Friability	Disturbance Risk	Material Risk	Control Priority	Recommended Action	Record of Works
2	8 Loch Street -Ground Floor -Entrance Foyer, All elevations												
	Walls -Fibre cement sheet	Asbestos	5-956 {TPS000457}	Identified, Negative	-	-	-	-	-	-	-	No further action required	
3	8 Loch Street -Ground Floor -Stairwell, All elevations												
	Walls -Fibre cement sheet	Asbestos	As 5-956 {TPS000457}	Strongly Assumed, Negative	-	-	-	-	-	-	-	No further action required	
4	8 Loch Street -Ground Floor -Garage / Laundry, All elevations												
	Walls -Fibre cement sheet	Asbestos	5-959 {TPS000458}	Identified, Negative	-	-	-	-	-	-	-	No further action required	
5	8 Loch Street -Ground Floor -External, All elevations												
	Walls -Fibre cement sheet	Asbestos	5-960 {TPS000459}	Identified, Negative	-	-	-	-	-	-	-	No further action required

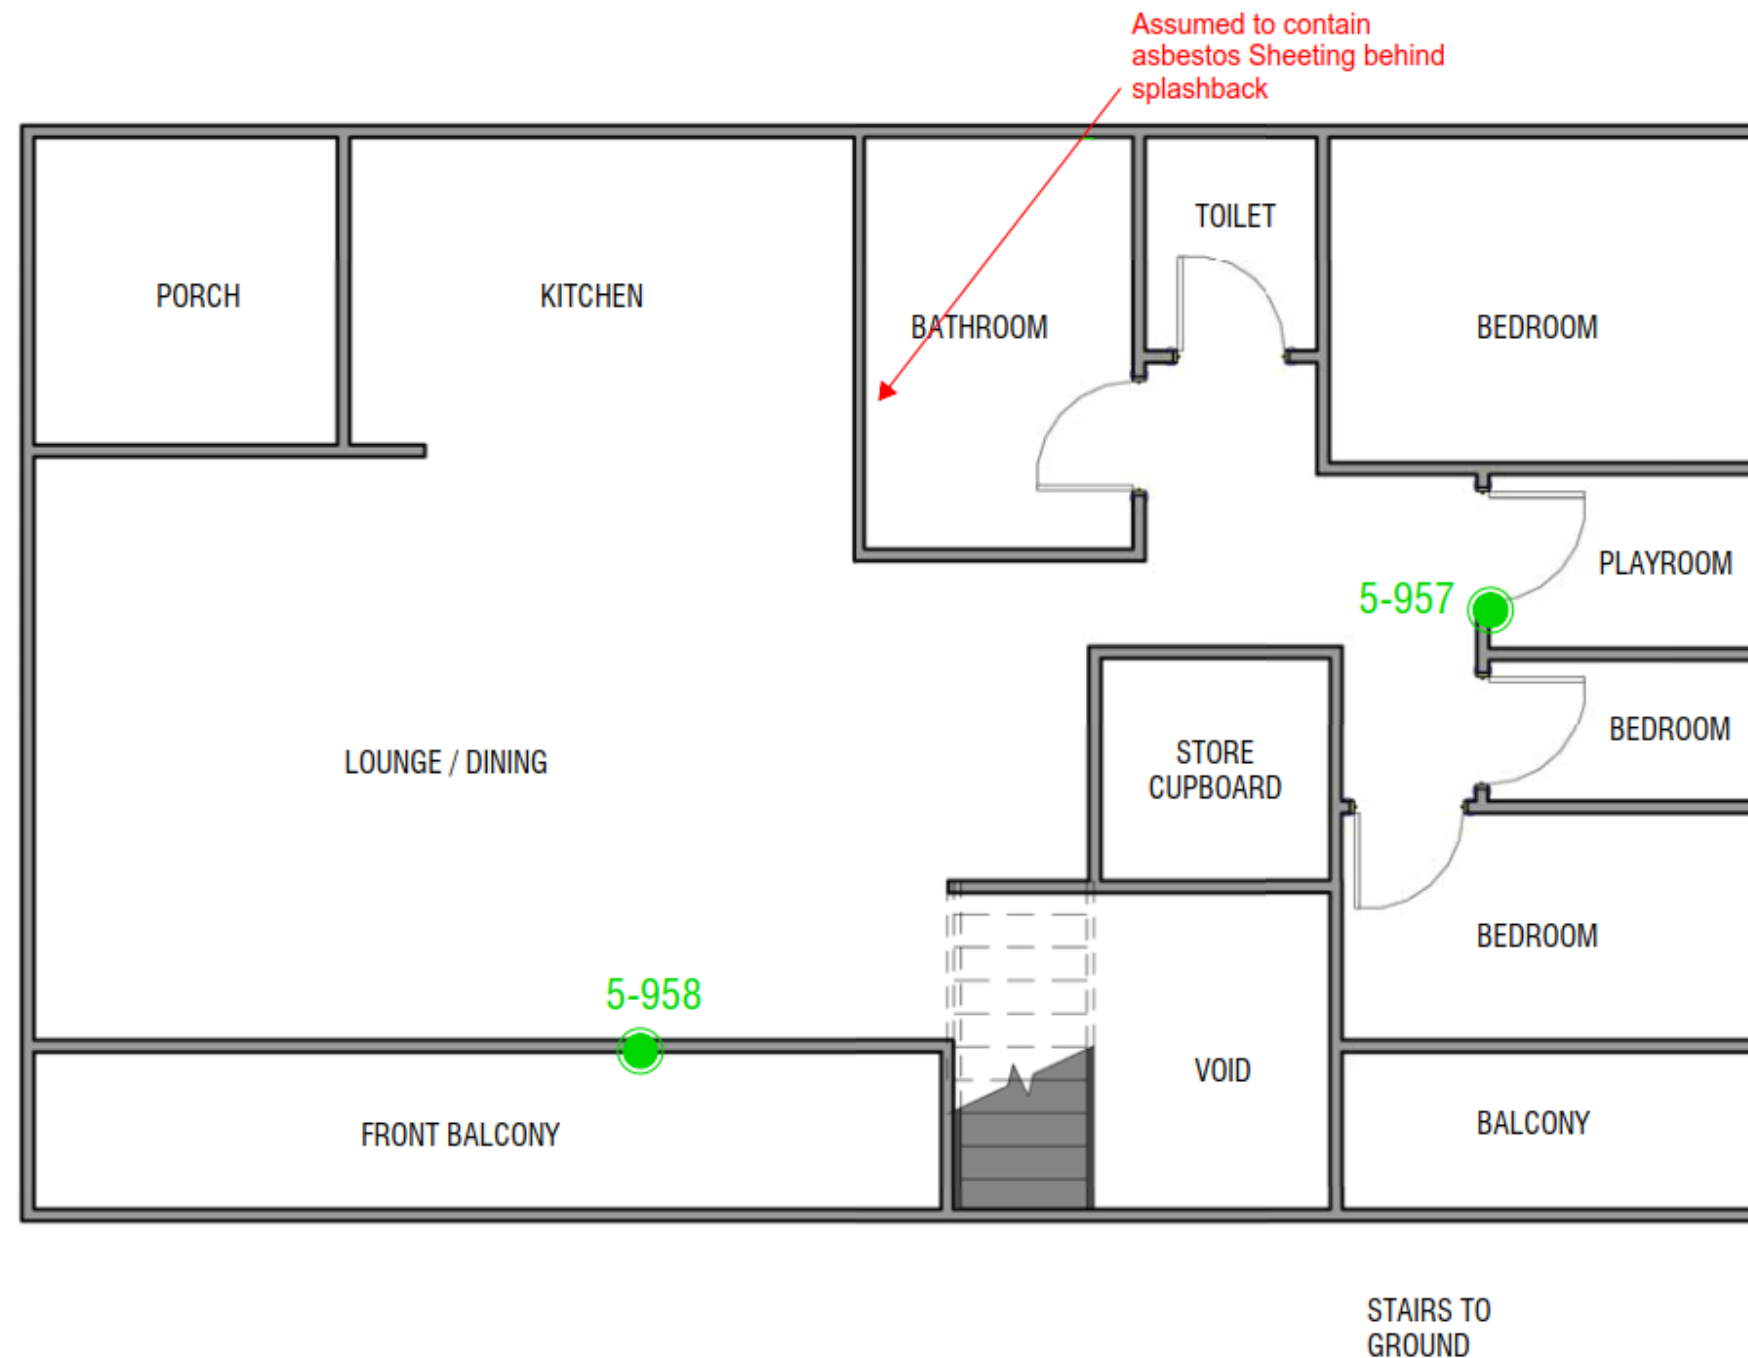
Item No	Location / Description	Hazard Type	Sample No.	Item Status	Est. Extent	Current Label	Condition	Friability	Disturbance Risk	Material Risk	Control Priority	Recommended Action	Record of Works
10	8 Loch Street -1st Floor -Bedroom South West, All elevations												
	Walls -Fibre cement sheet	Asbestos	As 5-957 {TPS000460}	Strongly Assumed, Negative	-	-	-	-	-	-	-	No further action required	
11	8 Loch Street -1st Floor -Master Bedroom, All elevations												
	Walls -Fibre cement sheet	Asbestos	As 5-957 {TPS000460}	Strongly Assumed, Negative	-	-	-	-	-	-	-	No further action required	
12	8 Loch Street -1st Floor -Kitchen/Dining/Lounge, All elevations												
	Walls -Fibre cement sheet	Asbestos	As 5-957 {TPS000460}	Strongly Assumed, Negative	-	-	-	-	-	-	-	No further action required	
13	8 Loch Street -1st Floor -External, All elevations -Upper sheeting												
	Wall lining -Fibre cement sheet	Asbestos	5-958 {TPS000461}	Identified, Negative	-	-	-	-	-	-	-	No further action required

6	8 Loch Street -1st Floor -Kids Bedroom, All elevations												
	Walls -Fibre cement sheet	Asbestos	5-957 {TPS000460}	Identified, Negative	-	-	-	-	-	-	-	No further action required

Item No	Location / Description	Hazard Type	Sample No.	Item Status	Est. Extent	Current Label	Condition	Friability	Disturbance Risk	Material Risk	Control Priority	Recommended Action	Record of Works
7	8 Loch Street -1st Floor -Bedroom South East, All elevations												
	Walls -Fibre cement sheet	Asbestos	As 5-957 {TPS000460}	Strongly Assumed, Negative	-	-	-	-	-	-	-	No further action required	
8	8 Loch Street -1st Floor -Toilet, All elevations												
	Walls -Fibre cement sheet	Asbestos	As 5-957 {TPS000460}	Strongly Assumed, Negative	-	-	-	-	-	-	-	No further action required	
9	8 Loch Street -1st Floor -Bathroom, All elevations												
	Walls -Fibre cement sheet	Asbestos	As 5-957 {TPS000460}	Strongly Assumed, Negative	-	-	-	-	-	-	-	No further action required
