**ASBESTOS CONTAINING MATERIALS  
SURVEY REPORT**

**8 Gladstone Street, Emerald QLD 4720**

Report Number 622.10968.00000-0050-R01-ASR-8 Gladstone St

01 November 2017

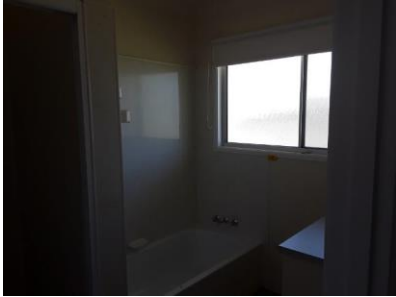
Ground Floor Bathroom	Walls throughout, Fibrous Cement	12m <sup>2</sup>	NAD
5-948

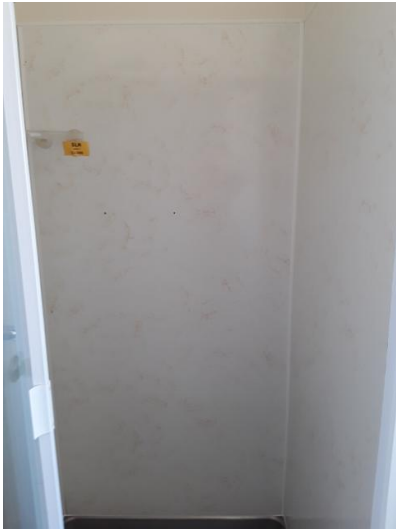
Ground Floor Bathroom	Shower lining and bath surround, Fibrous Cement	6m <sup>2</sup>	NAD

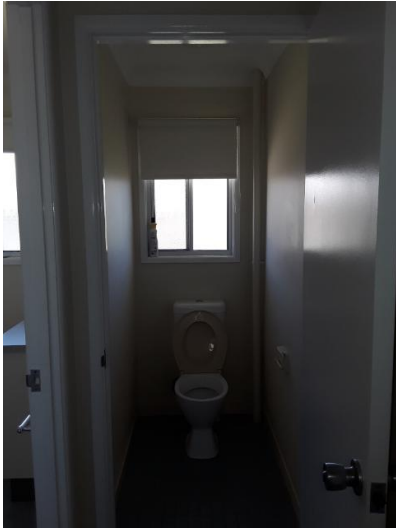
Ground Floor Toilet	Walls throughout, Fibrous Cement	8m²	NAD
5-952

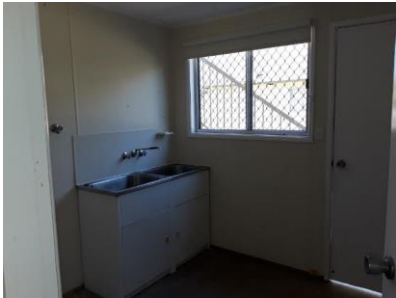
Ground Floor laundry	Walls throughout , Fibrous Cement	2pm²	NAD

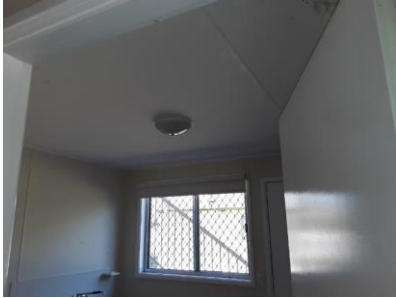
Ground Floor laundry and storeroom	Ceiling, Fibrous Cement	16m <sup>2</sup>	NAD
Similar to 5-952

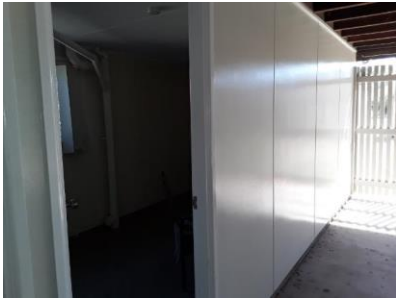
Ground Floor Storeroom	Wall throughout internally and externally, Fibrous Cement	66m <sup>2</sup>	NAD
Similar to 5-952

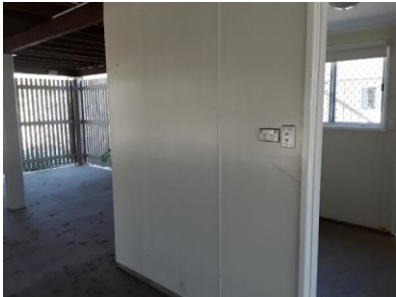
Ground Floor Laundry	Walls externally, Fibrous Cement	18m <sup>2</sup>	NAD

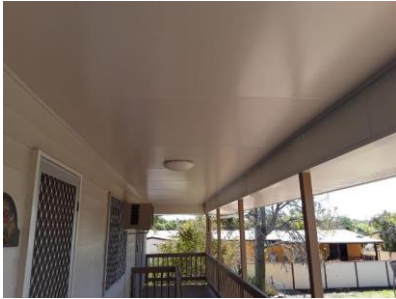
External Front porch	Ceiling, Fibrous Cement	22m <sup>2</sup>	NAD
5-951

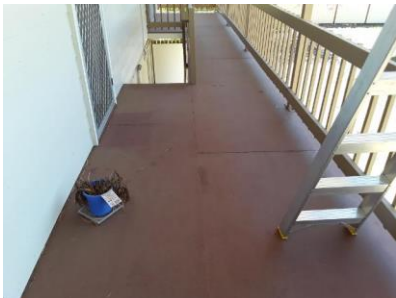
External Front porch	Floor sheeting , Fibrous Cement	22m <sup>2</sup>	NAD
