ASBESTOS CONTAINING MATERIALS SURVEY REPORT

Building 7 Engine clean area
Emerald Campus

Report Number 622.10968.00000/0050-R01-V01-ASR-Bld7-Engine Clean Area

11 October 2017

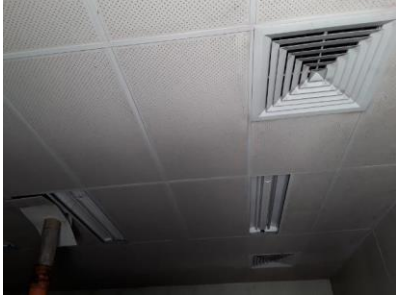
Ground Floor C1.10	Suspended ceiling tiles perforated , Fibrous Cement	20m ²	NAD
1-093

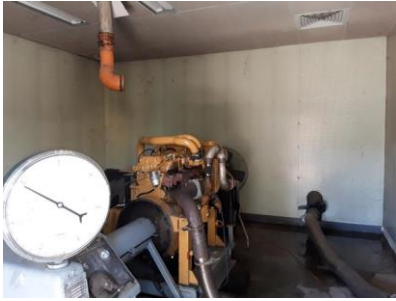
Ground Floor C1.10	Walls throughout perforated , Fibrous Cement	60m ²	NAD

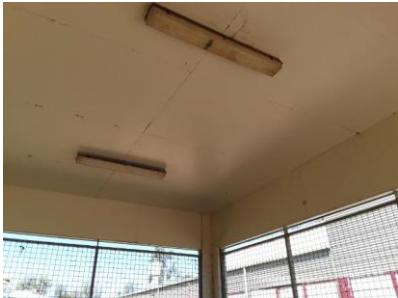
Ground Floor Engine clean area	Upper east and south wall sheeting and ceiling , Fibrous Cement	30	NAD
1-095

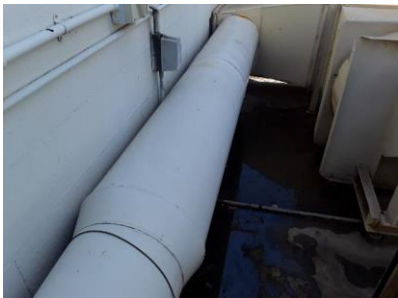
External South side duct work round pipe work running north south	Insulation to inside of pipe, Insulation	unknown	NAD
