ASBESTOS CONTAINING MATERIALS SURVEY REPORT

Block A
Emerald Campus

Report Number 622.10968.00000/0050-R01-V01-ASR-Block A

11 October 2017

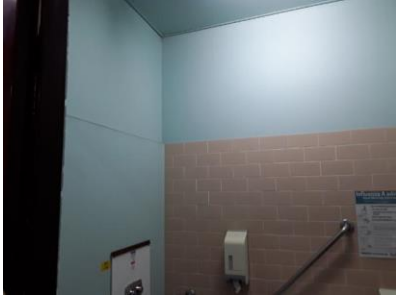
Ground Floor G.14	Wall north and west , Fibrous Cement	8m ²	NAD
1-051

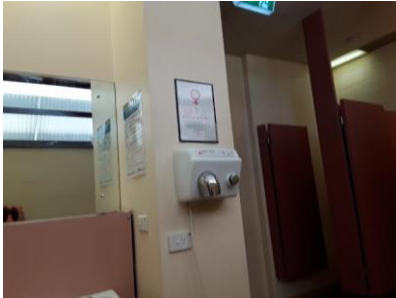
Ground Floor G.18 female toilets	walls- south wall and eastern cubicle wall, Fibrous Cement	18m ²	NAD

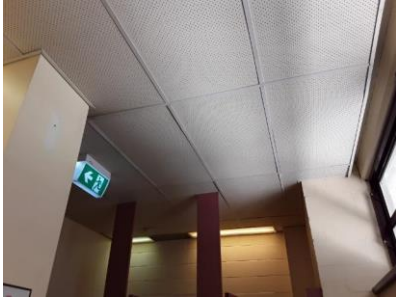
Ground Floor G.18 female toilets	Perforated ceiling tiles, Fibrous Cement	15m ²	NAD
Similar to 1-041

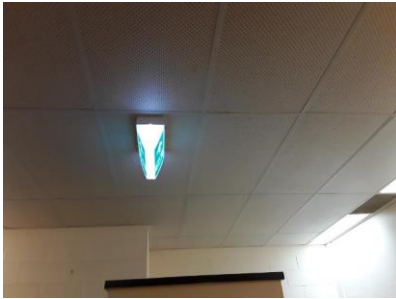
Ground Floor G.16 Male toilets	Perforated ceiling tiles, Fibrous Cement	15m ²	NAD
Similar to 1-051

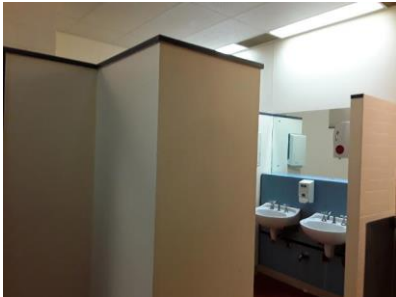
Ground Floor G.16 Male toilets	All walls except western and southern, Fibrous Cement	18m ²	NAD

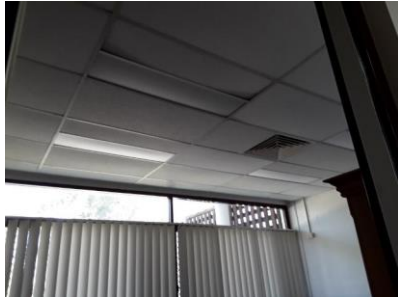
Ground Floor G.03	Perforated Ceiling tiles, Suspected Asbestos	9m ²	NAD
Similar to 1-046

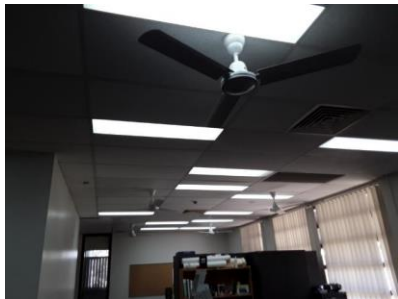
Ground Floor G.04	Perforated Ceiling tiles, Suspected Asbestos	80m ²	NAD
Similar to 1-046

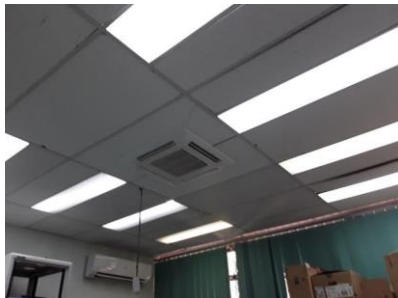
Ground Floor G.05	Perforated Ceiling tiles, Suspected Asbestos	9m ²	NAD

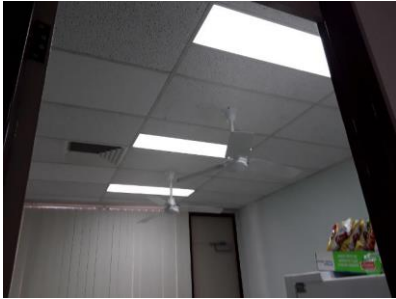
Ground Floor G.06	Perforated Ceiling tiles, Suspected Asbestos	12m ²	NAD
Similar to 1-051

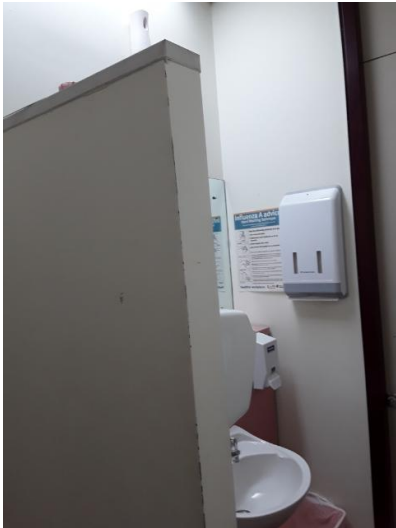
Ground Floor G.07 Female toilets near front office	East, west and nib walls, Fibrous Cement	12m ²	NAD

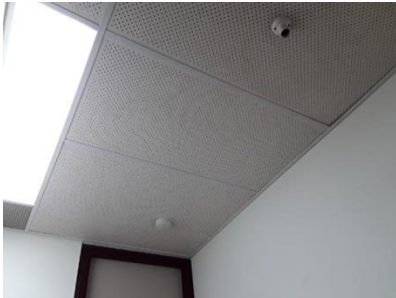
Ground Floor G.07 female toilets	Perforated ceiling tiles, Fibrous Cement	4m ²	NAD
Similar to 1-051

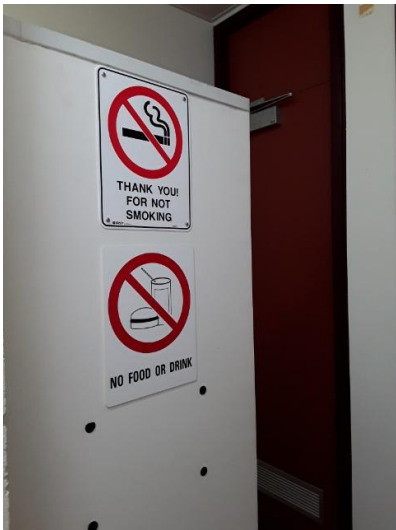
Ground Floor G.08 Male toilets	Dividing walls and west wall in wash room, Fibrous Cement	6m ²	NAD

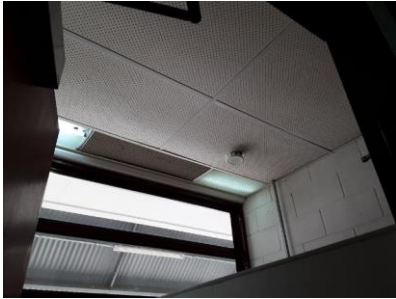
Ground Floor G.08 Male toilets	Perforated ceiling tiles, Fibrous Cement	7m ²	NAD
1-052

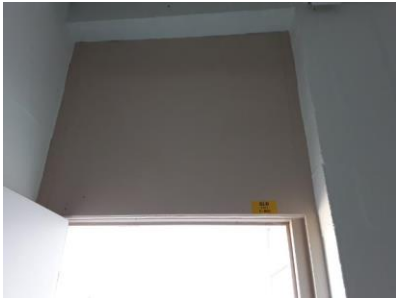
Ground Floor G.25	Infill South wall above door, Fibrous Cement	1m ²	NAD

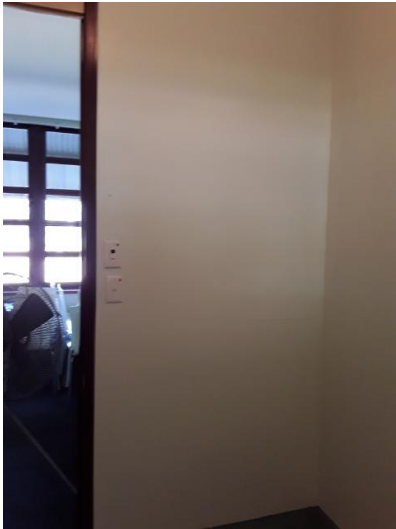
Ground Floor G.259	South wall, Fibrous Cement	3m ²	NAD
Similar to 1-046

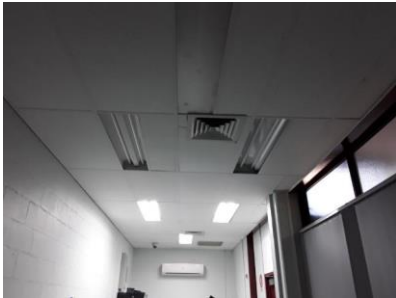
Ground Floor G.22	Perforated Ceiling tiles, Suspected Asbestos	15m ²	NAD

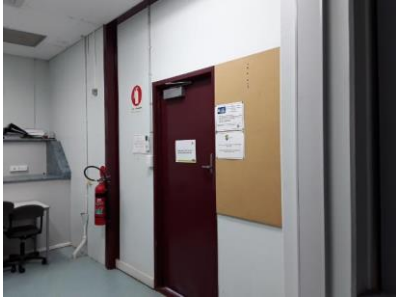
Ground Floor G.22	South wall around door at eastern end, Fibrous Cement	4m ²	NAD
Similar to 1-035

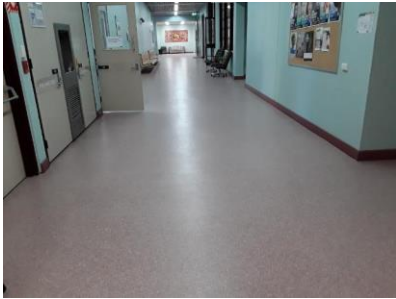
1st Floor Corridor	Floor vinyl sheet, Vinyl Products	86m ²	NAD
Similar to 1-034

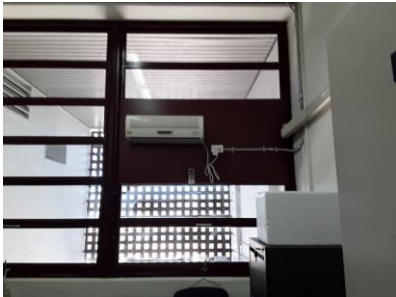
1st Floor 1.12	Infill east wall , Fibrous Cement	1m ²	NAD

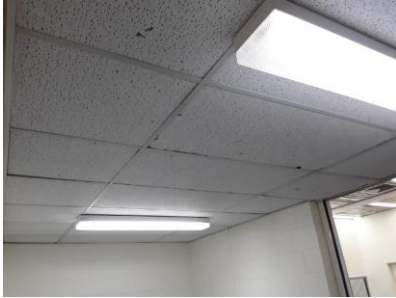
1st Floor 1.14	Perforated Ceiling tiles, Suspected Asbestos	16m ²	NAD
Similar to 1-046

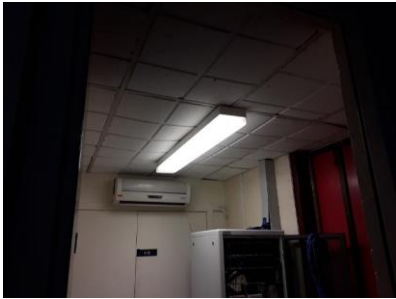
1st Floor 1.11	Perforated Ceiling tiles, Suspected Asbestos	5m ²	NAD
Similar to 1-045

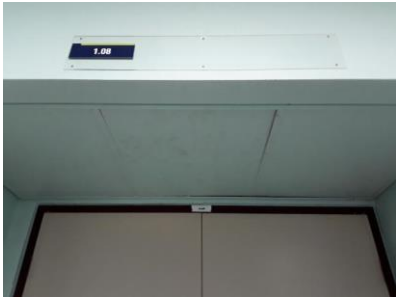
1st Floor 1.08 outside entrance door	Solid ceiling tiles, Fibrous Cement	2m ²	NAD

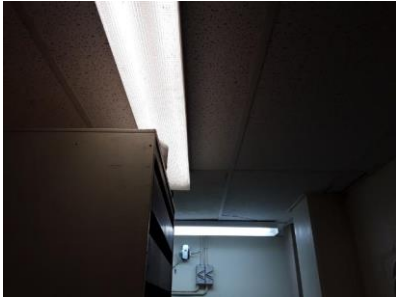
1st Floor 1.04	Perforated Ceiling tiles, Suspected Asbestos	4m ²	NAD
Similar to 1-036

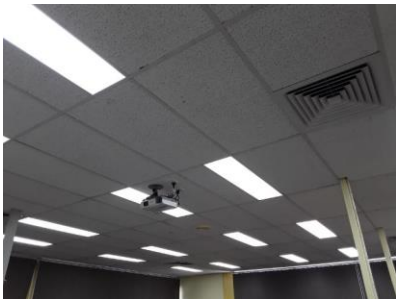
1st Floor 1.26	Perforated Ceiling tiles, Suspected Asbestos	85m ²	NAD
Similar to 1-036

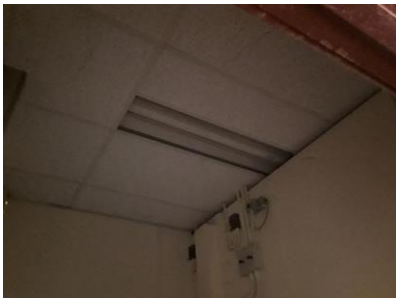
1st Floor 1.28 & 1.27	Perforated Ceiling tiles, Suspected Asbestos	15m ²	NAD

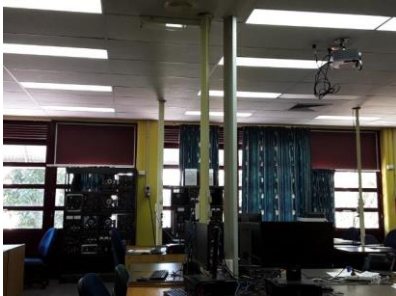
1st Floor 1.29	Infill above windows on North and west sides, also one below window on west side, Fibrous Cement	4m ²	NAD
Similar to 1-036

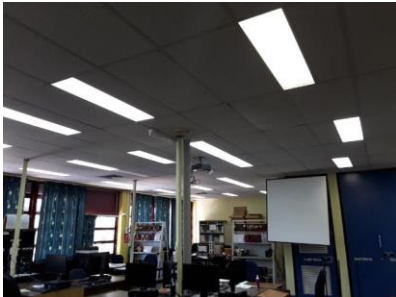
1st Floor 1.29	Perforated Ceiling tiles, Suspected Asbestos	100m ²	NAD
Similar to 1-036

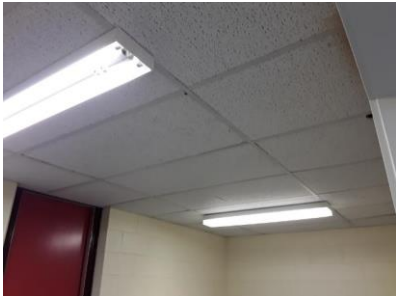
1st Floor 1.22	Perforated Ceiling tiles, Suspected Asbestos	14m ²	NAD

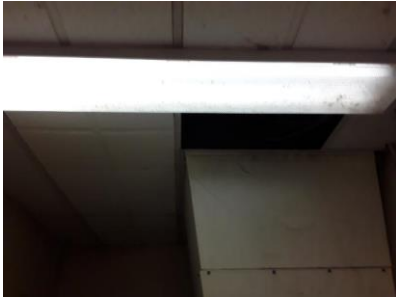
1st Floor 1.10	Perforated Ceiling tiles, Suspected Asbestos	4m ²	NAD
1-033

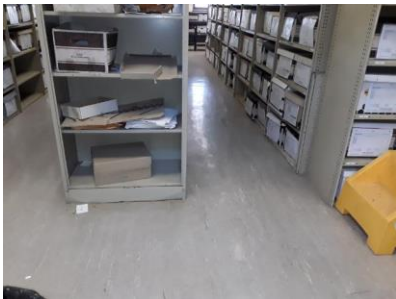
2nd Floor 2.03- Archive room	Floor vinyl sheet, Vinyl Products	108m ²	NAD
Similar to 1-033

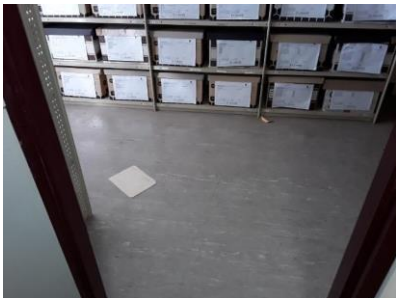
2nd Floor 2.04- Archive room store	Floor vinyl sheet, Vinyl Products	15m ²	NAD

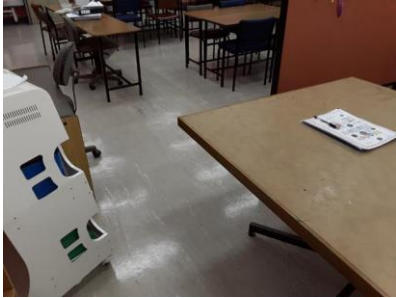
2nd Floor 2.02	Floor vinyl sheet, Vinyl Products	50m ²	NAD
1-034

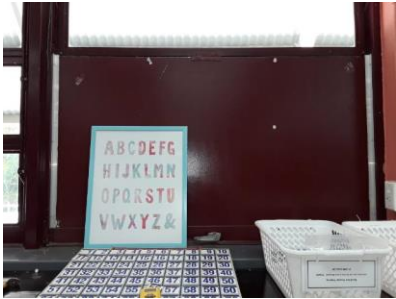
2nd Floor 2.02	Infill, Fibrous Cement	1m ²	NAD
1-036

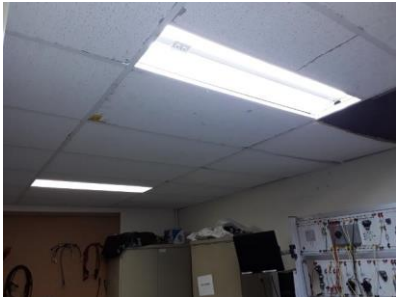
2nd Floor 2.10	Perforated Ceiling tiles, Suspected Asbestos	10m ²	NAD

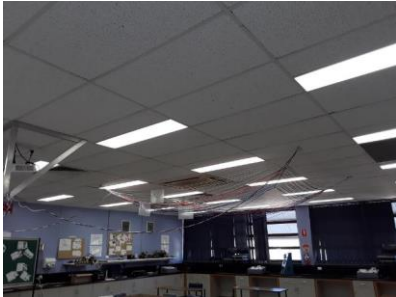
2nd Floor 2.09	Perforated Ceiling tiles, Suspected Asbestos	90m ²	NAD
Similar to 1-033

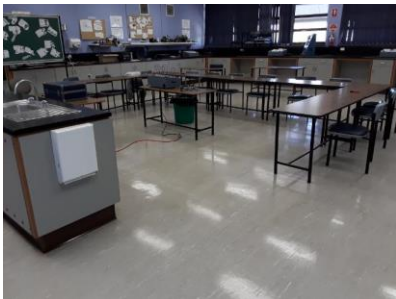
2nd Floor 2.09	Floor vinyl sheet, Vinyl Products	90m ²	NAD
Similar to 1-036

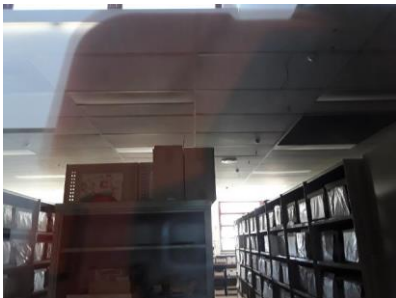
2nd Floor 2.03	Perforated Ceiling tiles, Suspected Asbestos	130m ²	NAD

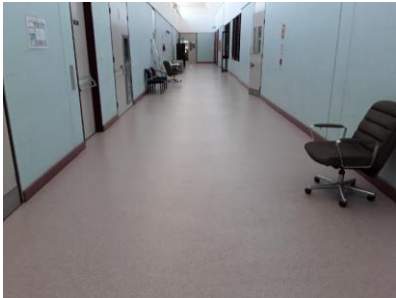
2nd Floor Corridor	Floor vinyl sheet, Vinyl Products	86m ²	NAD
Similar to 1-036		2nd Floor 2.02	Perforated Ceiling tiles, Suspected Asbestos	50m ²	NAD
1-037

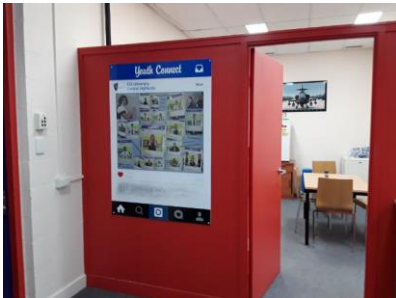
2nd Floor 2.12	Dividing wall to kitchen, Fibrous Cement	8m ²	NAD

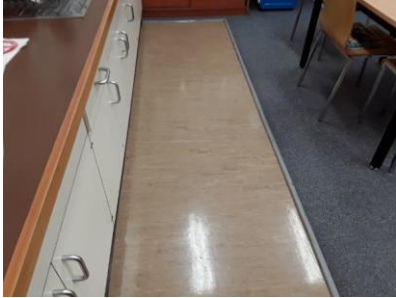
2nd Floor 2.12 kitchen	Vinyl sheet floor , Vinyl Products	5m ²	NAD
Similar to 1-036

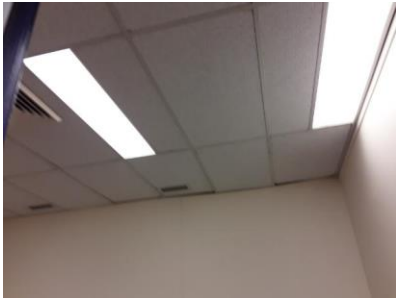
2nd Floor 2.13	Perforated Ceiling tiles, Suspected Asbestos	13m ²	NAD
Similar to 1-036

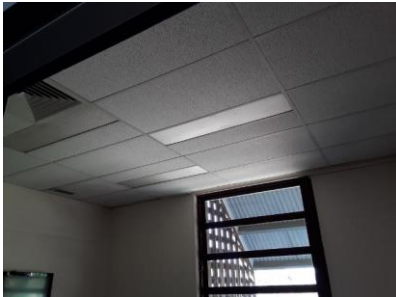
2nd Floor 2.14	Perforated Ceiling tiles, Suspected Asbestos	16m ²	NAD

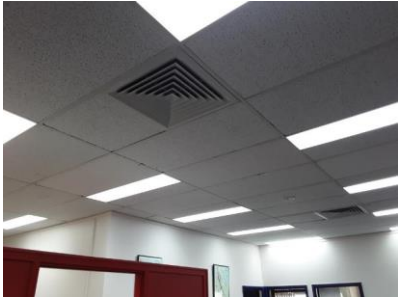
2nd Floor 2.12	Perforated Ceiling tiles, Suspected Asbestos	46m ²	NAD
Similar to 1-036

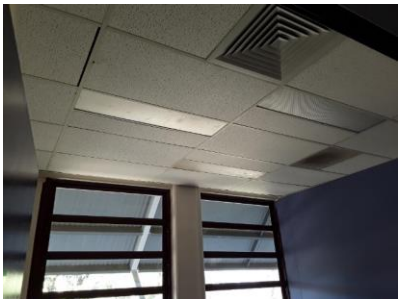
2nd Floor 2.15	Perforated Ceiling tiles, Suspected Asbestos	14m ²	NAD
Similar to 1-036

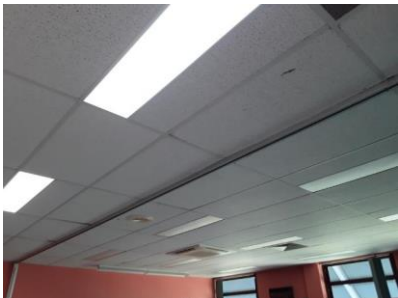
2nd Floor 2.16	Perforated Ceiling tiles, Suspected Asbestos	90m ²	NAD

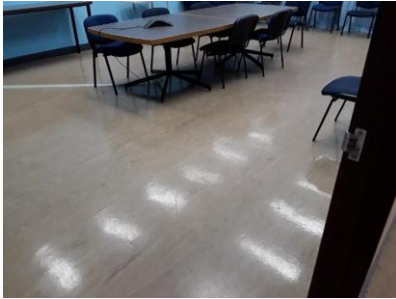
2nd Floor 2.18	Vinyl sheet floor , Vinyl Products	36m ²	NAD
1-040

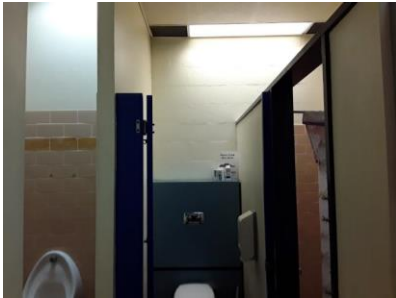
2nd Floor 2.27 - toilets area	Walls throughout, Fibrous Cement	m ²	NAD

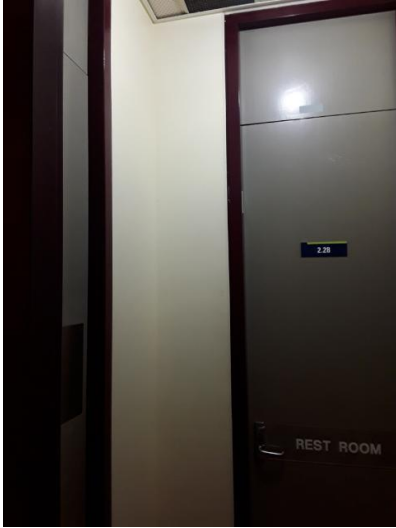
2nd Floor Female toilet Airlock	Walls throughout, Fibrous Cement	5m²	NAD

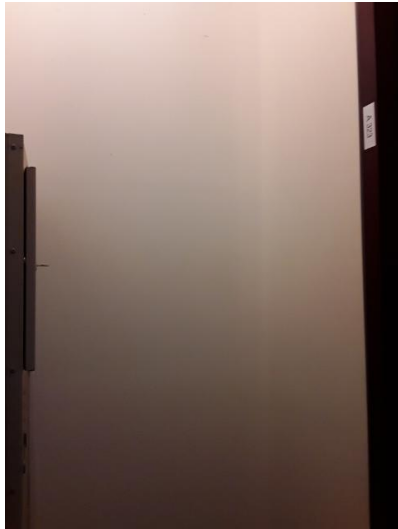
2nd Floor 2.27 airlock	Walls throughout, Fibrous Cement	5m²	NAD
1-041

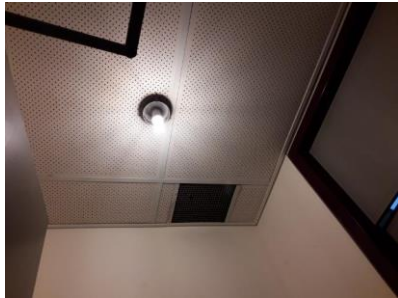
2nd Floor 2.27 airlock	Perforated ceiling tiles, Fibrous Cement	2m²	NAD

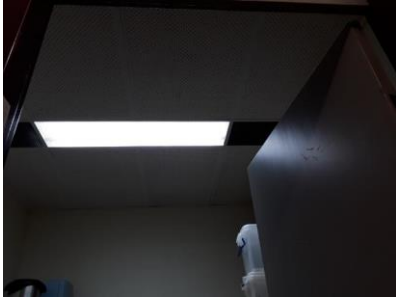
2nd Floor 2.28	Perforated ceiling tiles, Fibrous Cement	4m ²	NAD
Similar to 1-041

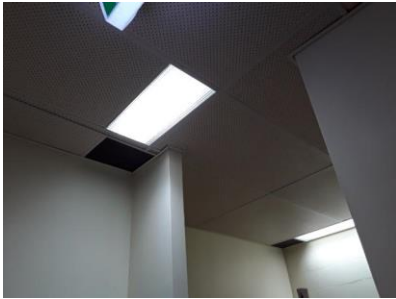
2nd Floor 2.29	Perforated ceiling tiles, Fibrous Cement	5m ²	NAD
Similar to 1-041

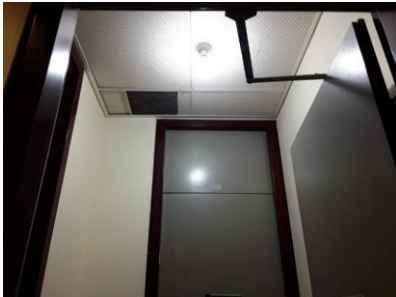
2nd Floor Female toilet Airlock	Perforated ceiling tiles, Fibrous Cement	2m ²	NAD

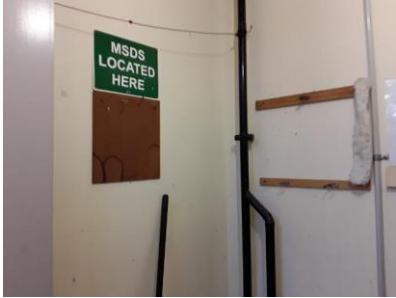
2nd Floor 2.21	Walls south and east, Fibrous Cement	4m ²	NAD
1-045

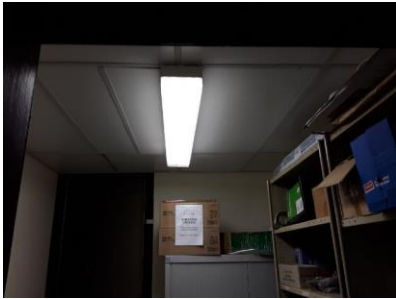
2nd Floor 2.20	Solid ceiling tiles, Fibrous Cement	3m ²	NAD
1-048

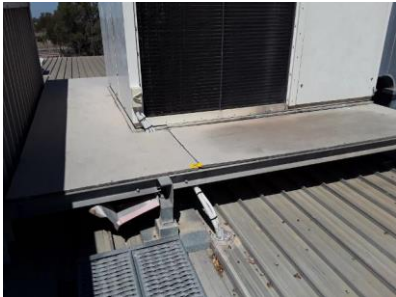
External Roof western end	Fibro sheeting below aircon units, Fibrous Cement	6m ²	NAD

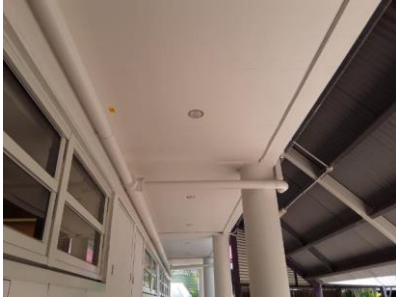
External North side soffit	Soffit, Fibrous Cement	31m ²	NAD
Similar to 1-055

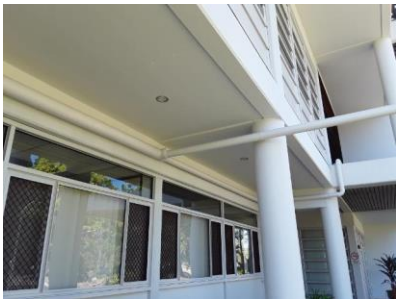
External south side soffit upper and lower level	Soffit, Fibrous Cement	40m ²	NAD
Similar to 1-055

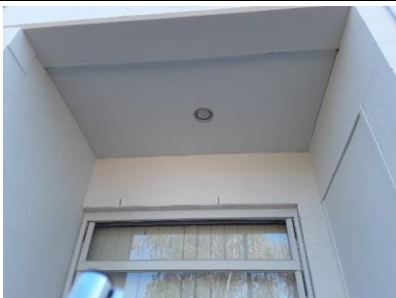
External eastern entrance ceiling	Soffit, Fibrous Cement	1m ²	NAD

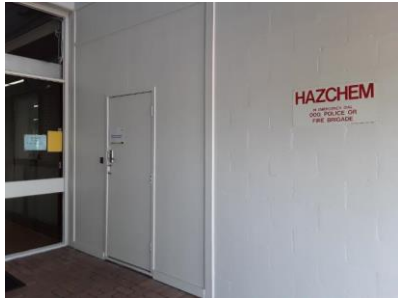
External east side entry wall sheeting around entry door to G22	Wall sheeting , Fibrous Cement	4m ²	NAD
1-056

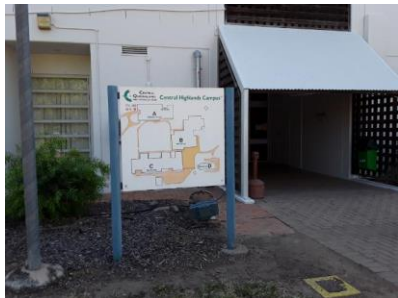
External east side campus map sign	sign , Fibrous Cement	2m ²	NAD
