ASBESTOS CONTAINING MATERIALS SURVEY REPORT

Block B
Emerald Campus

Report Number 622.10968.00000/0050-R01-ASR-Block B

11 October 2017

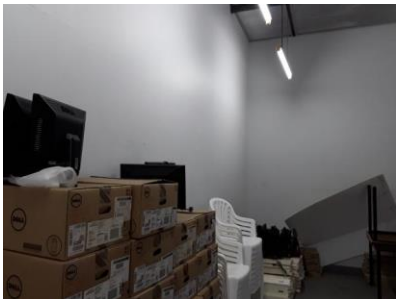
Ground Floor G.20	Wall - north, west, and south , Fibrous Cement	25	NAD
1-058

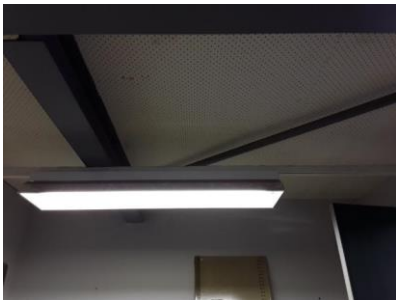
Ground Floor G.20	Ceiling south end, Fibrous Cement	4	NAD

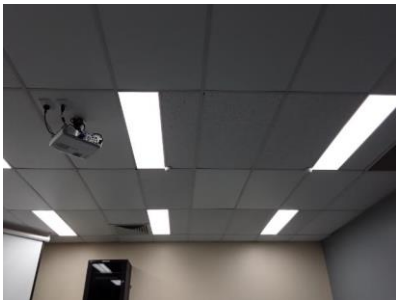
Ground Floor G.21	Perforated ceiling panels	20m ²	NAD
1-059

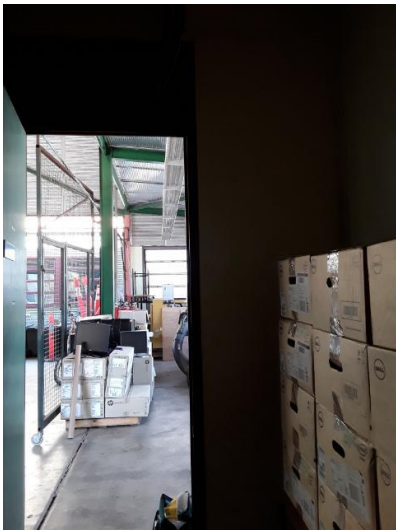
Ground Floor G.11	Wall - south , Fibrous Cement	4	NAD

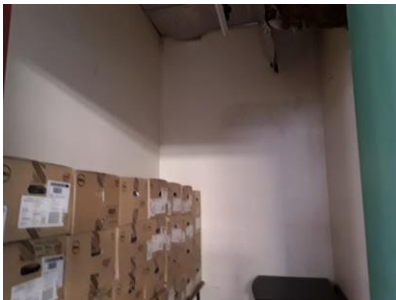
Ground Floor G.11	Wall - North, east, and west, Fibrous Cement	27m ²	NAD
1-061

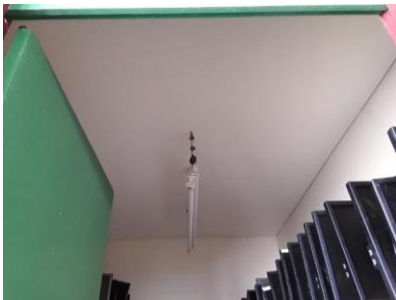
Ground Floor G.10	Ceiling , Fibrous Cement	7	NAD

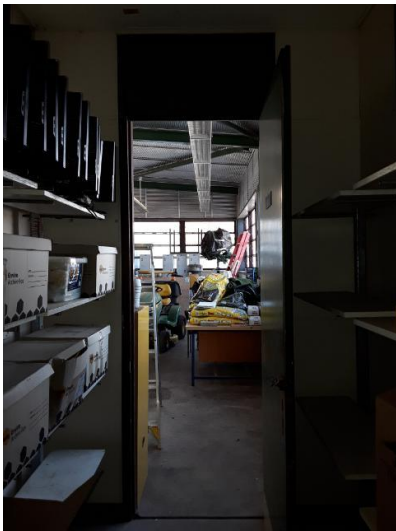
Ground Floor G.10	Wall - south , Fibrous Cement	4	NAD
Similar to 1-060

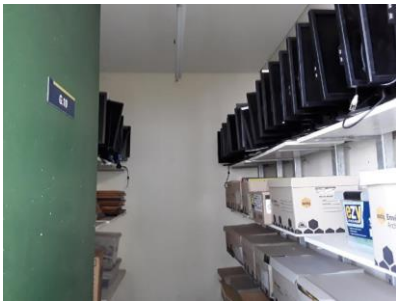
Ground Floor G.10	Wall - North, east, and west, Fibrous Cement	27m ²	NAD

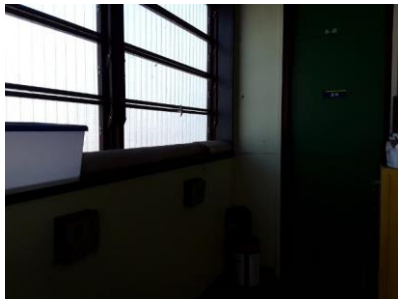
Ground Floor G.09	Roll of vinyl sheet on window ledge west side, Vinyl Products	unknown	NAD
1-061

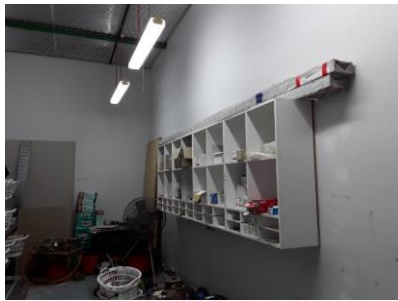
Ground Floor G.19	Wall - North, south , and east, Fibrous Cement	20m²	NAD
Similar to 1-058

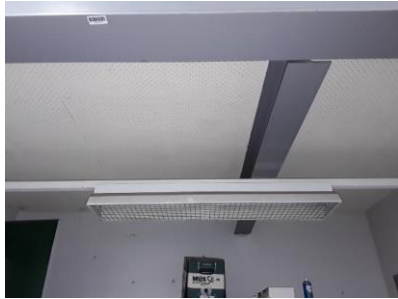
Ground Floor G.19	Ceiling south end, Fibrous Cement	4	NAD

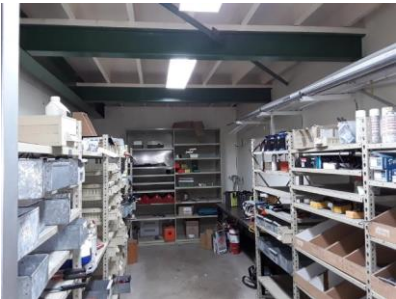
Ground Floor G.18	Wall - North, east, and west, Fibrous Cement	44m ²	NAD
1-065

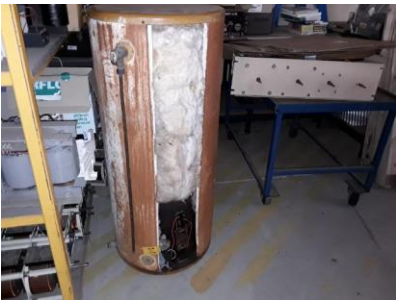
Ground Floor G.15	Insulation to redundant hot water tank, Insulation	3m ²	NAD
1-058

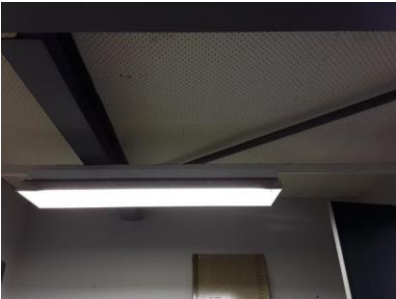
Ground Floor G.20	Ceiling south end, Fibrous Cement	4	NAD

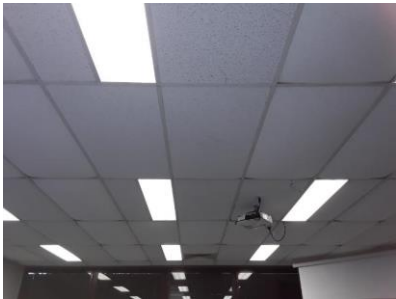
Ground Floor G.03	perforated ceiling panels, Suspected Asbestos	36m ²	NAD
Similar to 1-036 (sampled in Block A)

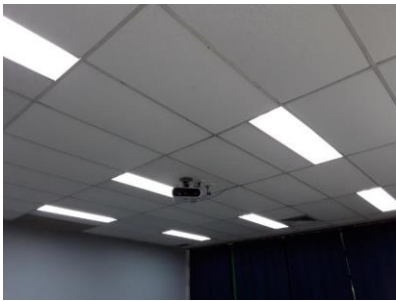
Ground Floor G.04	perforated ceiling panels, Suspected Asbestos	36m ²	NAD
1-068

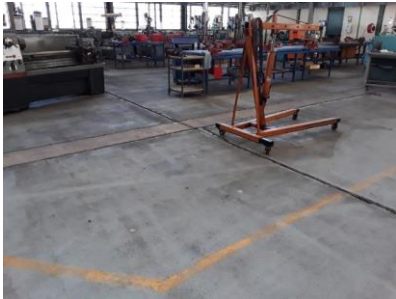
Ground Floor G.02	Mastic between concrete in floor, Bituminous Product	unknown	NAD

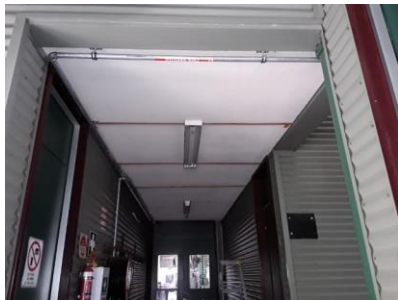
External Walkway south side of G.06	Ceiling, Fibrous Cement	12	NAD
1-067

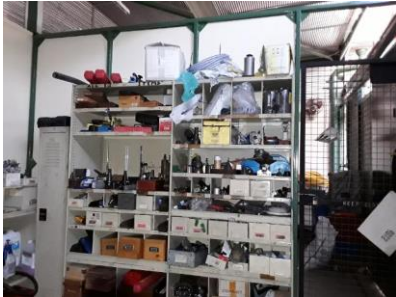
External G.05	Wall panels - centre of room dividing room, Fibrous Cement	10m ²	NAD
