ASBESTOS CONTAINING MATERIALS SURVEY REPORT

Block C
Emerald Campus

Report Number 622.10968.00000/0050-R01-ASR-Block C

11 October 2017

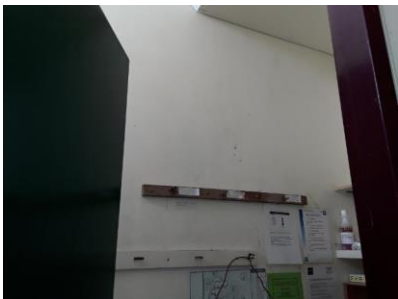
Ground Floor Cleaners room adjacent male toilet	Walls throughout, Fibrous Cement	10m ²	NAD
Similar to 1-074

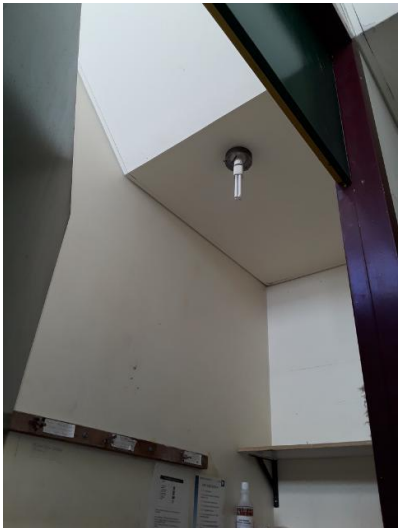
Ground Floor Cleaners room adjacent male toilet	Ceiling, Fibrous Cement	4m ²	NAD

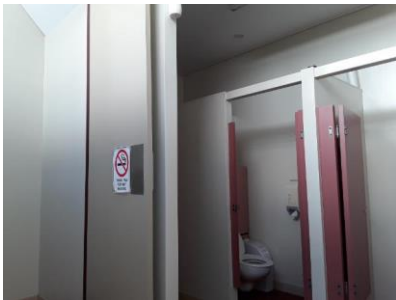
Ground Floor G.03 female toilet and airlock	Walls and toilet cubicles throughout , Fibrous Cement	56m ²	NAD
Similar to 1-074

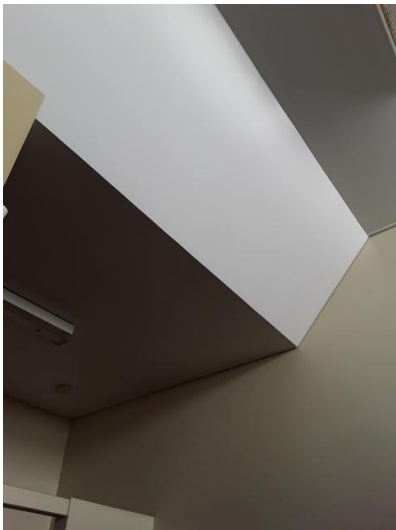
Ground Floor G.03 female toilet and airlock	Ceiling, Fibrous Cement	15m ²	NAD

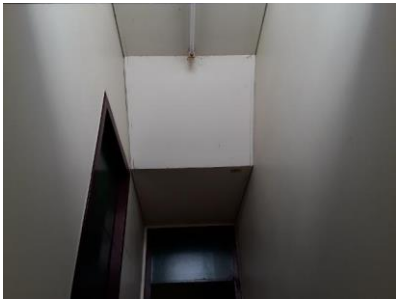
Ground Floor Airlock	Ceiling , Fibrous Cement	4m ²	NAD
Similar to 1-073

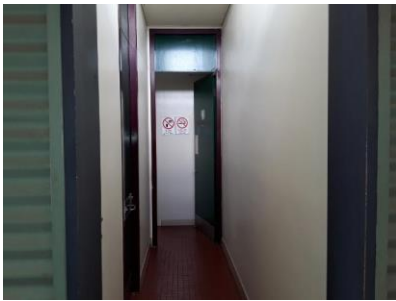
Ground Floor Airlock	Walls throughout, Fibrous Cement	8m ²	NAD
Similar to 1-074

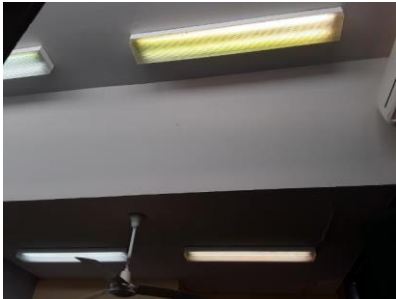
Ground Floor G.01	Ceiling, Fibrous Cement	12m ²	NAD

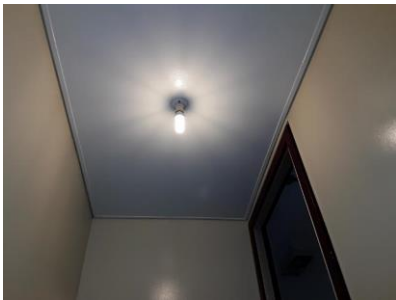
Ground Floor G.08 male toilets	Ceiling including infills to skylights, Fibrous Cement	30m ²	NAD
Similar to 1-074

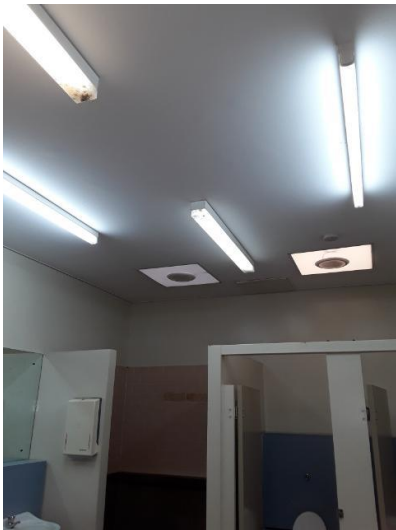
Ground Floor G.02 male toilets	Ceiling including infills to skylights, Fibrous Cement	16m ²	NAD

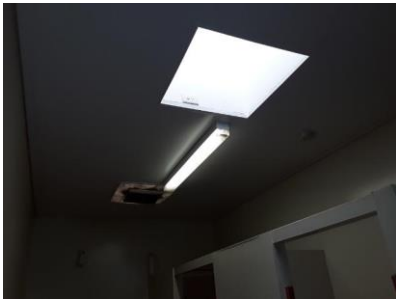
Ground Floor G.09 female toilet and airlock	Ceiling and infill to skylight, Fibrous Cement	15m ²	NAD
1-075

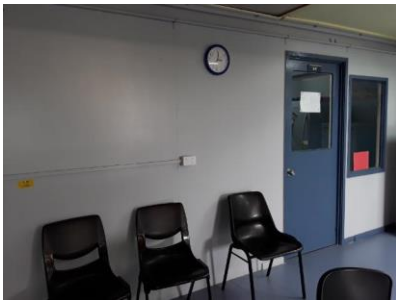
Ground Floor G.10	North wall, Fibrous Cement	6m ²	NAD
1-076

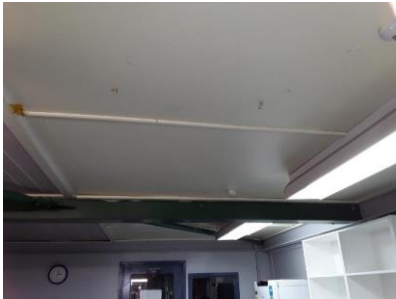
Ground Floor G.10	Ceiling eastern side, Fibrous Cement	8m ²	NAD

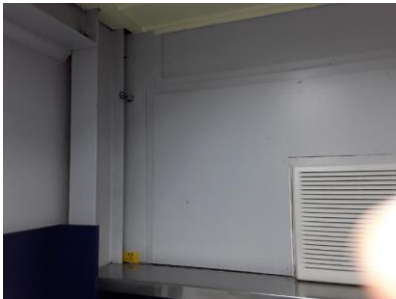
Ground Floor G.10	Infill South wall eastern corner, Fibrous Cement	<1m ²	NAD
1-078

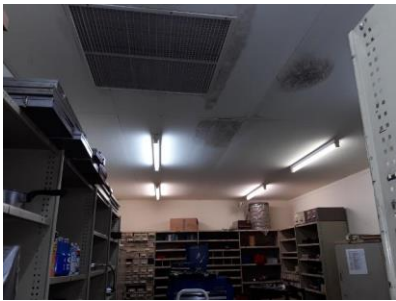
Ground Floor G.13	Ceiling , Fibrous Cement	38m ²	NAD
1-079

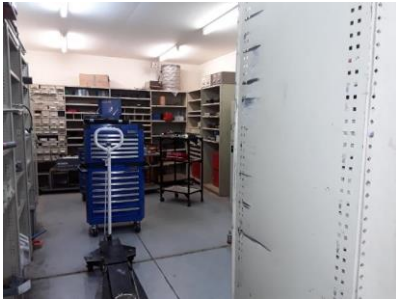
Ground Floor G.13	Walls throughout, Fibrous Cement	100m ²	NAD

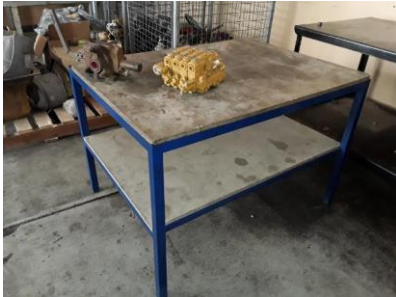
Ground Floor G.12	Compressed sheet to two benches , Fibrous Cement	4m ²	NAD
1-083

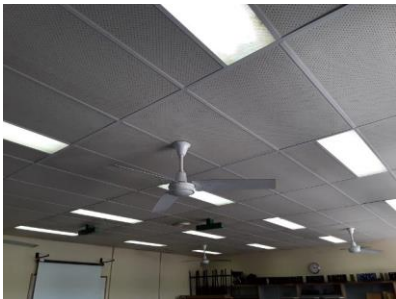
Ground Floor G.14	Suspended ceiling tiles perforated , Fibrous Cement	66m ²	NAD
1-088

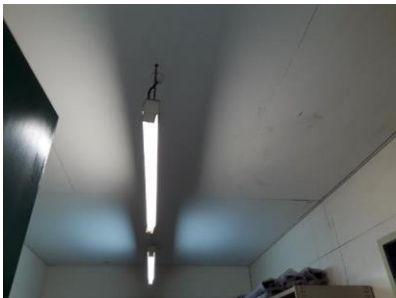
Ground Floor G.16	Ceiling , Fibrous Cement	18m ²	NAD

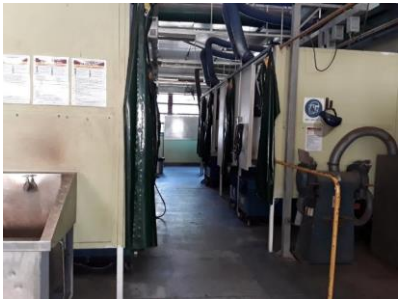
Ground Floor G.15	Welding booths, Fibrous Cement	140m ²	NAD
1-085

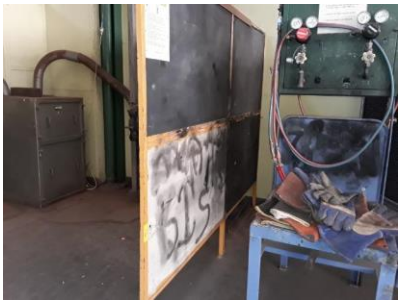
Ground Floor G.15	grinder bay dividing wall, Fibrous Cement	4m ²	NAD
1-086

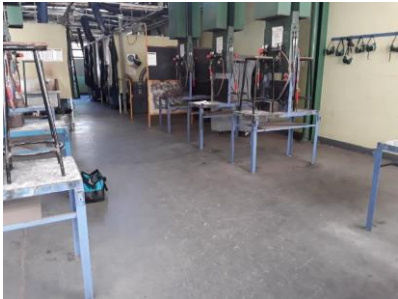
Ground Floor G.15	Work benches at northern end, Suspected Asbestos	7m ²	NAD

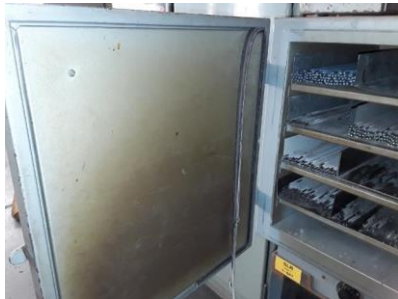
Ground Floor G.15	oven for welding rods, Gaskets (rope/woven)	.5lin m	NAD
1-082

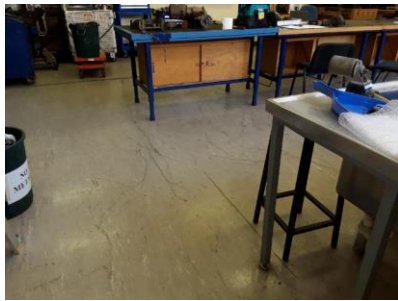
Ground Floor G.14	Floor Vinyl sheet, Vinyl Products	66m ²	NAD
Similar to 1-088

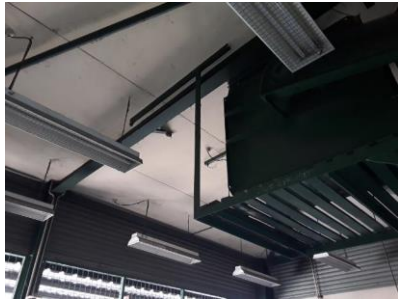
Ground Floor G.24	Ceiling , Fibrous Cement	18m ²	NAD

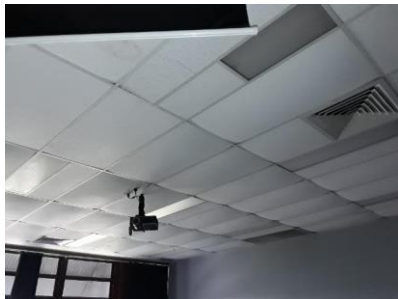
Ground Floor G.25	perforated ceiling panels, Suspected Asbestos	36m ²	NAD
Similar to 1-036

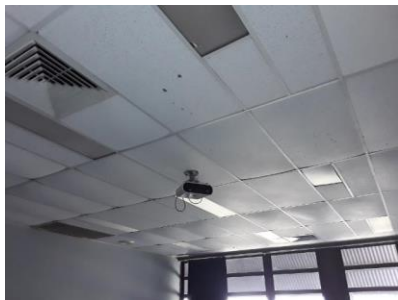
Ground Floor G.26	perforated ceiling panels, Suspected Asbestos	36m ²	NAD
1-092

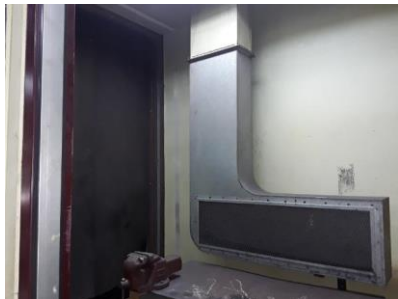
Ground Floor G.19 & G21 one room divided by large plastic divider	Walls throughout both sides, Fibrous Cement	18m ²	NAD

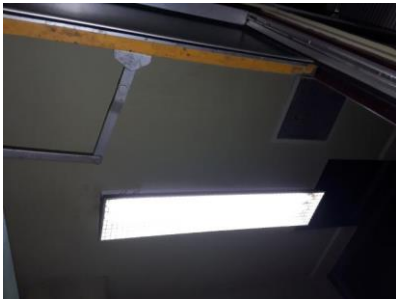
Ground Floor G.19 & G.21 - one room divided by large plastic divider	Ceiling throughout both sides of room , Fibrous Cement	8m ²	NAD
Similar to 1-074

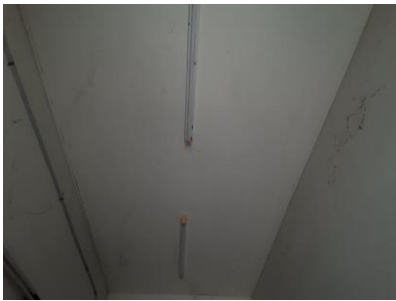
Ground Floor G.06	Ceiling , Fibrous Cement	14m ²	NAD
Similar to 1-074

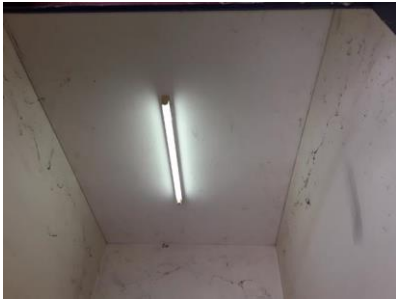
Ground Floor G.05	Ceiling , Fibrous Cement	6m ²	NAD

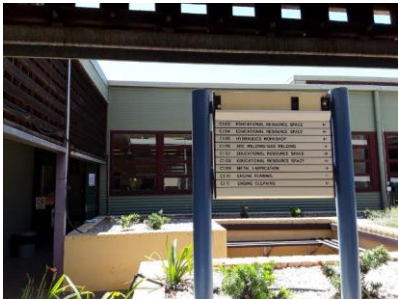
External G.14 external sign	sign south side, Fibrous Cement	<1m ²	NAD
Similar to 1-076

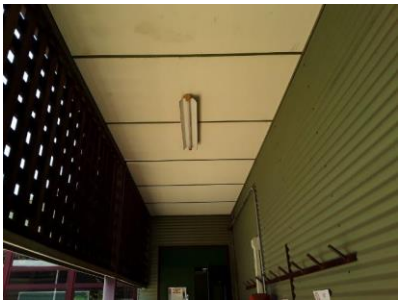
External G.15 Walkway running north south	Ceiling , Fibrous Cement	8m ²	NAD
Similar to 1-076

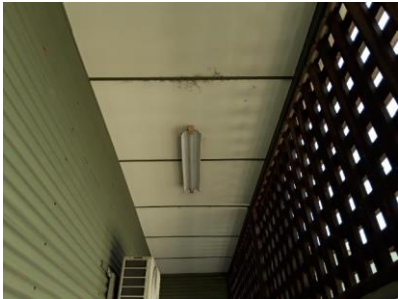
External G.14 Walkway running north south	Ceiling , Fibrous Cement	8m ²	NAD

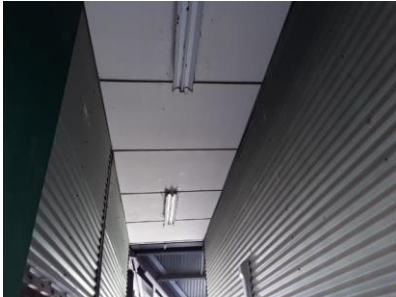
External G.20 south walkway	Ceiling, Fibrous Cement	10m ²	NAD
