**ASBESTOS CONTAINING MATERIALS
SURVEY REPORT**

**Block D
Emerald Campus**

Report Number 622.10968.00000/0050-R01-V01-ASR-Block D

11 October 2017

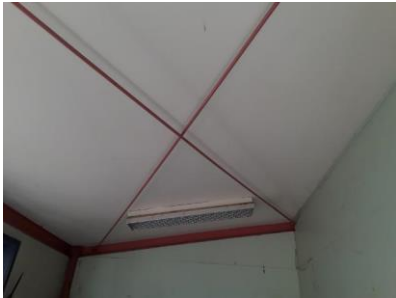
Sample No./ Visual Observation	Photo	Location			Analysis
		Int / Ext Floor Specific Location	Material Application	Extent	Result
1-070

Ground Floor G.04	Ceiling , Fibrous Cement	10m ²	NAD
Similar to 1-056 (sampled in Block A)

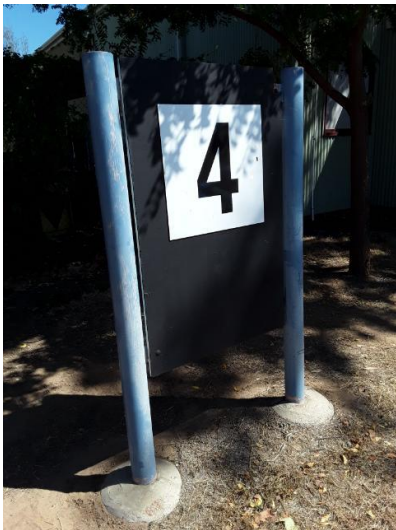
External East side building number sign	sign , Fibrous Cement	1m ²	NAD

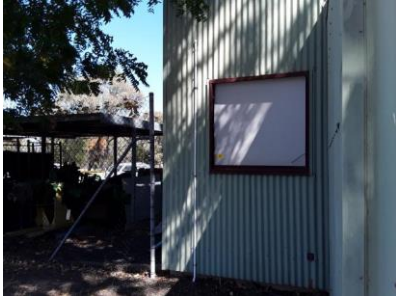
Sample No./ Visual Observation	Photo	Location			Analysis
		Int / Ext Floor Specific Location	Material Application	Extent	Result
1-071

External G.02 external east side	Infill to window, Fibrous Cement	1m ²	NAD
