COMPLIANCE ASBESTOS RE-INSPECTION AND RISK ASSESSMENT

NOVEMBER 2021

J033438

GLADSTONE CITY CAMPUS_Block B Derby Road
Derby Road
Gladstone QLD
4680

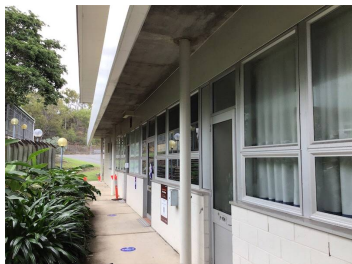
Location	Block B - Ground Floor - External - Downpipe - Moulded cement - North & South elevations

Hazard Type	Asbestos	Material Assessment		Disturbance Assessment		
Friability	Non-friable	Product Type	1	Occupancy		0
Sample No.	3-884 (AO000100)	Extent of damage	0	Disturbance		1
Result	Positive Chrysotile	Surface Treatment	1	Exposure		0
		Asbestos Type	1	Maintenance		0
Item Number	1	Material Score	3	Disturbance Score		1
		Priority Score	4	Very Low		
No Additional Photographic Evidence Available

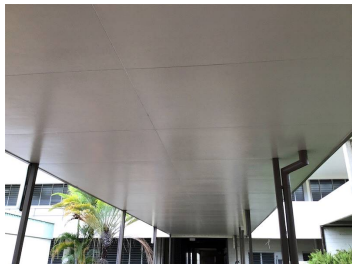
Location		Block B - Ground Floor - External - Covered walkway ceiling - Fibre cement sheet - Southern elevation

Hazard Type		Asbestos		Material Assessment			Disturbance Assessment					
Friability		Non-friable		Product Type			1		Occupancy		0	
Sample No.		3-854 (AO000102)		Extent of damage			0		Disturbance		1	
Result		Positive Chrysotile		Surface Treatment			1		Exposure		0	
				Asbestos Type			1		Maintenance		0	
Item Number		2		Material Score			3		Disturbance Score		1	
				Priority Score			4		Very Low			
No Additional Photographic Evidence Available

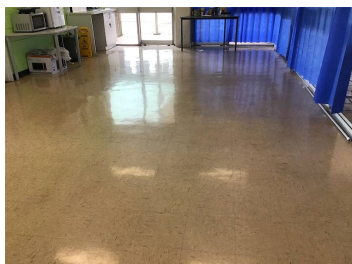
Location		Block B - Ground Floor - Dining Room (B111) - Floor covering - Vinyl tiles - Throughout				
Hazard Type		Asbestos	Material Assessment		Disturbance Assessment	
Friability		Non-friable	Product Type	1	Occupancy	1
Sample No.		3-845 (AO000104)	Extent of damage	0	Disturbance	2
Result		Positive Chrysotile	Surface Treatment	0	Exposure	1
			Asbestos Type	1	Maintenance	0
Item Number		3	Material Score	2	Disturbance Score	4
			Priority Score	6	Very Low	
No Additional Photographic Evidence Available

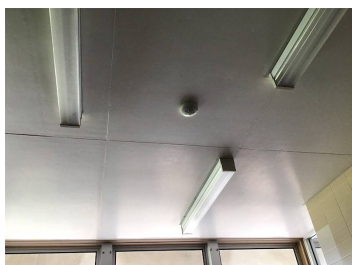
Location		Block B - Ground Floor - Kitchen (B112) - Ceiling lining - Fibre cement sheet - Throughout

Hazard Type		Asbestos	Material Assessment		Disturbance Assessment		
Friability		Non-friable	Product Type	1	Occupancy		1
Sample No.		3-857 (AO000105)	Extent of damage	0	Disturbance		1
Result		Positive Chrysotile	Surface Treatment	0	Exposure		0
			Asbestos Type	1	Maintenance		0
Item Number		4	Material Score	2	Disturbance Score		2
			Priority Score	4	Very Low		
No Additional Photographic Evidence Available

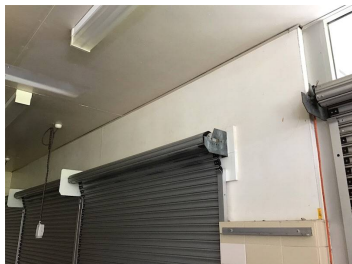
Location	Block B - Ground Floor - Kitchen (B112) - Wall sheeting - Fibre cement sheet - All elevation - behind ceramic tiles

Hazard Type	Asbestos	Material Assessment		Disturbance Assessment		
Friability	Non-friable	Product Type	1	Occupancy		1
Sample No.	3-858 (AO000106)	Extent of damage	0	Disturbance		2
Result	Positive Chrysotile	Surface Treatment	1	Exposure		0
		Asbestos Type	1	Maintenance		0
Item Number	5	Material Score	3	Disturbance Score		3
		Priority Score	6	Very Low		
No Additional Photographic Evidence Available

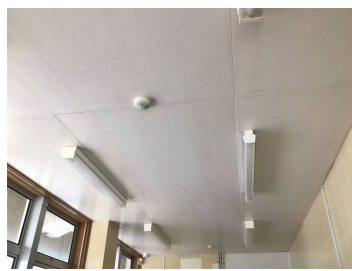
Location		Block B - Ground Floor - Prep Room (B113) - Ceiling lining - Fibre cement sheet - Throughout

Hazard Type		Asbestos	Material Assessment		Disturbance Assessment		
Friability		Non-friable	Product Type	1	Occupancy		0
Sample No.		As 3-857 {AO000105}	Extent of damage	0	Disturbance		1
Result		Strongly Assumed Positive Chrysotile	Surface Treatment	0	Exposure		0
			Asbestos Type	1	Maintenance		0
Item Number		6	Material Score	2	Disturbance Score		1
			Priority Score	3	Very Low		
No Additional Photographic Evidence Available

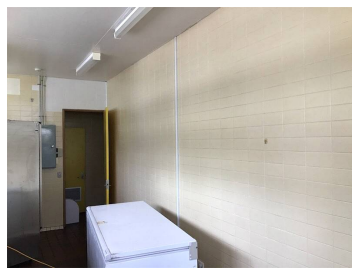
Location		Block B - Ground Floor - Prep Room (B113) - Wall sheeting - Fibre cement sheet - All elevations - Behind ceramic tiles									
Hazard Type		Asbestos		Material Assessment		Disturbance Assessment					
Friability		Non-friable		Product Type		1		Occupancy		0	
Sample No.		As 3-858 {AO000106}		Extent of damage		0		Disturbance		1	
Result		Strongly Assumed Positive Chrysotile		Surface Treatment		1		Exposure		0	
				Asbestos Type		1		Maintenance		0	
Item Number		7		Material Score		3		Disturbance Score		1	
				Priority Score		4		Very Low			
No Additional Photographic Evidence Available

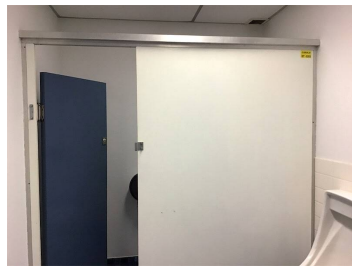
Location	Block B - Ground Floor - Male Bathroom (B110) - Partition wall - Fibre cement sheet - Central

Hazard Type	Asbestos	Material Assessment		Disturbance Assessment		
Friability	Non-friable	Product Type	1	Occupancy		1
Sample No.	3-846 (AO000107)	Extent of damage	0	Disturbance		1
Result	Positive Chrysotile	Surface Treatment	1	Exposure		0
		Asbestos Type	1	Maintenance		0
Item Number	8	Material Score	3	Disturbance Score		2
		Priority Score	5	Very Low		
No Additional Photographic Evidence Available

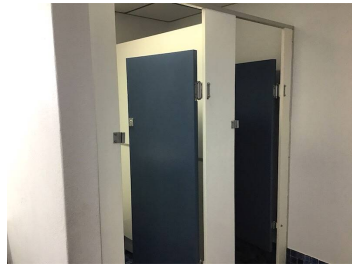
Location	Block B - Ground Floor - Female Bathroom (B109) - Partition wall - Fibre cement sheet - Central

Hazard Type	Asbestos	Material Assessment		Disturbance Assessment		
Friability	Non-friable	Product Type	1	Occupancy		1
Sample No.	As 3-846 (AO000107)	Extent of damage	0	Disturbance		1
Result	Strongly Assumed Positive Chrysotile	Surface Treatment	1	Exposure		0
		Asbestos Type	1	Maintenance		0
Item Number	9	Material Score	3	Disturbance Score		2
		Priority Score	5	Very Low		
No Additional Photographic Evidence Available

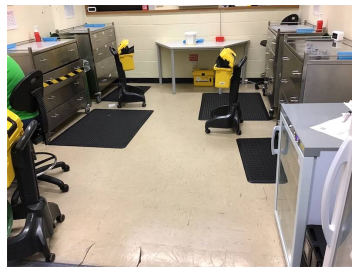
Location		Block B - Ground Floor - Office (B107) - Floor covering - Vinyl tiles - Throughout

Hazard Type		Asbestos	Material Assessment		Disturbance Assessment		
Friability		Non-friable	Product Type	1	Occupancy		0
Sample No.		As 3-845 {AO000104}	Extent of damage	0	Disturbance		1
Result		Strongly Assumed Positive Chrysotile	Surface Treatment	0	Exposure		0
			Asbestos Type	1	Maintenance		0
Item Number		10	Material Score	2	Disturbance Score		1
			Priority Score	3	Very Low		
No Additional Photographic Evidence Available

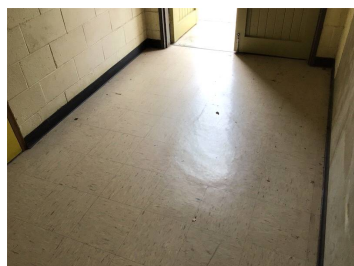
Hazard Type		Asbestos		Material Assessment			Disturbance Assessment			
Friability		Non-friable		Product Type			1	Occupancy	0	
Sample No.		As 3-845 (AO000104)		Extent of damage			0	Disturbance	1	
Result		Strongly Assumed Positive Chrysotile		Surface Treatment			0	Exposure	0	
				Asbestos Type			1	Maintenance	0	
Item Number		11		Material Score			2	Disturbance Score		1
				Priority Score			3	Very Low		
No Additional Photographic Evidence Available

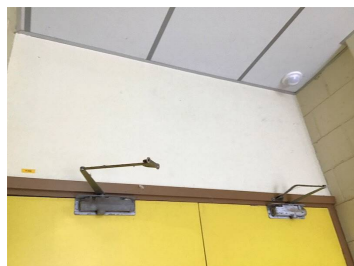
Hazard Type	Asbestos	Material Assessment		Disturbance Assessment		
Friability	Non-friable	Product Type	1	Occupancy		0
Sample No.	3-848 (AO000108)	Extent of damage	0	Disturbance		1
Result	Positive Chrysotile	Surface Treatment	1	Exposure		0
		Asbestos Type	1	Maintenance		0
Item Number	12	Material Score	3	Disturbance Score		1
		Priority Score	4	Very Low		
No Additional Photographic Evidence Available

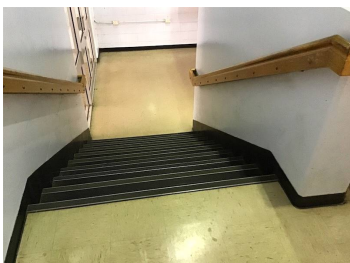
Hazard Type		Asbestos	Material Assessment		Disturbance Assessment		
Friability		Non-friable	Product Type	1	Occupancy		1
Sample No.		As 3-845 (AO000104)	Extent of damage	0	Disturbance		1
Result		Strongly Assumed Positive Chrysotile	Surface Treatment	0	Exposure		0
			Asbestos Type	1	Maintenance		0
Item Number		13	Material Score	2	Disturbance Score		2
			Priority Score	4	Very Low		
No Additional Photographic Evidence Available

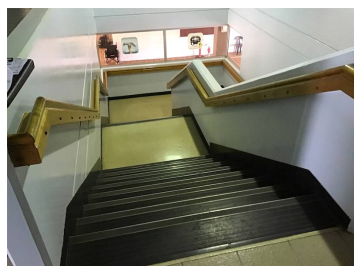
Hazard Type		Asbestos	Material Assessment		Disturbance Assessment		
Friability		Non-friable	Product Type	1	Occupancy		1
Sample No.		As 3-845 {AO000104}	Extent of damage	0	Disturbance		1
Result		Strongly Assumed Positive Chrysotile	Surface Treatment	0	Exposure		0
			Asbestos Type	1	Maintenance		0
Item Number		14	Material Score	2	Disturbance Score		2
			Priority Score	4	Very Low		
No Additional Photographic Evidence Available

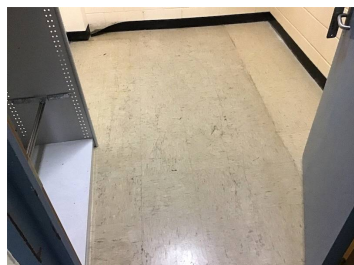
Hazard Type		Asbestos	Material Assessment		Disturbance Assessment		
Friability		Non-friable	Product Type	1	Occupancy		1
Sample No.		As 3-845 (AO000104)	Extent of damage	0	Disturbance		1
Result		Strongly Assumed Positive Chrysotile	Surface Treatment	0	Exposure		0
			Asbestos Type	1	Maintenance		0
Item Number		15	Material Score	2	Disturbance Score		2
			Priority Score	4	Very Low		
No Additional Photographic Evidence Available

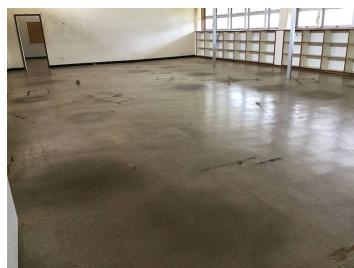
Hazard Type		Asbestos		Material Assessment			Disturbance Assessment			
Friability		Non-friable		Product Type			1	Occupancy	1	
Sample No.		As 3-845 (AO000104)		Extent of damage			0	Disturbance	2	
Result		Strongly Assumed Positive Chrysotile		Surface Treatment			0	Exposure	0	
				Asbestos Type			1	Maintenance	0	
Item Number		16		Material Score			2	Disturbance Score		3
				Priority Score			5	Very Low		
No Additional Photographic Evidence Available

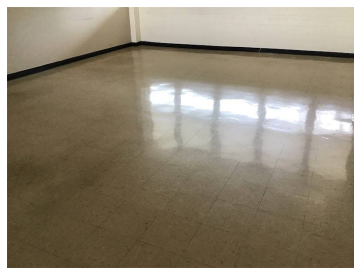
Hazard Type		Asbestos		Material Assessment			Disturbance Assessment	
Friability		Non-friable		Product Type			1	
Sample No.		As 3-845 {AO000104}		Extent of damage			0	
Result		Strongly Assumed Positive Chrysotile		Surface Treatment			0	
				Asbestos Type			1	
Item Number		17		Material Score			2	
				Priority Score			5	
						Very Low		
No Additional Photographic Evidence Available

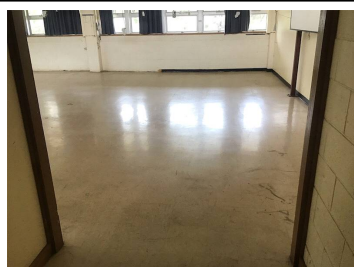
Hazard Type		Asbestos	Material Assessment		Disturbance Assessment		
Friability		Non-friable	Product Type	1	Occupancy		1
Sample No.		As 3-845 {AO000104}	Extent of damage	0	Disturbance		2
Result		Strongly Assumed Positive Chrysotile	Surface Treatment	0	Exposure		0
			Asbestos Type	1	Maintenance		0
Item Number		18	Material Score	2	Disturbance Score		3
			Priority Score	5	Very Low		
No Additional Photographic Evidence Available

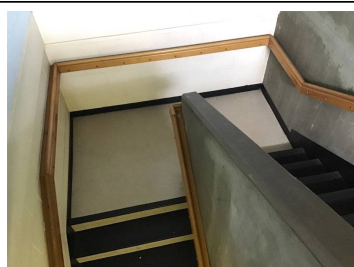
Location		Block B - 1st Floor - Stairs (B237) - Floor covering - Vinyl tiles - Throughout

Hazard Type		Asbestos		Material Assessment			Disturbance Assessment	
Friability		Non-friable		Product Type			1	
Sample No.		As 3-845 (AO000104)		Extent of damage			0	
Result		Strongly Assumed Positive Chrysotile		Surface Treatment			0	
				Asbestos Type			1	
Item Number		20		Material Score			2	
				Priority Score			5	
				Disturbance Score			3	
						Very Low		
No Additional Photographic Evidence Available

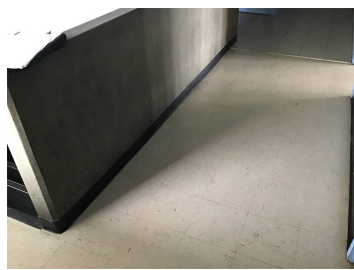
Hazard Type		Asbestos	Material Assessment		Disturbance Assessment		
Friability		Non-friable	Product Type	1	Occupancy		1
Sample No.		As 3-845 (AO000104)	Extent of damage	0	Disturbance		1
Result		Strongly Assumed Positive Chrysotile	Surface Treatment	0	Exposure		0
			Asbestos Type	1	Maintenance		0
Item Number	21	Material Score	2	Disturbance Score			2
		Priority Score	4	Very Low			
No Additional Photographic Evidence Available

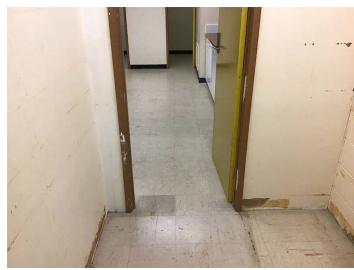
Hazard Type		Asbestos	Material Assessment		Disturbance Assessment		
Friability		Non-friable	Product Type	1	Occupancy		1
Sample No.		As 3-845 {AO000104}	Extent of damage	0	Disturbance		1
Result		Strongly Assumed Positive Chrysotile	Surface Treatment	0	Exposure		0
			Asbestos Type	1	Maintenance		0
Item Number		22	Material Score	2	Disturbance Score		2
			Priority Score	4	Very Low		
No Additional Photographic Evidence Available

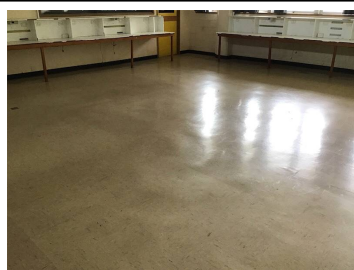
Hazard Type		Asbestos	Material Assessment		Disturbance Assessment		
Friability		Non-friable	Product Type	1	Occupancy		1
Sample No.		As 3-845 {AO000104}	Extent of damage	0	Disturbance		1
Result		Strongly Assumed Positive Chrysotile	Surface Treatment	0	Exposure		0
			Asbestos Type	1	Maintenance		0
Item Number		23	Material Score	2	Disturbance Score		2
			Priority Score	4	Very Low		
No Additional Photographic Evidence Available

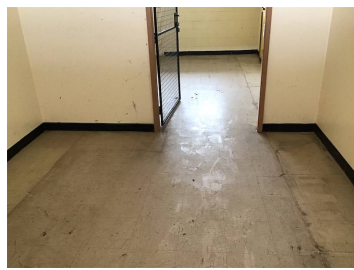
Hazard Type		Asbestos	Material Assessment		Disturbance Assessment		
Friability		Non-friable	Product Type	1	Occupancy		1
Sample No.		As 3-845 {AO000104}	Extent of damage	0	Disturbance		1
Result		Strongly Assumed Positive Chrysotile	Surface Treatment	0	Exposure		0
			Asbestos Type	1	Maintenance		0
Item Number		24	Material Score	2	Disturbance Score		2
			Priority Score	4	Very Low		
No Additional Photographic Evidence Available

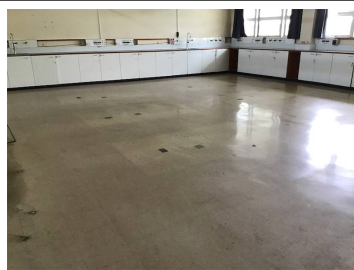
Hazard Type		Asbestos		Material Assessment			Disturbance Assessment			
Friability		Non-friable		Product Type			1	Occupancy	1	
Sample No.		As 3-845 (AO000104)		Extent of damage			0	Disturbance	1	
Result		Strongly Assumed Positive Chrysotile		Surface Treatment			0	Exposure	0	
				Asbestos Type			1	Maintenance	0	
Item Number		25		Material Score			2	Disturbance Score		2
				Priority Score			4	Very Low		
No Additional Photographic Evidence Available

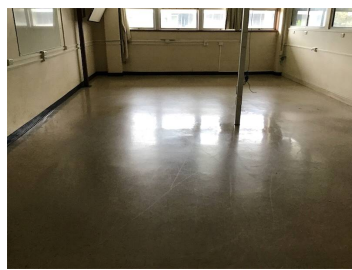
Hazard Type		Asbestos		Material Assessment			Disturbance Assessment		
Friability		Non-friable		Product Type			1	Occupancy	1
Sample No.		As 3-845 {AO000104}		Extent of damage			0	Disturbance	2
Result		Strongly Assumed Positive Chrysotile		Surface Treatment			0	Exposure	0
				Asbestos Type			1	Maintenance	0
Item Number		26		Material Score			2	Disturbance Score	3
				Priority Score			5	Very Low	
No Additional Photographic Evidence Available

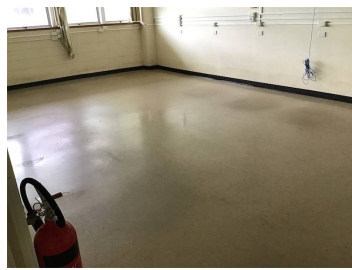
Hazard Type		Asbestos	Material Assessment		Disturbance Assessment		
Friability		Non-friable	Product Type	1	Occupancy		1
Sample No.		As 3-845 {AO000104}	Extent of damage	0	Disturbance		2
Result		Strongly Assumed Positive Chrysotile	Surface Treatment	0	Exposure		0
			Asbestos Type	1	Maintenance		0
Item Number		27	Material Score	2	Disturbance Score		3
			Priority Score	5	Very Low		
No Additional Photographic Evidence Available

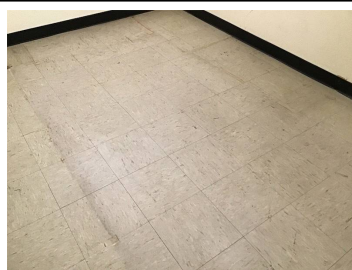
Hazard Type		Asbestos	Material Assessment		Disturbance Assessment			
Friability		Non-friable	Product Type	1	Occupancy		1	
Sample No.		As 3-845 {AO000104}	Extent of damage	0	Disturbance		1	
Result		Strongly Assumed Positive Chrysotile		Surface Treatment	0		Exposure	0
				Asbestos Type	1		Maintenance	0
Item Number		28		Material Score	2		Disturbance Score	2
				Priority Score	4		Very Low	
No Additional Photographic Evidence Available

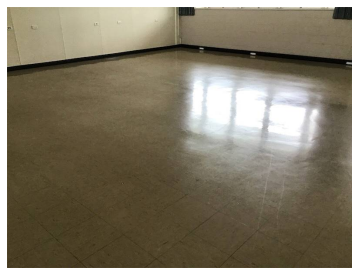
Hazard Type		Asbestos	Material Assessment		Disturbance Assessment		
Friability		Non-friable	Product Type	1	Occupancy		1
Sample No.		As 3-845 {AO000104}	Extent of damage	0	Disturbance		1
Result		Strongly Assumed Positive Chrysotile	Surface Treatment	0	Exposure		0
			Asbestos Type	1	Maintenance		0
Item Number		29	Material Score	2	Disturbance Score		2
			Priority Score	4	Very Low		
No Additional Photographic Evidence Available

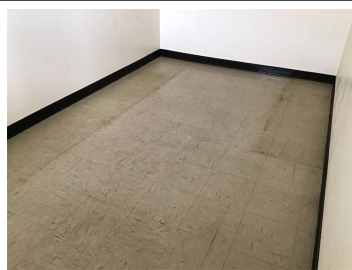
Hazard Type		Asbestos	Material Assessment		Disturbance Assessment		
Friability		Non-friable	Product Type	1	Occupancy		1
Sample No.		As 3-845 {AO000104}	Extent of damage	0	Disturbance		1
Result		Strongly Assumed Positive Chrysotile	Surface Treatment	0	Exposure		1
			Asbestos Type	1	Maintenance		0
Item Number		30	Material Score	2	Disturbance Score		3
			Priority Score	5	Very Low		
No Additional Photographic Evidence Available

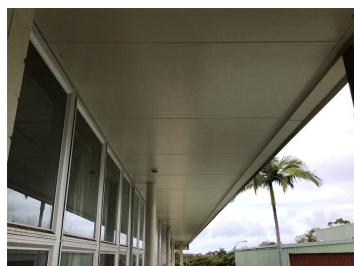
Hazard Type		Asbestos	Material Assessment		Disturbance Assessment		
Friability		Non-friable	Product Type	1	Occupancy		1
Sample No.		3-856 {AO000111}	Extent of damage	0	Disturbance		0
Result		Positive Chrysotile	Surface Treatment	1	Exposure		0
			Asbestos Type	1	Maintenance		0
Item Number		31	Material Score	3	Disturbance Score		1
			Priority Score	4	Very Low		
No Additional Photographic Evidence Available

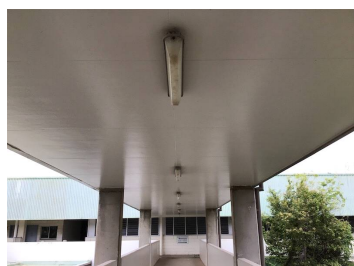
Hazard Type		Asbestos	Material Assessment		Disturbance Assessment		
Friability		Non-friable	Product Type	1	Occupancy		1
Sample No.		3-853 (AO000110)	Extent of damage	0	Disturbance		0
Result		Positive Chrysotile	Surface Treatment	1	Exposure		0
			Asbestos Type	1	Maintenance		0
Item Number		44	Material Score	3	Disturbance Score		1
			Priority Score	4	Very Low		
No Additional Photographic Evidence Available

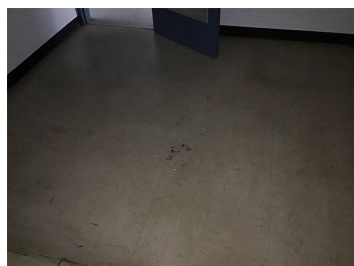
Location		Block B - 1st Floor - Female Lockers (B218) - Floor covering - Vinyl tiles - Throughout

Hazard Type		Asbestos		Material Assessment			Disturbance Assessment	
Friability		Non-friable		Product Type			1	
Sample No.		As 3-845 (AO000104)		Extent of damage			0	
Result		Strongly Assumed Positive Chrysotile		Surface Treatment			0	
				Asbestos Type			1	
Item Number		33		Material Score			2	
				Priority Score			4	
							Very Low	
No Additional Photographic Evidence Available

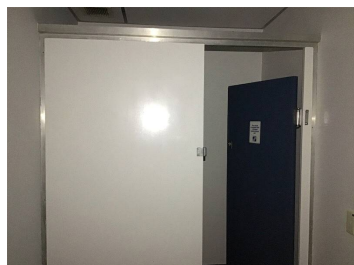
Hazard Type		Asbestos	Material Assessment		Disturbance Assessment		
Friability		Non-friable	Product Type	1	Occupancy		1
Sample No.		As 3-846 (AO000107)	Extent of damage	0	Disturbance		1
Result		Strongly Assumed Positive Chrysotile	Surface Treatment	1	Exposure		0
			Asbestos Type	1	Maintenance		0
Item Number		34	Material Score	3	Disturbance Score		2
			Priority Score	5	Very Low		
No Additional Photographic Evidence Available

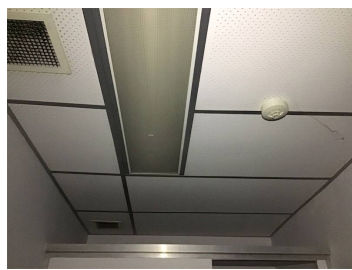
Hazard Type		Asbestos	Material Assessment		Disturbance Assessment		
Friability		Non-friable	Product Type	1	Occupancy		1
Sample No.		As 3-852 {AO000109}	Extent of damage	0	Disturbance		1
Result		Strongly Assumed Positive Chrysotile	Surface Treatment	1	Exposure		0
			Asbestos Type	1	Maintenance		0
Item Number		35	Material Score	3	Disturbance Score		2
			Priority Score	5	Very Low		
No Additional Photographic Evidence Available

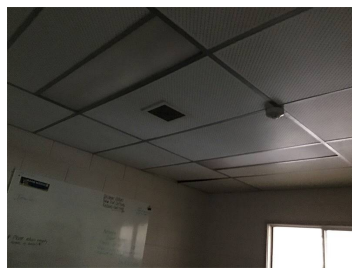
Hazard Type		Asbestos	Material Assessment		Disturbance Assessment		
Friability		Non-friable	Product Type	1	Occupancy		1
Sample No.		As 3-852 {AO000109}	Extent of damage	0	Disturbance		1
Result		Strongly Assumed Positive Chrysotile	Surface Treatment	1	Exposure		0
			Asbestos Type	1	Maintenance		0
Item Number		36	Material Score	3	Disturbance Score		2
			Priority Score	5	Very Low		
No Additional Photographic Evidence Available

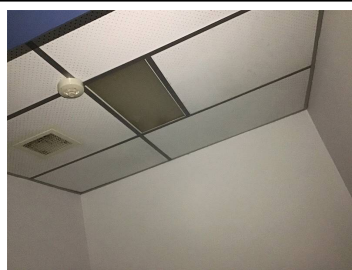
Hazard Type		Asbestos	Material Assessment		Disturbance Assessment		
Friability		Non-friable	Product Type	1	Occupancy		1
Sample No.		As 3-852 {AO000109}	Extent of damage	0	Disturbance		1
Result		Strongly Assumed Positive Chrysotile	Surface Treatment	1	Exposure		0
			Asbestos Type	1	Maintenance		0
Item Number		37	Material Score	3	Disturbance Score		2
			Priority Score	5	Very Low		
No Additional Photographic Evidence Available

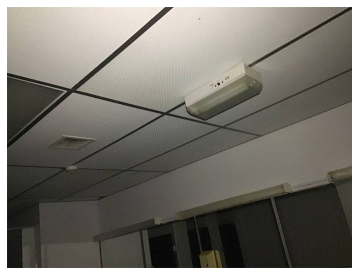
Hazard Type		Asbestos	Material Assessment		Disturbance Assessment		
Friability		Non-friable	Product Type	1	Occupancy		1
Sample No.		As 3-852 {AO000109}	Extent of damage	0	Disturbance		1
Result		Strongly Assumed Positive Chrysotile	Surface Treatment	1	Exposure		0
			Asbestos Type	1	Maintenance		0
Item Number		38	Material Score	3	Disturbance Score		2
			Priority Score	5	Very Low		
No Additional Photographic Evidence Available

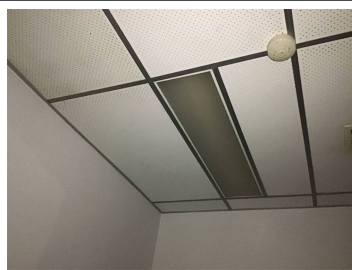
Hazard Type		Asbestos	Material Assessment		Disturbance Assessment		
Friability		Non-friable	Product Type	1	Occupancy		1
Sample No.		As 3-852 {AO000109}	Extent of damage	0	Disturbance		1
Result		Strongly Assumed Positive Chrysotile	Surface Treatment	1	Exposure		0
			Asbestos Type	1	Maintenance		0
Item Number		39	Material Score	3	Disturbance Score		2
			Priority Score	5	Very Low		
No Additional Photographic Evidence Available

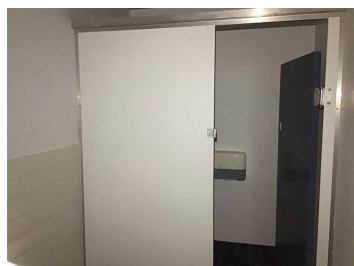
Hazard Type		Asbestos		Material Assessment			Disturbance Assessment	
Friability		Non-friable		Product Type			1	
Sample No.		As 3-846 (AO000107)		Extent of damage			0	
Result		Strongly Assumed Positive Chrysotile		Surface Treatment			1	
				Asbestos Type			1	
Item Number		40		Material Score			3	
				Priority Score			5	
						Very Low		
No Additional Photographic Evidence Available

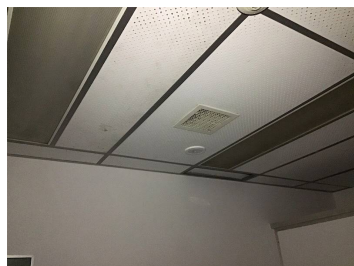
Hazard Type		Asbestos	Material Assessment		Disturbance Assessment		
Friability		Non-friable	Product Type	1	Occupancy		1
Sample No.		As 3-852 (AO000109)	Extent of damage	0	Disturbance		1
Result		Strongly Assumed Positive Chrysotile	Surface Treatment	1	Exposure		0
			Asbestos Type	1	Maintenance		0
Item Number		41	Material Score	3	Disturbance Score		2
			Priority Score	5	Very Low		
No Additional Photographic Evidence Available

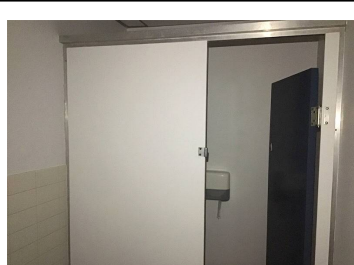
Hazard Type		Asbestos	Material Assessment		Disturbance Assessment		
Friability		Non-friable	Product Type	1	Occupancy		1
Sample No.		As 3-846 {AO000107}	Extent of damage	0	Disturbance		1
Result		Strongly Assumed Positive Chrysotile	Surface Treatment	1	Exposure		0
			Asbestos Type	1	Maintenance		0
Item Number		42	Material Score	3	Disturbance Score		2
			Priority Score	5	Very Low		
No Additional Photographic Evidence Available

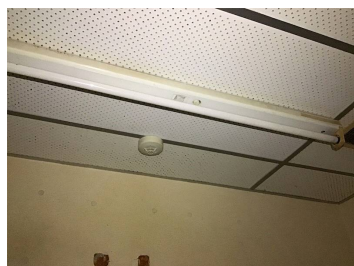
Hazard Type		Asbestos	Material Assessment		Disturbance Assessment		
Friability		Non-friable	Product Type	1	Occupancy		0
Sample No.		As 3-852 (AO000109)	Extent of damage	0	Disturbance		0
Result		Strongly Assumed Positive Chrysotile	Surface Treatment	1	Exposure		0
			Asbestos Type	1	Maintenance		0
Item Number	43	Material Score	3	Disturbance Score			0
		Priority Score	3	Very Low			
No Additional Photographic Evidence Available
