ASBESTOS CONTAINING MATERIALS SURVEY REPORT

Building 6 - Grounds Store
Gladstone City Campus

Report Number 622.10968.00000/0070-R01-V01-ASR-Ground Store

11 October 2017

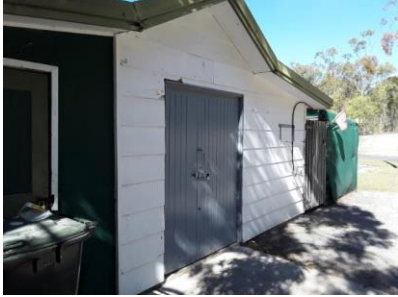
1st Floor EXTERNAL WALL SHEETING	WALL SHEETING - HARDIPLANK - EAST, SOUTH AND WEST ELEVATIONS, Fibrous Cement	16m ²	NAD
3-874

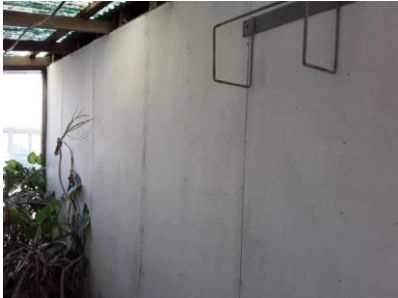
1st Floor EXTERNAL WALL SHEETING	WALL SHEETING - NORTH ELEVATION, Fibrous Cement	8m ²	NAD
