COMPLIANCE ASBESTOS RE-INSPECTION AND RISK ASSESSMENT

NOVEMBER 2021

J033482

GLADSTONE CITY CAMPUS_Block C Derby Road
Derby Road
Gladstone QLD
4680

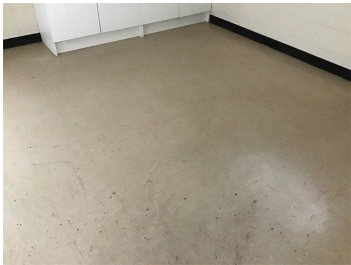
Location	Block C - Ground Floor - Male Change Room - Floor covering - Vinyl tiles - Throughout

Hazard Type	Asbestos	Material Assessment	Disturbance Assessment	
Friability	Non-friable	Product Type	1	
Sample No.	3-823 {AO000112}	Extent of damage	0	
Result	Positive Chrysotile	Surface Treatment	0	
		Asbestos Type	1	
Item Number	1	Material Score	2	
		Priority Score	3	Very Low

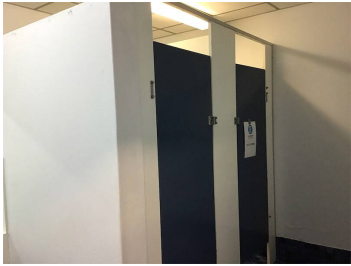
Location	Block C - Ground Floor - Female Bathroom - Partition wall - Fibre cement sheet - Central

Hazard Type	Asbestos	Material Assessment	Disturbance Assessment	
Friability	Non-friable	Product Type	1	
Sample No.	3-824 {AO000113}	Extent of damage	0	
Result	Positive Chrysotile	Surface Treatment	1	
		Asbestos Type	1	
Item Number	2	Material Score	3	
		Priority Score	5	Very Low

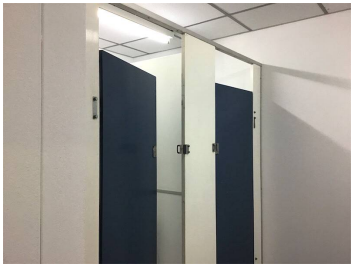
Location	Block C - Ground Floor - Male Staff Bathroom - Partition wall - Fibre cement sheet - Central

Hazard Type	Asbestos	Material Assessment	Disturbance Assessment	
Friability	Non-friable	Product Type	1	
Sample No.	As 3-824 {AO000113}	Extent of damage	0	
Result	Strongly Assumed Positive Chrysotile	Surface Treatment	1	
		Asbestos Type	1	
Item Number	4	Material Score	3	
		Priority Score	5	Very Low

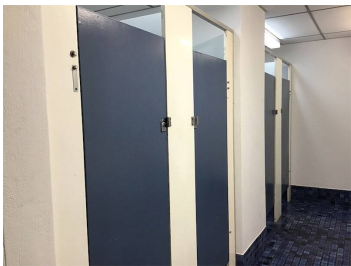
Location	Block C - Ground Floor - Male Bathroom - Partition wall - Fibre cement sheet - Central

Hazard Type	Asbestos	Material Assessment	Disturbance Assessment	
Friability	Non-friable	Product Type	1	
Sample No.	As 3-824 {AO000113}	Extent of damage	0	
Result	Strongly Assumed Positive Chrysotile	Surface Treatment	1	
		Asbestos Type	1	
Item Number	5	Material Score	3	
		Priority Score	5	Very Low

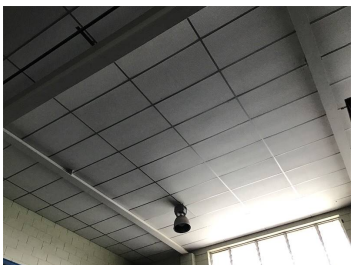
Location	Block C - 1st Floor - Main Store - Perforated ceiling tiles - Fibre cement - Throughout

Hazard Type	Asbestos	Material Assessment	Disturbance Assessment	
Friability	Non-friable	Product Type	1	
Sample No.	3-839 {AO000115}	Extent of damage	0	
Result	Positive Chrysotile	Surface Treatment	1	
		Asbestos Type	1	
Item Number	6	Material Score	3	
		Priority Score	4	Very Low

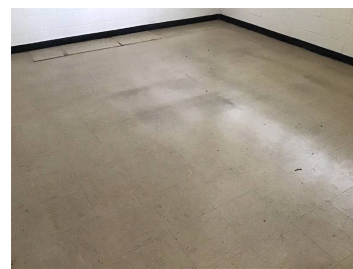
Location		Block C - 1st Floor - Staff Common Room - Floor covering - Vinyl tiles - Throughout			
Hazard Type		Asbestos	Material Assessment		Disturbance Assessment
Friability	Non-friable	Product Type	1	Occupancy	0
Sample No.	3-834 (AO000116)	Extent of damage	0	Disturbance	1
Result	Positive Chrysotile	Surface Treatment	1	Exposure	0
		Asbestos Type	1	Maintenance	0
Item Number	7	Material Score	3	Disturbance Score	1
		Priority Score	4	Very Low

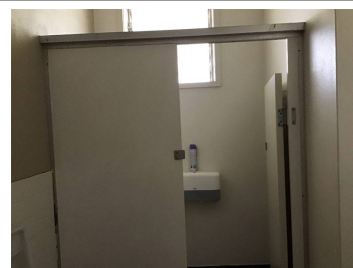
Location		Block C - 1st Floor - Male Staff Bathroom - Partition wall - Fibre cement sheet - Central					
Hazard Type		Asbestos		Material Assessment		Disturbance Assessment	
Friability		Non-friable		Product Type		1	
Sample No.		3-835 (AO000117)		Extent of damage		0	
Result		Positive Chrysotile		Surface Treatment		1	
				Asbestos Type		1	
Item Number		8		Material Score		3	
				Priority Score		5	
				Disturbance Score		2	
						Very Low

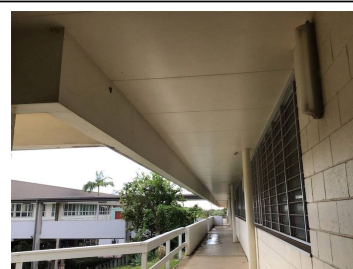
Location		Block C - 1st Floor - External - Soffit - Fibre cement sheet - North elevation				
Hazard Type		Asbestos	Material Assessment		Disturbance Assessment	
Friability		Non-friable	Product Type	1	Occupancy	1
Sample No.		3-840 (AO000118)	Extent of damage	0	Disturbance	1
Result		Positive Chrysotile	Surface Treatment	1	Exposure	0
			Asbestos Type	1	Maintenance	0
Item Number	9	Material Score	3	Disturbance Score		2
		Priority Score	5	Very Low

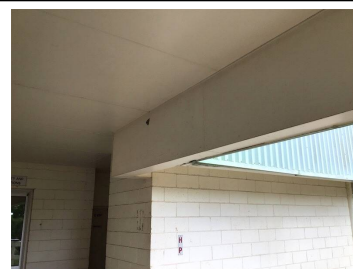
Location		Block C - 1st Floor - External - Fascia - Fibre cement sheet - Internal facing - all elevations				
Hazard Type		Asbestos	Material Assessment		Disturbance Assessment	
Friability		Non-friable	Product Type	1	Occupancy	1
Sample No.		3-841 {AO000119}	Extent of damage	0	Disturbance	1
Result		Positive Chrysotile	Surface Treatment	1	Exposure	0
			Asbestos Type	1	Maintenance	0
Item Number	10	Material Score	3	Disturbance Score	2	
		Priority Score	5	Very Low

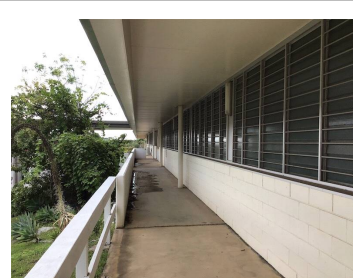
Location		Block C - 1st Floor - External - Downpipe - Moulded cement - North, West & South elevations									
Hazard Type		Asbestos		Material Assessment		Disturbance Assessment					
Friability		Non-friable		Product Type		1		Occupancy		0	
Sample No.		3-844 {AO000120}		Extent of damage		0		Disturbance		1	
Result		Positive Chrysotile		Surface Treatment		1		Exposure		0	
				Asbestos Type		1		Maintenance		0	
Item Number		11		Material Score		3		Disturbance Score		1	
				Priority Score		4		Very Low

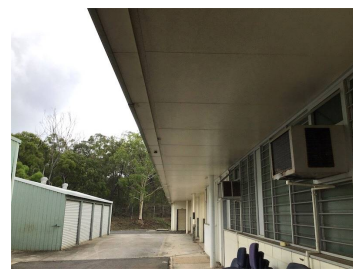
Location		Block C - 1st Floor - External - Soffit - Fibre cement sheet - South elevation									
Hazard Type		Asbestos		Material Assessment		Disturbance Assessment					
Friability		Non-friable		Product Type		1		Occupancy		1	
Sample No.		As 3-840 {AO000118}		Extent of damage		0		Disturbance		1	
Result		Strongly Assumed Positive Chrysotile		Surface Treatment		1		Exposure		0	
				Asbestos Type		1		Maintenance		0	
Item Number		37		Material Score		3		Disturbance Score		2	
				Priority Score		5		Very Low

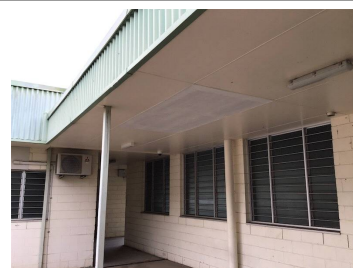
Location		Block C - 1st Floor - External - Awning - Fibre cement sheet - West elevation									
Hazard Type		Asbestos		Material Assessment		Disturbance Assessment					
Friability		Non-friable		Product Type		1		Occupancy		0	
Sample No.		As 3-840 {AO000118}		Extent of damage		0		Disturbance		1	
Result		Strongly Assumed Positive Chrysotile		Surface Treatment		1		Exposure		0	
				Asbestos Type		1		Maintenance		0	
Item Number		40		Material Score		3		Disturbance Score		1	
				Priority Score		4		Very Low

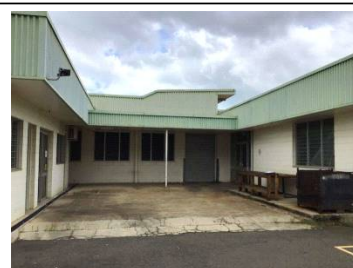
Location		Block C - 1st Floor - External - High level soffit - Fibre cement sheet - West elevation				
Hazard Type		Asbestos	Material Assessment		Disturbance Assessment	
Friability		Non-friable	Product Type	1	Occupancy	0
Sample No.		As 3-840 {AO000118}	Extent of damage	0	Disturbance	1
Result		Strongly Assumed Positive Chrysotile	Surface Treatment	1	Exposure	0
			Asbestos Type	1	Maintenance	0
Item Number	41	Material Score	3	Disturbance Score		1
		Priority Score	4	Very Low

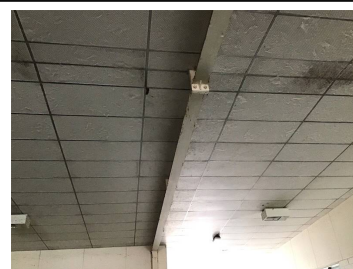
Location		Block C - 1st Floor - Breezeway - Perforated ceiling tiles - Fibre cement - Throughout				
Hazard Type		Asbestos	Material Assessment		Disturbance Assessment	
Friability		Non-friable	Product Type	1	Occupancy	0
Sample No.		3-827 {AO000121}	Extent of damage	0	Disturbance	2
Result		Positive Chrysotile	Surface Treatment	1	Exposure	0
			Asbestos Type	1	Maintenance	0
Item Number		12	Material Score	3	Disturbance Score	2
			Priority Score	5	Very Low

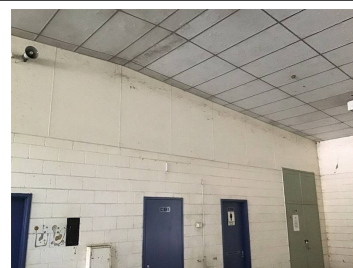
Location		Block C - 1st Floor - Breezeway - Wall sheeting - Fibre cement sheet - All elevations			
Hazard Type		Asbestos	Material Assessment		Disturbance Assessment
Friability	Non-friable	Product Type	1	Occupancy	0
Sample No.	3-826 {AO000122}	Extent of damage	0	Disturbance	2
Result	Positive Chrysotile	Surface Treatment	1	Exposure	0
		Asbestos Type	1	Maintenance	0
Item Number	13	Material Score	3	Disturbance Score	2
		Priority Score	5	Very Low

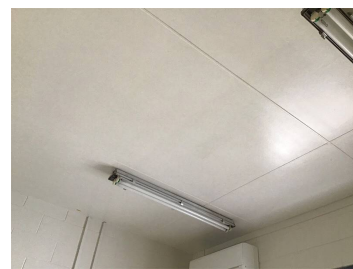
Location		Block C - 1st Floor - Office - Ceiling tiles - Fibre cement - Throughout									
Hazard Type		Asbestos		Material Assessment		Disturbance Assessment					
Friability		Non-friable		Product Type		1		Occupancy		0	
Sample No.		3-830 (AO000123)		Extent of damage		0		Disturbance		1	
Result		Positive Chrysotile		Surface Treatment		1		Exposure		0	
				Asbestos Type		1		Maintenance		0	
Item Number		14		Material Score		3		Disturbance Score		1	
				Priority Score		4		Very Low

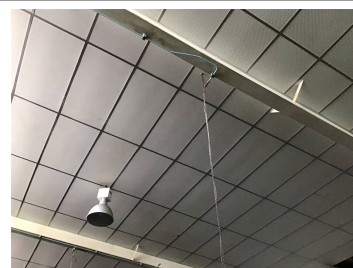
Location		Block C - 1st Floor - Auto Workshop - Perforated ceiling tiles - Fibre cement - Throughout									
Hazard Type		Asbestos		Material Assessment		Disturbance Assessment					
Friability		Non-friable		Product Type		1		Occupancy		0	
Sample No.		As 3-839 (AO000115)		Extent of damage		0		Disturbance		2	
Result		Strongly Assumed Positive Chrysotile		Surface Treatment		1		Exposure		0	
				Asbestos Type		1		Maintenance		0	
Item Number		16		Material Score		3		Disturbance Score		2	
				Priority Score		5		Very Low

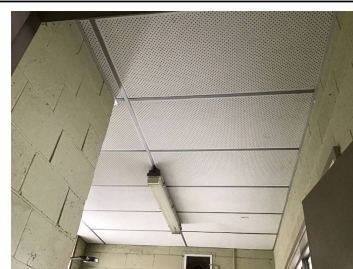
Location		Block C - 1st Floor - Battery Charge - Perforated ceiling tiles - Fibre cement - Throughout				
Hazard Type		Asbestos	Material Assessment		Disturbance Assessment	
Friability		Non-friable	Product Type	1	Occupancy	0
Sample No.		As 3-839 (AO000115)	Extent of damage	0	Disturbance	1
Result		Strongly Assumed Positive Chrysotile	Surface Treatment	1	Exposure	0
			Asbestos Type	1	Maintenance	0
Item Number		17	Material Score	3	Disturbance Score	1
			Priority Score	4	Very Low

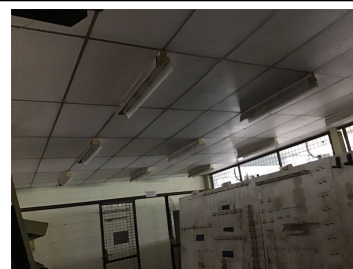
Location		Block C - 1st Floor - Tool Store - Perforated ceiling tiles - Fibre cement - Throughout				
Hazard Type		Asbestos	Material Assessment		Disturbance Assessment	
Friability		Non-friable	Product Type	1	Occupancy	0
Sample No.		As 3-839 (AO000115)	Extent of damage	0	Disturbance	1
Result		Strongly Assumed Positive Chrysotile	Surface Treatment	1	Exposure	0
			Asbestos Type	1	Maintenance	0
Item Number		18	Material Score	3	Disturbance Score	1
			Priority Score	4	Very Low

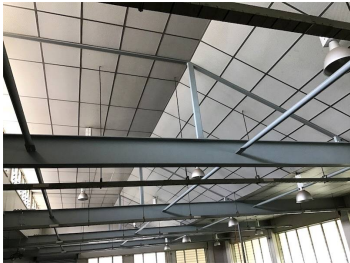
Location	Block C - 1st Floor - Machine Workshop - Perforated ceiling tiles - Fibre cement - Throughout

Hazard Type	Asbestos	Material Assessment		Disturbance Assessment	
Friability	Non-friable	Product Type	1	Occupancy	0
Sample No.	As 3-839 {AO000115}	Extent of damage	0	Disturbance	1
Result	Strongly Assumed Positive Chrysotile	Surface Treatment	1	Exposure	0
		Asbestos Type	1	Maintenance	0
Item Number	20	Material Score	3	Disturbance Score	1
		Priority Score	4	Very Low

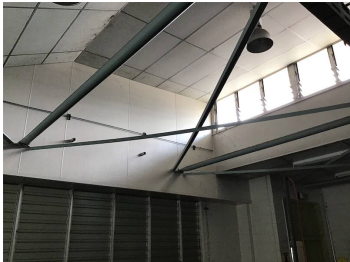
Location	Block C - 1st Floor - Machine Workshop - Wall sheeting - Fibre cement - All elevations

Hazard Type	Asbestos	Material Assessment		Disturbance Assessment	
Friability	Non-friable	Product Type	1	Occupancy	0
Sample No.	As 3-829 {AO000122}	Extent of damage	0	Disturbance	1
Result	Strongly Assumed Positive Chrysotile	Surface Treatment	1	Exposure	0
		Asbestos Type	1	Maintenance	0
Item Number	21	Material Score	3	Disturbance Score	1
		Priority Score	4	Very Low

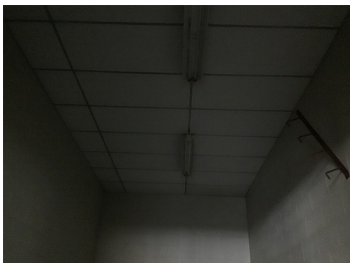
Location	Block C - 1st Floor - Project Store - Perforated ceiling tiles - Fibre cement - Perforated ceiling tiles - Fibre cement

Hazard Type	Asbestos	Material Assessment		Disturbance Assessment	
Friability	Non-friable	Product Type	1	Occupancy	0
Sample No.	As 3-827 {AO000121}	Extent of damage	0	Disturbance	1
Result	Strongly Assumed Positive Chrysotile	Surface Treatment	1	Exposure	0
		Asbestos Type	1	Maintenance	0
Item Number	22	Material Score	3	Disturbance Score	1
		Priority Score	4	Very Low

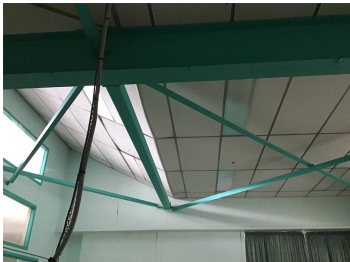
Location	Block C - 1st Floor - Classroom - Perforated ceiling tiles - Fibre cement - Throughout

Hazard Type	Asbestos	Material Assessment		Disturbance Assessment	
Friability	Non-friable	Product Type	1	Occupancy	0
Sample No.	As 3-827 {AO000121}	Extent of damage	0	Disturbance	2
Result	Strongly Assumed Positive Chrysotile	Surface Treatment	1	Exposure	0
		Asbestos Type	1	Maintenance	0
Item Number	23	Material Score	3	Disturbance Score	2
		Priority Score	5	Very Low

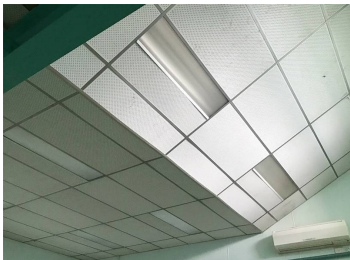
Location	Block C - 1st Floor - Classroom - Perforated ceiling tiles - Fibre cement - Throughout

Hazard Type	Asbestos	Material Assessment		Disturbance Assessment	
Friability	Non-friable	Product Type	1	Occupancy	0
Sample No.	As 3-827 {AO000121}	Extent of damage	0	Disturbance	2
Result	Strongly Assumed Positive Chrysotile	Surface Treatment	1	Exposure	0
		Asbestos Type	1	Maintenance	0
Item Number	24	Material Score	3	Disturbance Score	2
		Priority Score	5	Very Low

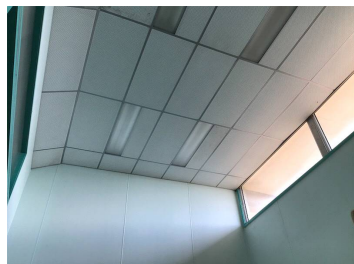
Location		Block C - 1st Floor - Classroom - Perforated ceiling tiles - Fibre cement - Throughout

Hazard Type		Asbestos		Material Assessment			Disturbance Assessment					
Friability		Non-friable		Product Type			1		Occupancy		0	
Sample No.		As 3-827 {AO000121}		Extent of damage			0		Disturbance		2	
Result		Strongly Assumed Positive Chrysotile		Surface Treatment			1		Exposure		0	
				Asbestos Type			1		Maintenance		0	
Item Number		25		Material Score			3		Disturbance Score		2	
				Priority Score			5		Very Low

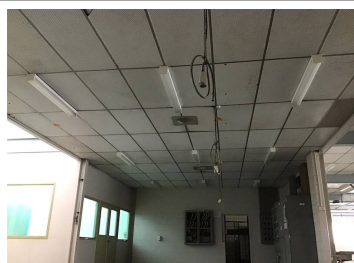
Location		Block C - 1st Floor - Fitting Workshop - Perforated ceiling tiles - Fibre cement - Throughout				
Hazard Type		Asbestos	Material Assessment		Disturbance Assessment	
Friability		Non-friable	Product Type	1	Occupancy	0
Sample No.		As 3-827 {AO000121}	Extent of damage	0	Disturbance	1
Result		Strongly Assumed Positive Chrysotile	Surface Treatment	1	Exposure	0
			Asbestos Type	1	Maintenance	0
Item Number	27	Material Score	3	Disturbance Score		1
		Priority Score	4	Very Low

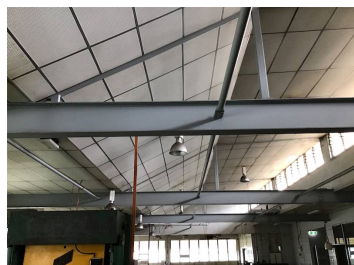
Location		Block C - 1st Floor - Metal Fabrication - Perforated ceiling tiles - Fibre cement - Throughout

Hazard Type		Asbestos	Material Assessment		Disturbance Assessment			
Friability		Non-friable	Product Type	1	Occupancy		0	
Sample No.		As 3-827 {AO000121}	Extent of damage	0	Disturbance		2	
Result		Strongly Assumed Positive Chrysotile	Surface Treatment		1		Exposure	0
			Asbestos Type		1		Maintenance	0
Item Number		28	Material Score		3		Disturbance Score	2
			Priority Score		5		Very Low

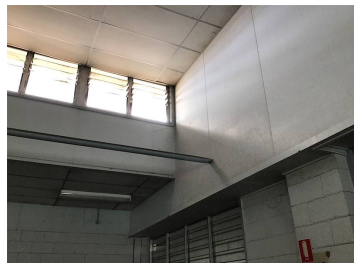
Location		Block C - 1st Floor - Metal Fabrication - Wall sheeting - Fibre cement - All elevations

Hazard Type		Asbestos	Material Assessment		Disturbance Assessment		
Friability		Non-friable	Product Type	1	Occupancy		0
Sample No.		As 3-826 (AO000122}	Extent of damage	0	Disturbance		2
Result		Strongly Assumed Positive Chrysotile	Surface Treatment	1	Exposure		0
			Asbestos Type	1	Maintenance		0
Item Number	29	Material Score	3	Disturbance Score	2		
		Priority Score	5	Very Low

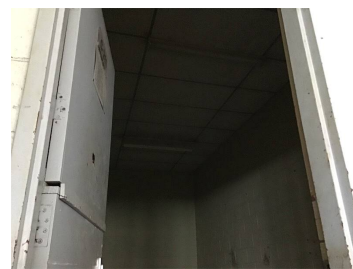
Location		Block C - 1st Floor - Project Store - Perforated ceiling tiles - Fibre cement - Throughout									
Hazard Type		Asbestos		Material Assessment		Disturbance Assessment					
Friability		Non-friable		Product Type		1		Occupancy		0	
Sample No.		As 3-827 {AO000121}		Extent of damage		0		Disturbance		1	
Result		Strongly Assumed Positive Chrysotile		Surface Treatment		1		Exposure		0	
				Asbestos Type		1		Maintenance		0	
Item Number		30		Material Score		3		Disturbance Score		1	
				Priority Score		4		Very Low

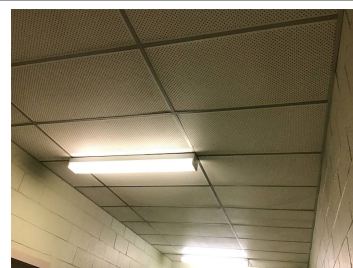
Location		Block C - 1st Floor - Stairwell - Perforated ceiling tiles - Fibre cement - Throughout									
Hazard Type		Asbestos		Material Assessment		Disturbance Assessment					
Friability		Non-friable		Product Type		1		Occupancy		0	
Sample No.		As 3-827 {AO000121}		Extent of damage		0		Disturbance		2	
Result		Strongly Assumed Positive Chrysotile		Surface Treatment		1		Exposure		0	
				Asbestos Type		1		Maintenance		0	
Item Number		31		Material Score		3		Disturbance Score		2	
				Priority Score		5		Very Low

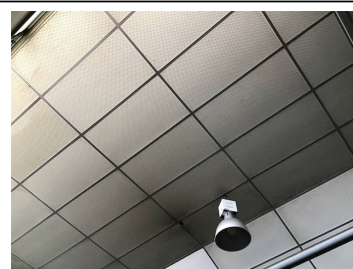
Location		Block C - 1st Floor - Gas Welding - Perforated ceiling tiles - Fibre cement - Throughout				
Hazard Type		Asbestos	Material Assessment		Disturbance Assessment	
Friability		Non-friable	Product Type	1	Occupancy	0
Sample No.		As 3-827 {AO000121}	Extent of damage	0	Disturbance	2
Result		Strongly Assumed Positive Chrysotile	Surface Treatment	1	Exposure	0
			Asbestos Type	1	Maintenance	0
Item Number		32	Material Score	3	Disturbance Score	2
			Priority Score	5	Very Low

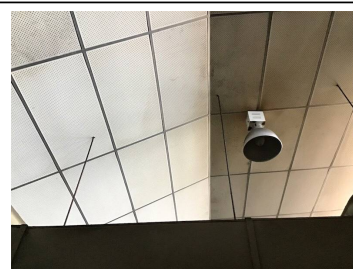
Location		Block C - 1st Floor - Arc Welding - Perforated ceiling tiles - Fibre cement - Throughout									
Hazard Type		Asbestos		Material Assessment		Disturbance Assessment					
Friability		Non-friable		Product Type		1		Occupancy		0	
Sample No.		As 3-827 {AO000121}		Extent of damage		0		Disturbance		1	
Result		Strongly Assumed Positive Chrysotile		Surface Treatment		1		Exposure		0	
				Asbestos Type		1		Maintenance		0	
Item Number		33		Material Score		3		Disturbance Score		1	
				Priority Score		4		Very Low

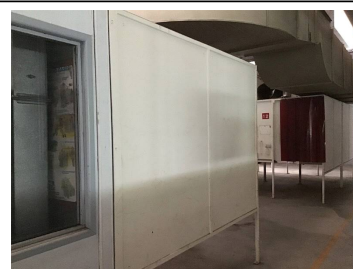
Location		Block C - 1st Floor - Arc Welding - Welding bay walls - Fibre cement sheet - All elevations									
Hazard Type		Asbestos		Material Assessment		Disturbance Assessment					
Friability		Non-friable		Product Type		1		Occupancy		0	
Sample No.		3-831 {AO000125}		Extent of damage		0		Disturbance		2	
Result		Positive Chrysotile		Surface Treatment		1		Exposure		0	
				Asbestos Type		1		Maintenance		0	
Item Number		36		Material Score		3		Disturbance Score		2	
				Priority Score		5		Very Low

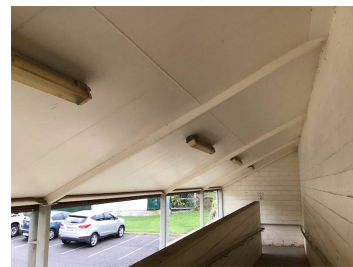
Location		Block C - 1st Floor - Disabled Ramp - Ceiling - Fibre cement sheet - Throughout				
Hazard Type		Asbestos	Material Assessment		Disturbance Assessment	
Friability		Non-friable	Product Type	1	Occupancy	1
Sample No.		3-842 (AO000126)	Extent of damage	0	Disturbance	1
Result		Positive Chrysotile	Surface Treatment	1	Exposure	0
			Asbestos Type	1	Maintenance	0
Item Number	38	Material Score	3	Disturbance Score	2	
		Priority Score	5	Very Low

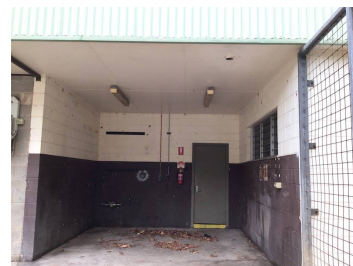
Location		Block C - 1st Floor - External Storage - Awning - Fibre cement sheet - Throughout									
Hazard Type		Asbestos		Material Assessment		Disturbance Assessment					
Friability		Non-friable		Product Type		1		Occupancy		0	
Sample No.		As 3-840 {AO000118}		Extent of damage		0		Disturbance		0	
Result		Strongly Assumed Positive Chrysotile		Surface Treatment		1		Exposure		0	
				Asbestos Type		1		Maintenance		0	
Item Number		39		Material Score		3		Disturbance Score		0	
				Priority Score		3		Very Low
