# COMPLIANCE ASBESTOS RE-INSPECTION AND RISK ASSESSMENT

NOVEMBER 2021

J033439

GLADSTONE CITY CAMPUS\_Block D Derby Road  
Derby Road  
Gladstone QLD  
4680

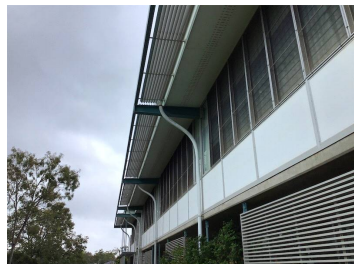
Location		Block D - 1st Floor - External - Soffit - Fibre cement sheet - North elevation

Hazard Type		Asbestos	Material Assessment		Disturbance Assessment	
Friability	Non-friable	Product Type	1	Occupancy	0	
Sample No.	3-840 {AO000127}	Extent of damage	0	Disturbance	0	
Result	Positive Chrysotile	Surface Treatment	1	Exposure	0	
		Asbestos Type	1	Maintenance	0	
Item Number	1	Material Score	3	Disturbance Score	0	
		Priority Score	3	Very Low		
No Additional Photographic Evidence Available

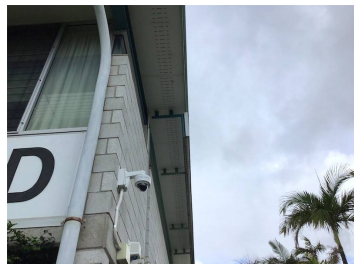
Location		Block D - 1st Floor - External - Soffit - Fibre cement sheet - West elevation

Hazard Type		Asbestos	Material Assessment		Disturbance Assessment		
Friability		Non-friable	Product Type	1	Occupancy		0
Sample No.		As 3-840 {AO000127}	Extent of damage	0	Disturbance		0
Result		Strongly Assumed Positive Chrysotile	Surface Treatment	1	Exposure		0
			Asbestos Type	1	Maintenance		0
Item Number		2	Material Score	3	Disturbance Score		0
			Priority Score	3	Very Low		
No Additional Photographic Evidence Available

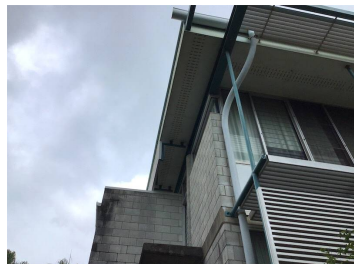
Location		Block D - 1st Floor - External - Soffit - Fibre cement sheet - East elevation

3	Block D -1st Floor -External, East elevation												
	Soffit -Fibre cement sheet	Asbestos	As 3-840 {AO000127}	Strongly Assumed, Positive	10m <sup>2</sup>	No	Good Condition	Non-friable	Very Low	Very Low	P4	Label & Manage In Situ

Hazard Type		Asbestos	Material Assessment		Disturbance Assessment		
Friability		Non-friable	Product Type	1	Occupancy		0
Sample No.		As 3-840 {AO000127}	Extent of damage	0	Disturbance		0
Result		Strongly Assumed Positive Chrysotile	Surface Treatment	1	Exposure		0
			Asbestos Type	1	Maintenance		0
Item Number		3	Material Score	3	Disturbance Score		0
			Priority Score	3	Very Low		
No Additional Photographic Evidence Available
