COMPLIANCE ASBESTOS RE-INSPECTION AND RISK ASSESSMENT

NOVEMBER 2021

J033483

GLADSTONE CITY CAMPUS_Block E Derby Road
Derby Road
Gladstone QLD
4680

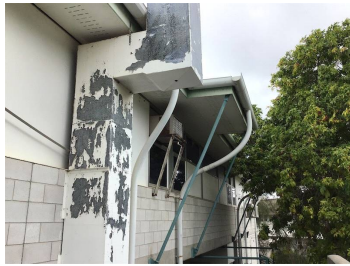
Location		Block E - 1st Floor - External - Soffit - Fibre cement sheet - South elevation

Hazard Type		Asbestos		Material Assessment			Disturbance Assessment		
Friability		Non-friable		Product Type			1	Occupancy	0
Sample No.		3-855 {AO000128}		Extent of damage			0	Disturbance	1
Result		Positive Chrysotile		Surface Treatment			1	Exposure	0
				Asbestos Type			1	Maintenance	0
Item Number		1		Material Score			3	Disturbance Score	1
				Priority Score			4	Very Low	
No Additional Photographic Evidence Available

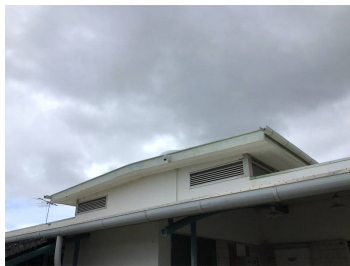
Location		Block E - 1st Floor - External - Upper soffit - Fibre cement sheet - All elevations

2	Block E -1st Floor -External, All elevations												
	Upper soffit -Fibre cement sheet	Asbestos	Visual	Assumed, Positive	100m ²	No	Good Condition	Non-friable	Very Low	Low	P4	Manage In Situ

Hazard Type	Asbestos	Material Assessment		Disturbance Assessment		
Friability	Non-friable	Product Type	1	Occupancy	0	
Sample No.	Visual	Extent of damage	0	Disturbance	1	
Result	Assumed Positive Unknown or Crocidolite	Surface Treatment	1	Exposure	0	
		Asbestos Type	3	Maintenance	0	
Item Number	2	Material Score	5	Disturbance Score	1	
		Priority Score	6	Very Low		
No Additional Photographic Evidence Available
