CLIENT: CQ University Australia

SITE ADDRESS: Derby Road, Gladstone QLD 4680

AREA: Building 5 (Office Store) – Ground Level

PLAN TYPE: Asbestos

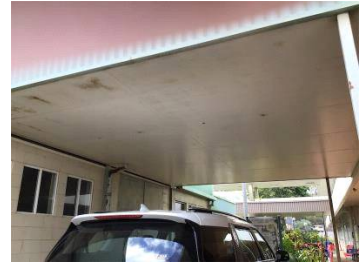
Location	Building 5 - Office Store - Ground Floor - External - Awning - Fibre cement sheet - West elevation				
Hazard Type	Asbestos	Material Assessment		Disturbance Assessment	
Friability	Non-friable	Product Type	1	Occupancy	0
Sample No.	3-883 (AO000129)	Extent of damage	0	Disturbance	1
Result	Positive Chrysotile	Surface Treatment	1	Exposure	0
		Asbestos Type	1	Maintenance	0
Item Number	1	Material Score	3	Disturbance Score	1
		Priority Score	4	Very Low
