COMPLIANCE ASBESTOS RE-INSPECTION AND RISK ASSESSMENT

NOVEMBER 2021

J033440

GLADSTONE CITY CAMPUS_Building 5 Derby Road
Derby Road
Gladstone QLD
4680

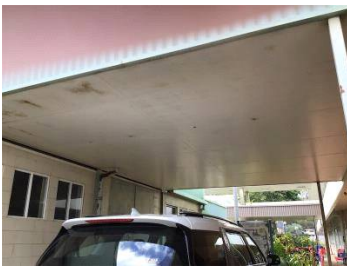
Location		Building 5 - Office Store - Ground Floor - External - Awning - Fibre cement sheet - West elevation									
Hazard Type		Asbestos		Material Assessment		Disturbance Assessment					
Friability		Non-friable		Product Type		1		Occupancy		0	
Sample No.		3-883 {AO000129}		Extent of damage		0		Disturbance		1	
Result		Positive Chrysotile		Surface Treatment		1		Exposure		0	
				Asbestos Type		1		Maintenance		0	
Item Number		1		Material Score		3		Disturbance Score		1	
				Priority Score		4		Very Low
