**ASBESTOS CONTAINING MATERIALS  
SURVEY REPORT**

**MARTIN HANSEN BUILDING 601  
Gladstone Marina Campus  
Bryan Jordan Drive, Queensland**

Report Number 622.10968.00000/0020-R01-BLD 601-ASR

28 September 2017

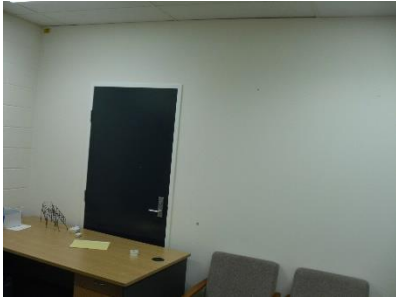
1st Floor G.06-1	WALL LINING - EASTERN ELEVATION, Fibrous Cement	4m <sup>2</sup>	NAD
3-754

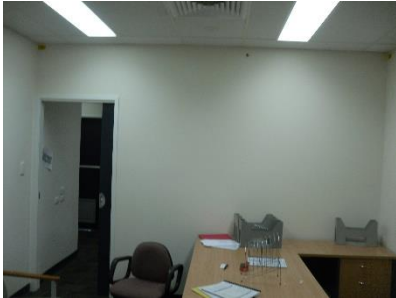
1st Floor G.06-1	WALL LINING - SOUTHERN ELEVATION, Fibrous Cement	m <sup>2</sup>	NAD

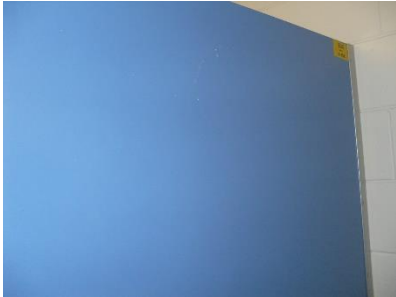
1st Floor G.T17	CUBICLE WALL - WESTERN ELEVATION, Fibrous Cement		NAD
3-759

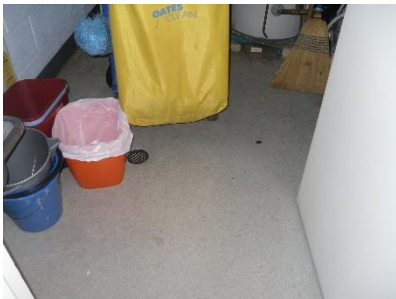
1st Floor G.14	VINYL SHEET, Vinyl Products		NAD
3-762

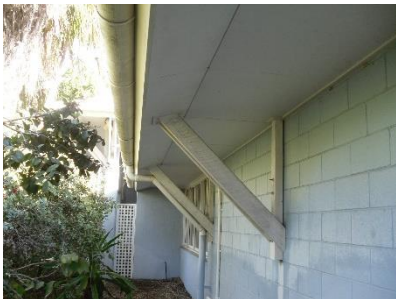
1st Floor EXTERNAL. EASTERN ELEVATION. OUTSIDE G.23	SOFFIT, Fibrous Cement		NAD

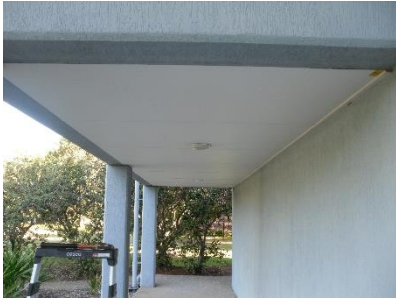
1st Floor EXTERNAL. EASTERN ELEVATION. OUTSIDE GS.51	SOFFIT, Fibrous Cement		NAD
3-763		1st Floor EXTERNAL. SOUTHERN ELEVATION. OUTSIDE G.09	SOFFIT, Fibrous Cement		NAD
3-764		1st Floor EXTERNAL. SOUTHERN ELEVATION. OUTSIDE G.S.52	SOFFIT, Fibrous Cement		NAD
3-765

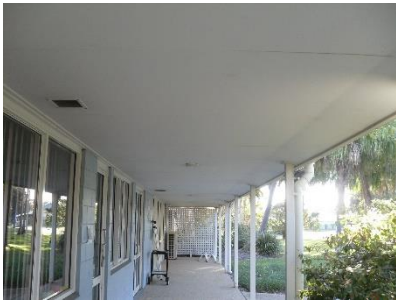
1st Floor EXTERNAL. NORTHERN ELEVATION. OUTSIDE G.47	SOFFIT, Fibrous Cement		NAD
3-765		1st Floor EXTERNAL. WESTERN ELEVATION.	SOFFIT, Fibrous Cement		NAD
Similar to 3-765		1st Floor EXTERNAL. LEVEL 2	SOFFIT - NORTH ,EAST, SOUTH AND WESTERN ELEVATIONS, Fibrous Cement		NAD

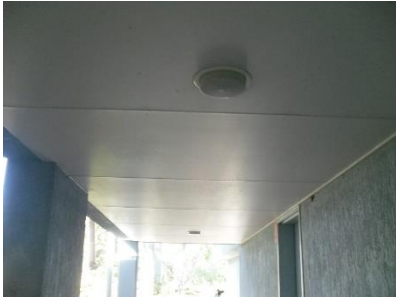
1st Floor EXTERNAL. EASTERN ELEVATION. OUTSIDE G.49	CEILING LINING, Fibrous Cement		NAD
