**ASBESTOS CONTAINING MATERIALS
SURVEY REPORT**

**BUILDING 604
ENVIRONMENTAL SCIENCE CENTRE
Gladstone Marina Campus
Bryan Jordan Drive, Gladstone Marina, Queensland**

Report Number 622.10968.00000/0020-R01-Bld 604-ASR

28 September 2017

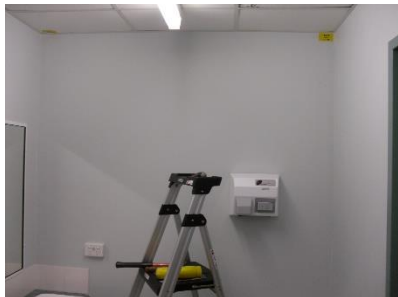
Ground Floor G.T04 MALE TOILET	WALL SHEETING - NORTHERN ELEVATION , Fibrous Cement	6m ²	NAD
3-767

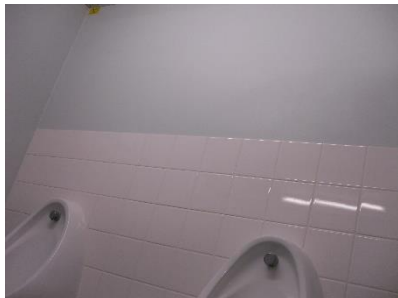
Ground Floor G.T04 MALE TOILET	WALL SHEETING - EASTERN AND SOUTHERN ELEVATIONS, Fibrous Cement	12m ²	NAD

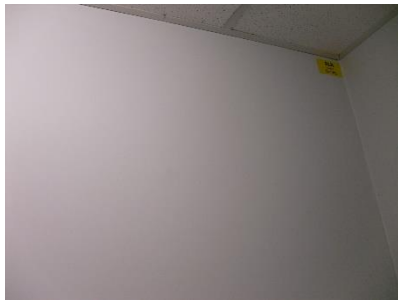
Ground Floor G.T04 MALE TOILET - HANDWASH AREA	WALL SHEETING - WESTERN ELEVATION , Fibrous Cement	6m ²	NAD
Similar to 3-768		Ground Floor G.T04 MALE TOILET - HANDWASH AREA	WALL SHEETING - NORTH,EASTERN AND SOUTHERN ELEVATIONS, Fibrous Cement	14m ²	NAD
3-769		Ground Floor G.T04 MALE TOILET	CEILING, Fibrous Cement	6m ²	NAD
3-770

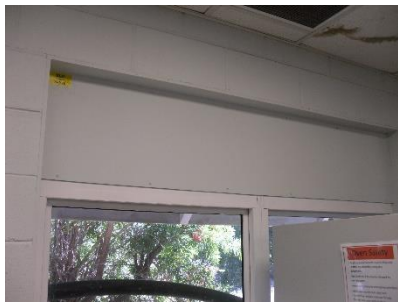
Ground Floor G.14	INFILL PANEL - WESTERN ELEVATION , Fibrous Cement	1m ²	NAD

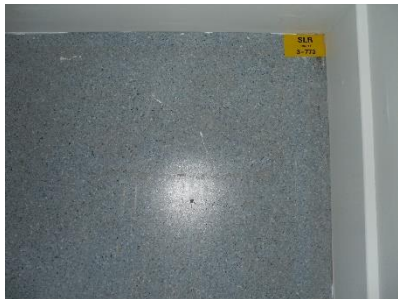
Ground Floor G.P.a08 UNDERNEATH THE STAIRWELL	VINYL SHEETING TO FLOOR, Vinyl Products	6m ²	NAD
3-774

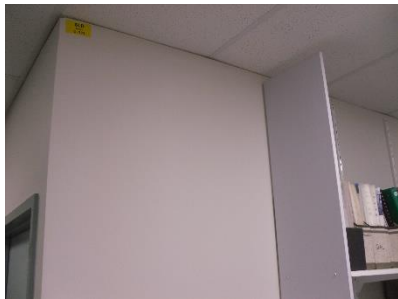
Ground Floor LEVEL 1. ROOM 1.06	WALL SHEETING - SOUTHERN ELEVATION , Fibrous Cement	4m ²	NAD
Similar to 3-774		Ground Floor LEVEL 1. ROOM 1.06	WALL SHEETING - NORTHERN AND EASTERN ELEVATIONS, Fibrous Cement	8m ²	NAD

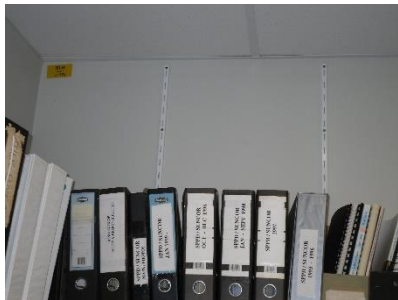
Ground Floor LEVEL 1. ROOM 1.06	WALL SHEETING - WESTERN ELEVATION , Fibrous Cement	4m ²	NAD
3-781

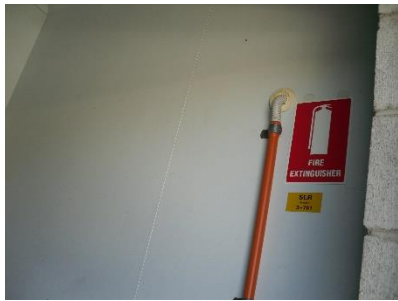
Ground Floor GP.28	WALL SHEETING - EASTERN ELEVATION , Fibrous Cement	6m ²	NAD
3-783

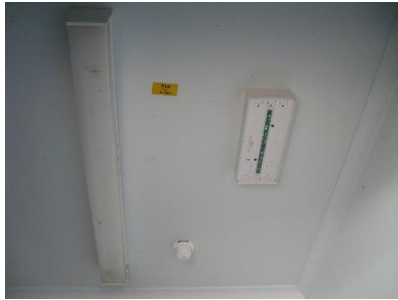
Ground Floor GP.28	CEILING , Fibrous Cement	6m ²	NAD

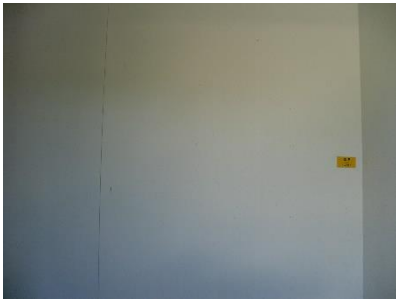
Ground Floor GP.28	WALL SHEETING - NORTHERN ELEVATION , Fibrous Cement	6m ²	NAD
3-785

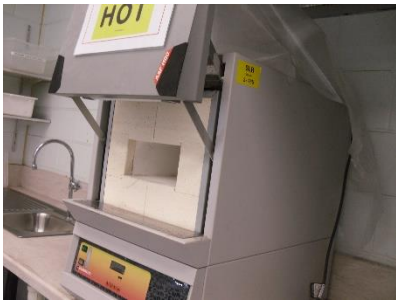
Ground Floor G.14	CARBOLITE OVEN - INTERNAL LINING , Fibrous Cement	6m ²	NAD
3-776	 	Ground Floor EXTERNAL	SOFFIT - NORTHERN ELEVATION , Fibrous Cement	20m ²	NAD

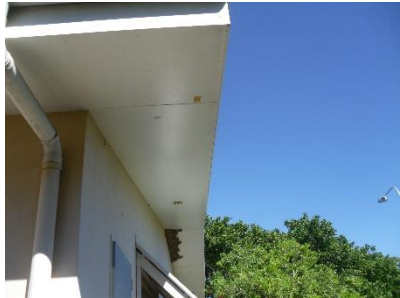
Ground Floor EXTERNAL	SOFFIT - WESTERN ELEVATION , Fibrous Cement	20m ²	NAD
3-779

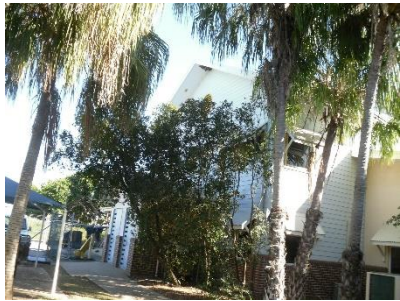
Ground Floor EXTERNAL	SOFFIT - EASTERN ELEVATION , Fibrous Cement	20m ²	NAD

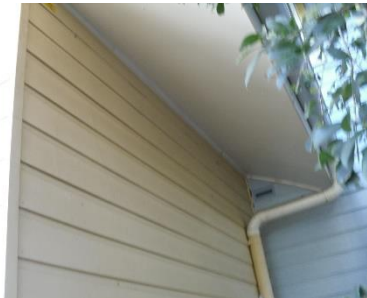
Ground Floor EXTERNAL	CLADDING - SOUTHERN ELEVATION, Fibrous Cement	25m ²	NAD
