**ASBESTOS CONTAINING MATERIALS
SURVEY REPORT**

**BUILDING 610
GLADSTONE ENGINEERING CENTRE PELM CELL 6 & 8
Gladstone Marina Campus
Bryan Jordan Drive, Gladstone Marina, Queensland**

Report Number 622.10968.00000/0020-R01-Bld 610-ASR

28 September 2017

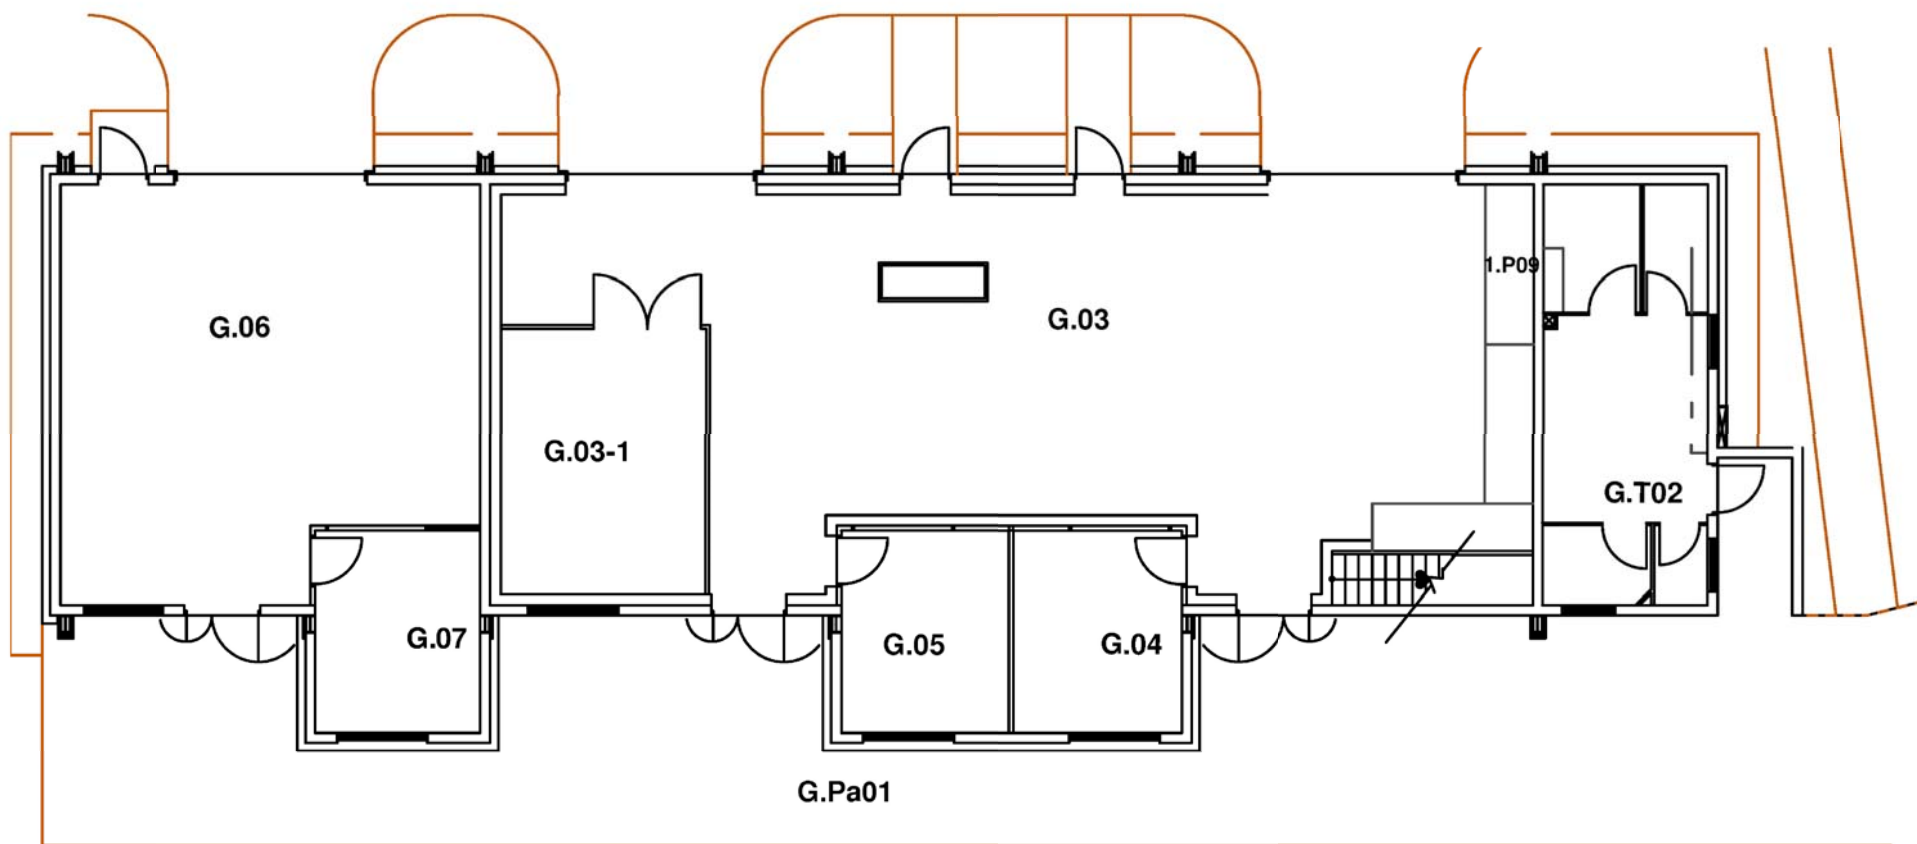
Building No:	610
Inspection Date:	24/07/17 - 27/07/17
Inspected By:	NC
Figure No.:	SLR62210968-610-01
Drawn By:	LF
Drawn Date:	07/9/17

No Samples Taken
No Asbestos Detected
