ASBESTOS CONTAINING MATERIALS SURVEY REPORT

BUILDING 603
LEO ZUSSINO Building (Engineering Trade Centre)
Gladstone Marina Campus
Bryan Jordan Drive, Gladstone Marina, Queensland

Report Number 622.10968.00000/0020-R01- Bld 603-ASR

29 September 2017

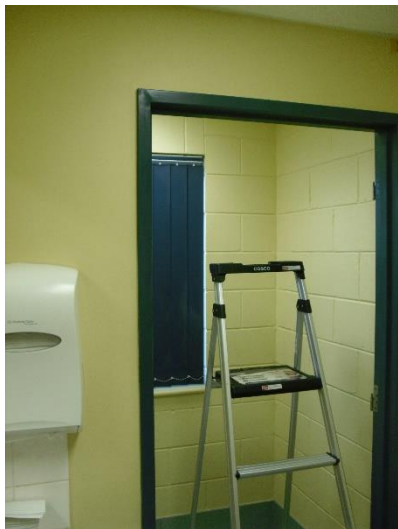
1st Floor GT.17	WALL SHEETING - EASTERN ELEVATION, Plaster Board		NAD
3-722

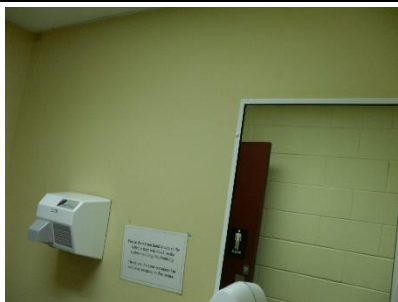
1st Floor GT.17	WALL SHEETING - SOUTHERN ELEVATION, Plaster Board		NAD

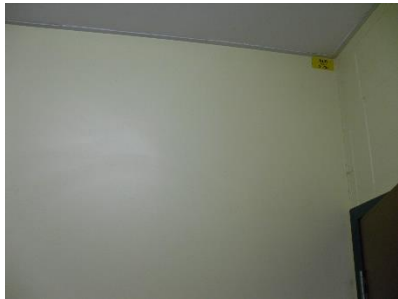
1st Floor GT.17	WALL SHEETING - EASTERN ELEVATION, Plaster Board		NAD
3-724

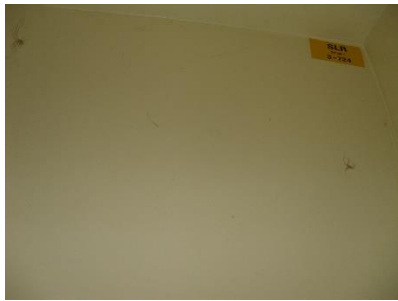
1st Floor GT.22	WALL SHEETING - WESTERN ELEVATION, Plaster Board		NAD
3-725

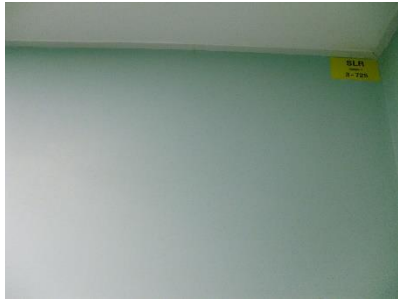
1st Floor GT.43	WALL LINING - NORTHERN ELEVATION, Fibrous Cement		NAD

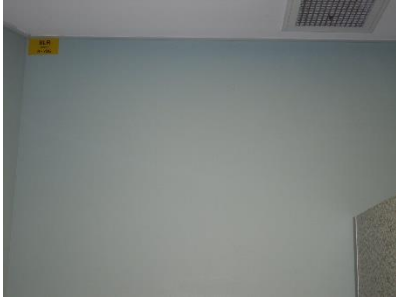
1st Floor GT.43	EASTERN CUBICLE - SOUTHERN ELEVATION - WALL, Fibrous Cement		NAD
3-727

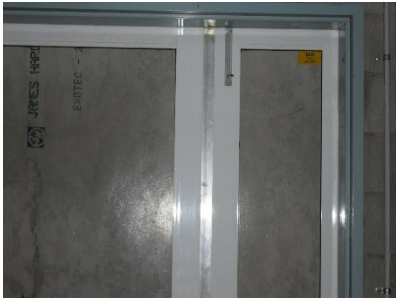
1st Floor GT.38	LINING TO DOOR - NORTHERN ELEVATION , Fibrous Cement		NAD
3-728

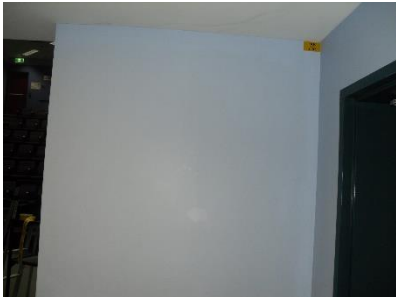
1st Floor G.35	WALL LINING - ENTRY POINT TO ROOM -NORTHERN ELEVATION, Fibrous Cement		NAD

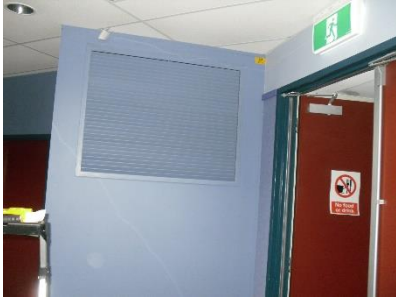
1st Floor G.35	WALL LINING -NORTHERN ELEVATION, Fibrous Cement		NAD
3-730

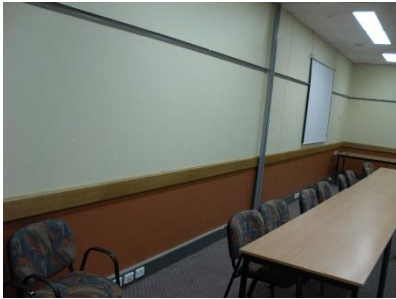
1st Floor G.31	LOWER WALL - NORTHERN ELEVATION, Fibrous Cement		NAD
3-731

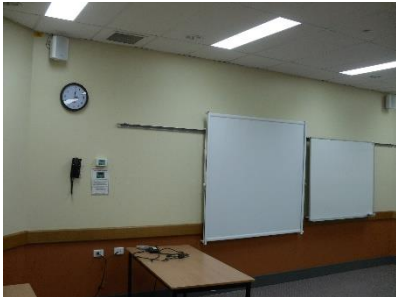
1st Floor G.31	WALL SHEETING - WEST ELEVATION, Fibrous Cement		NAD

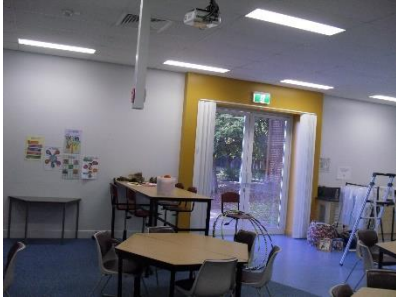
1st Floor G.25	WALL SHEETING - WEST ELEVATION, Fibrous Cement		NAD
3-733

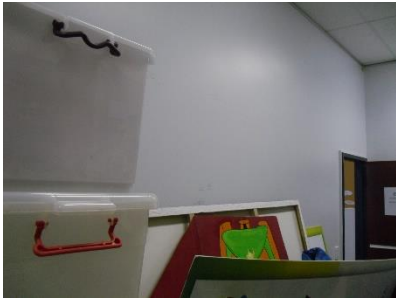
1st Floor G.25-2	WALL SHEETING - WEST ELEVATION, Fibrous Cement		NAD
3-734

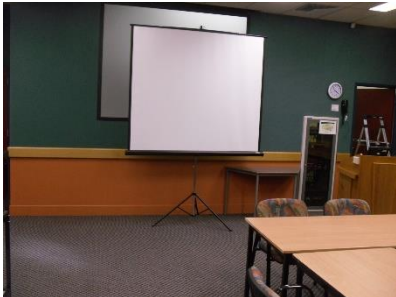
1st Floor G.28	LOWER WALL SHEETING - SOUTHERN ELEVATION, Plaster Board		NAD

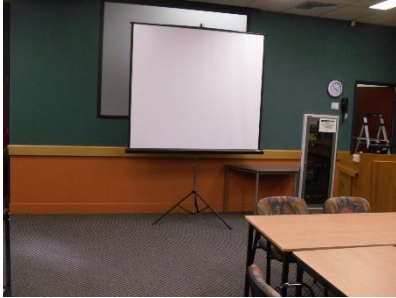
1st Floor G.PA04	WALL SHEETING - SOUTHERN ELEVATION, Plaster Board		NAD
3-736

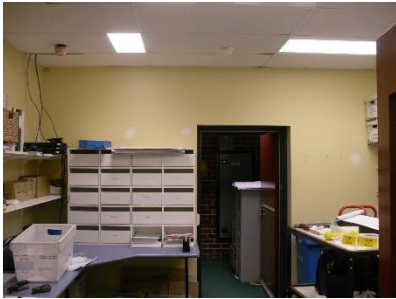
1st Floor G.05	WALL SHEETING - NORTHERN ELEVATION, Fibrous Cement		NAD
3-737

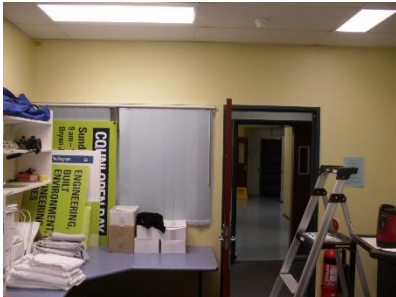
1st Floor G.05	WALL SHEETING - WESTERN ELEVATION, Fibrous Cement		NAD

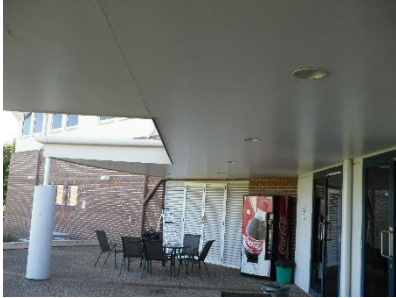
1st Floor EXTERNAL - COVERED AREA - ADJACENT TO G.P47	CEILING LINING, Fibrous Cement		NAD
3-745

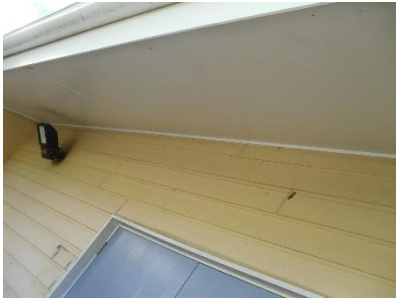
1st Floor EXTERNAL - SOUTHERN ELEVATION - ADJACENT TO G.S48 LOADING DOCK	SOFFIT, Fibrous Cement		NAD
3-746

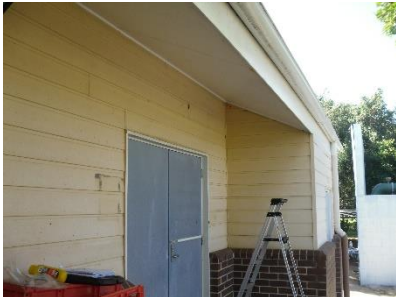
1st Floor EXTERNAL - SOUTHERN ELEVATION - LOADING BAY - SOFFIT	WALL CLADDING , Fibrous Cement		NAD

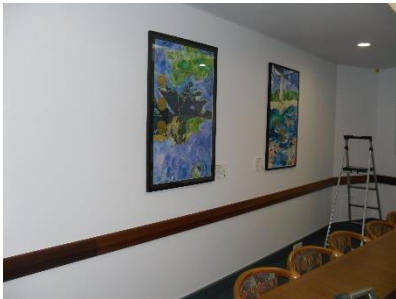
2nd Floor 1.12	WALL SHEETING - WESTERN ELEVATION, Fibrous Cement		NAD
3-739

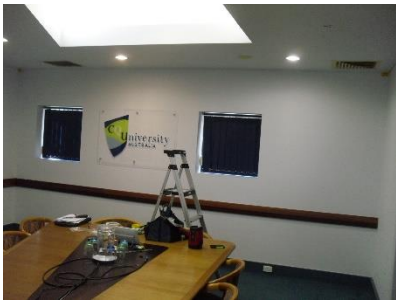
2nd Floor 1.12	WALL SHEETING- NORTHERN ELEVATION , Fibrous Cement		NAD
3-740

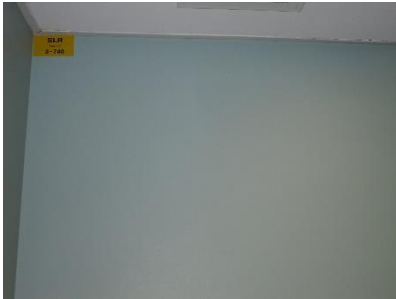
2nd Floor T.13	WALL SHEETING - NORTHERN ELEVATION, Fibrous Cement		NAD

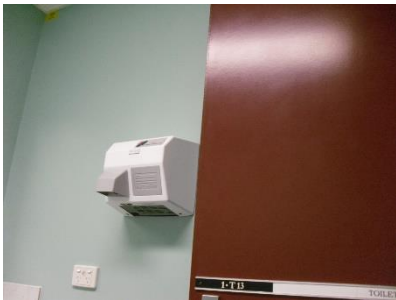
2nd Floor T.13	WALL SHEETING - EASTERN ELEVATION, Fibrous Cement		NAD
3-742

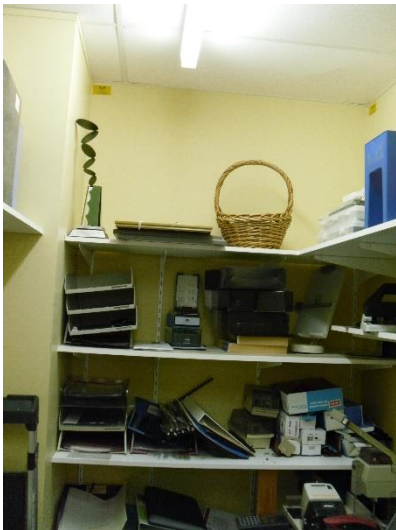
2nd Floor 1.21	WALL SHEETING - EASTERN ELEVATION, Plaster Board		NAD

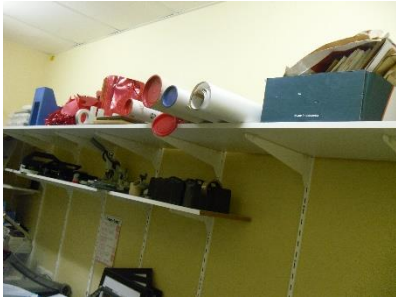
2nd Floor 1.21	WALL SHEETING - SOUTHERN ELEVATION, Plaster Board		NAD
